CIVIL AVIATION AUTHORITY OF VIETNAM

**FINAL REPORT¹
INVESTIGATION RESULT OF SERIOUS INCIDENT
LANDED ON RUNWAY UNDER CONSTRUCTION
ON 29/04/2018 AT CAM RANH INTERNATIONAL AIRPORT**

Hanoi, July 2018

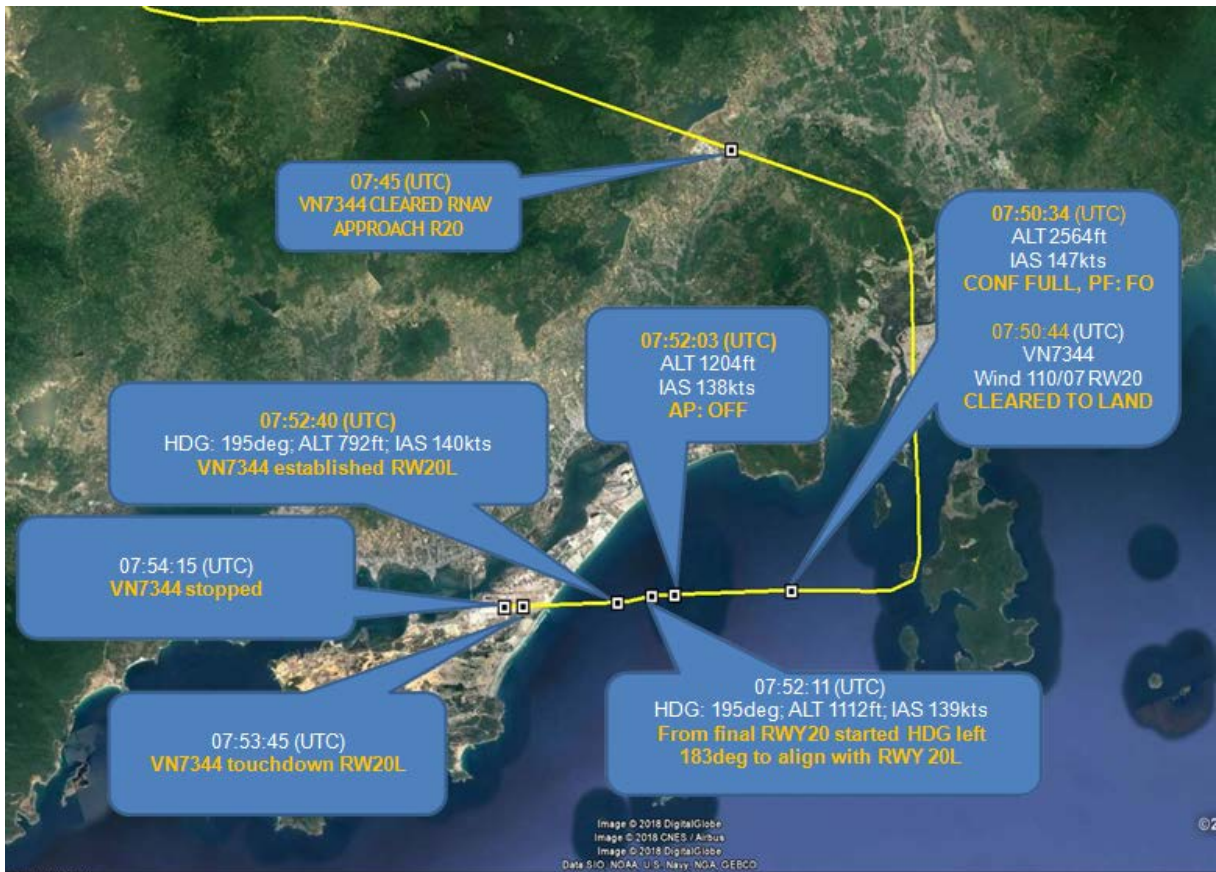
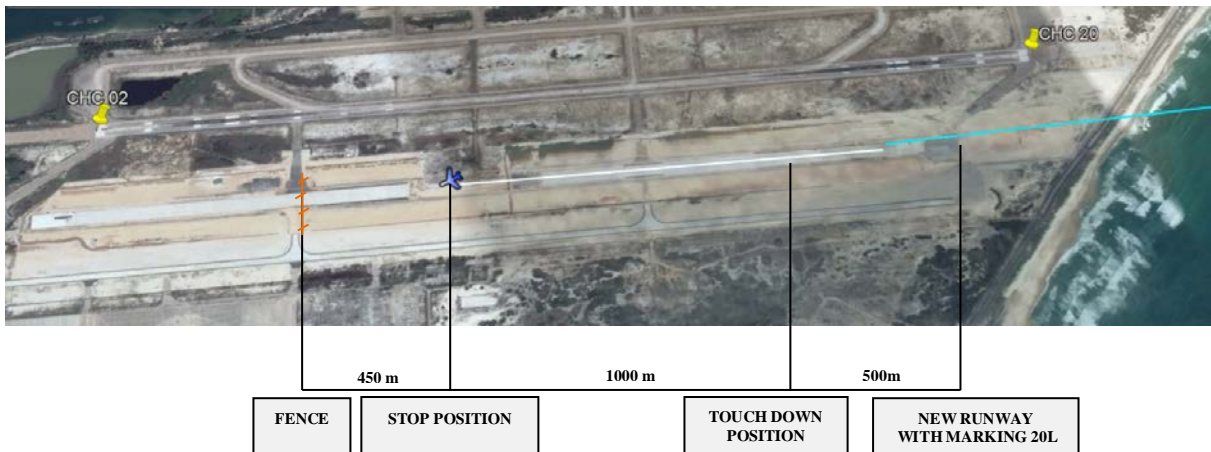
On April 29th 2018 14:53 (Local time), Vietnam Airlines flight crews operated A321 aircraft which was registered as VN-A613, made flight number VN 7344 route SGN-CXR. After implementing RNAV landing approach on runway RWY 20, in the Short Final at the altitude of 1204ft., the crew had turned off the auto-pilot and flight director functions, then performed the visual procedure and landed on the wrong runway, was under construction and had not put into operation at Cam Ranh International Airport.

The flight crew noticed that they landed on the wrong runway, then they implemented emergency stop on the aircraft right after the touch down process. The distance between the touch down and the RWY №2 runway heading (marked 20L) was about 500m. The distance between the touch down and the position where the aircraft was completely stopped was about 1000m. The distance between the stop position and the fence was about 450m.

Because of impediments which were rocks and building materials, the flight crew processed the emergency stop to prevent these obstacle courses. After the aircraft completely stopped on the runway RWY №2, the flight crew contacted the command tower and received a stop order. The flight crew turned off the main engine, then used auxiliary engine and waited for ground vehicle to take passengers to the airport terminal.

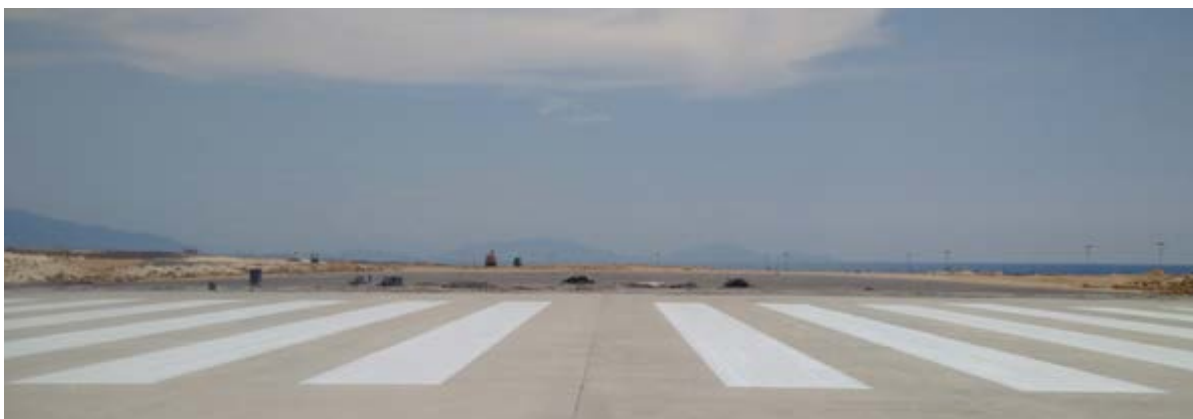
At the time of the incident, the heading of the runway № 2 which is near the 02 heading of the operating runway was still under construction. There were some rubbish and construction materials on the other heading of the runway № 2, where the incident occurred near the 20 heading. The painted marks are clear on the runway № 2 painted with mark 20L in which the letter L is coincident to the center line of the runway; the touch down area and the center of the runway were clearly painted with marks.

(View: Aircraft approaching)

+ Actual observation of the RWY heading from cockpit position, the “20” mark of the runway № 2 is more clear than the mark of the RWY 20 which is currently in operation.

- Inspect and guarantee the paint condition, airport markings based on standards, usually erase gums on the runway surface which is in operation at Cam Ranh international airport.

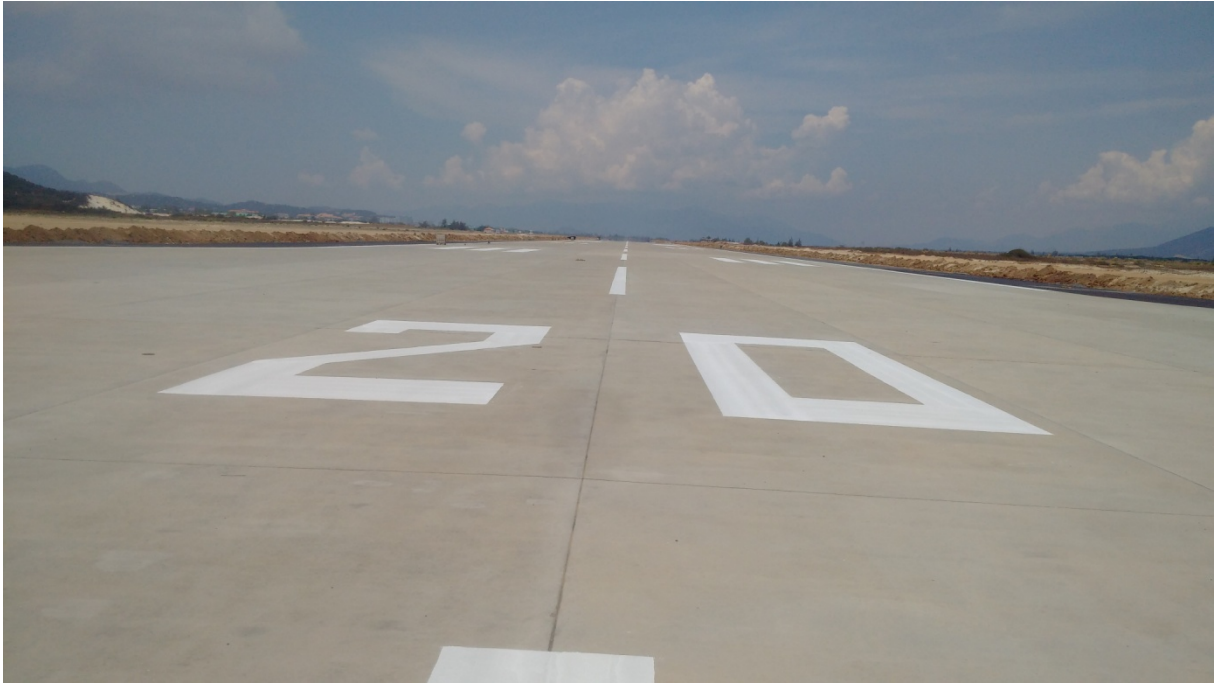
(View: Aircraft landing)

+ There is no warning sign of the no use runway when observing at the RWY 20L heading.

- Although new runway has shown no use (crossed out) on the airport map, however, the runway markings are already available on new runway and more visible than on the current runway, causing confusion for the flight crew.

- Immediately applying necessary solutions to inform and warn the aviation corporations who operate at Cam Ranh airport about unused runway.

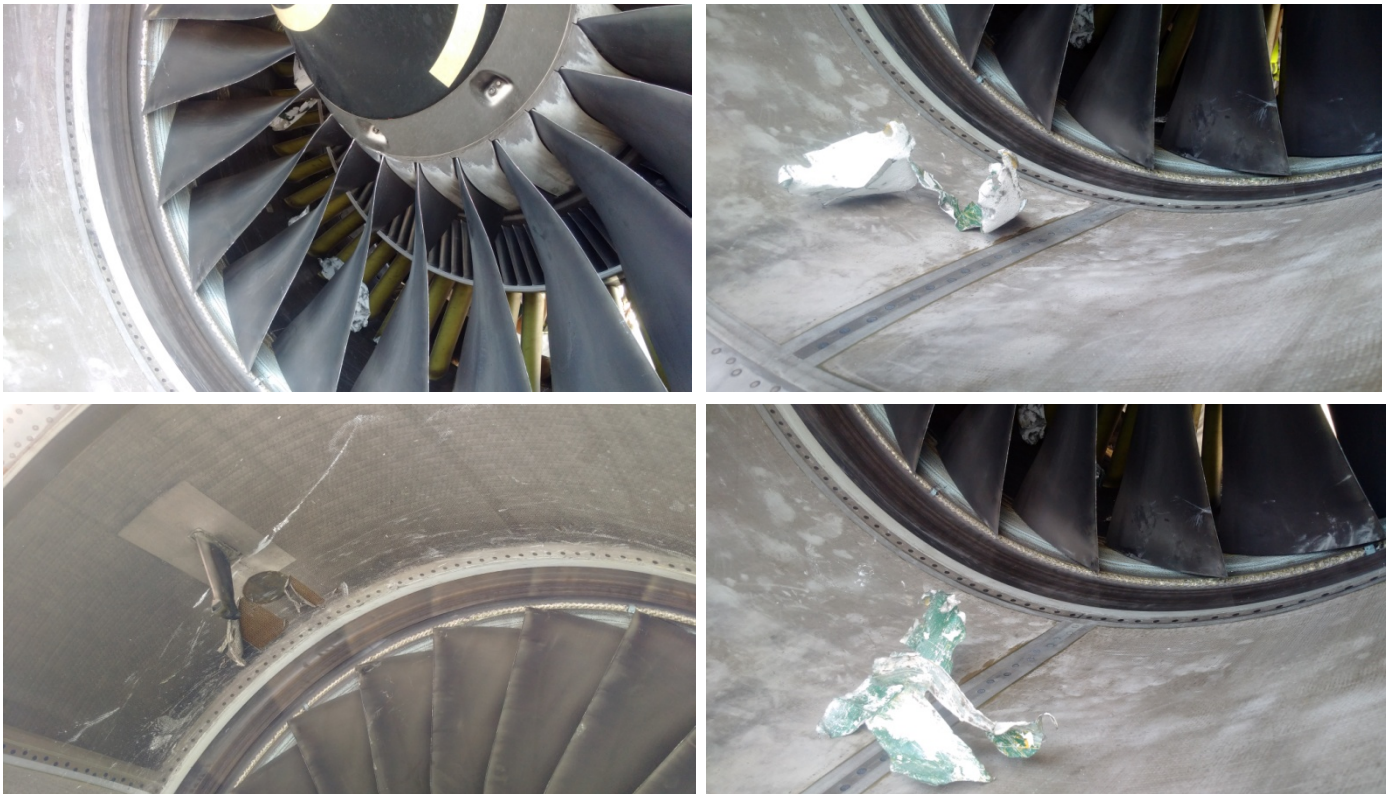
- a) Injuries to persons: no consequence
- b) Damage to aircraft:
 - i. The engine number 1's fan blades and intake area are damaged because of impediments which are gravels, rocks, iron pieces. The main part of the engine including compressor, combustion and turbine are under inspection and evaluation.
 - ii. LH is slightly damaged.

- iii. Vietnam Aviation Corporation is examining and evaluating aircraft damage (if any).
