CIVIL AVIATION AUTHORITY OF VIETNAM

**FINAL REPORT<sup>1</sup>**  
**INVESTIGATION RESULT OF SERIOUS INCIDENT**  
**HARD LANDING ON NOSE LANDING GEAR**  
**AIRBUS A321 MSN 8199 (VN-A653)**  
**FLIGHT VJ356 ON NOVEMBER 29<sup>TH</sup> 2018**

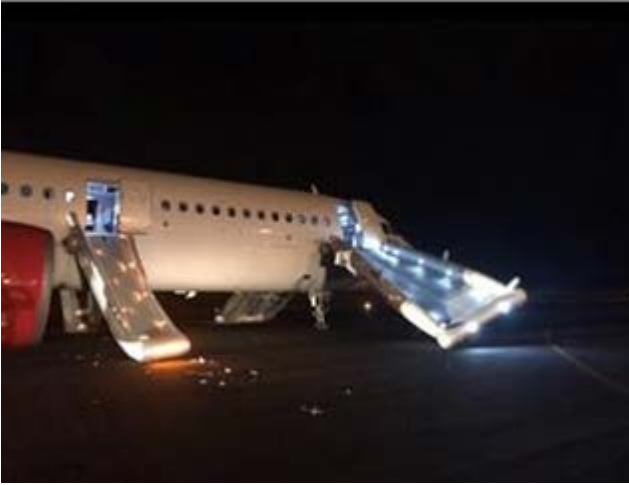
*Picture 01.*

At 16:02, the aircraft landed on RWY 09 at BMV airport, Buon Me Thuat city. In touch-down and deceleration process, 02 nose wheels fractured and separated from the nose landing gear. After completely stopped on the runway, the aircraft was incapable to move (see *Picture 01*). Flight crews carried out emergency procedure and evacuated passengers based on operation procedure. The total of 207 passengers were safely evacuated (see *Picture 02*).

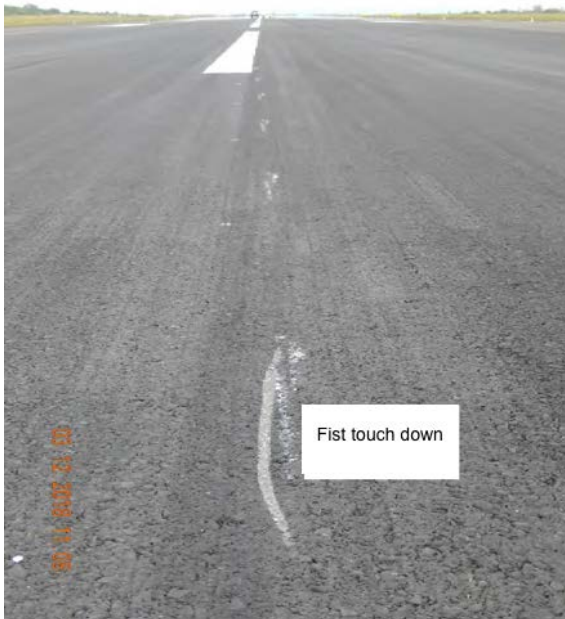
*Picture 04.*

The first touch-down mark of nose landing gear on RWY 09 was found at 659m from the beginning of the runway (see *Picture 04*).

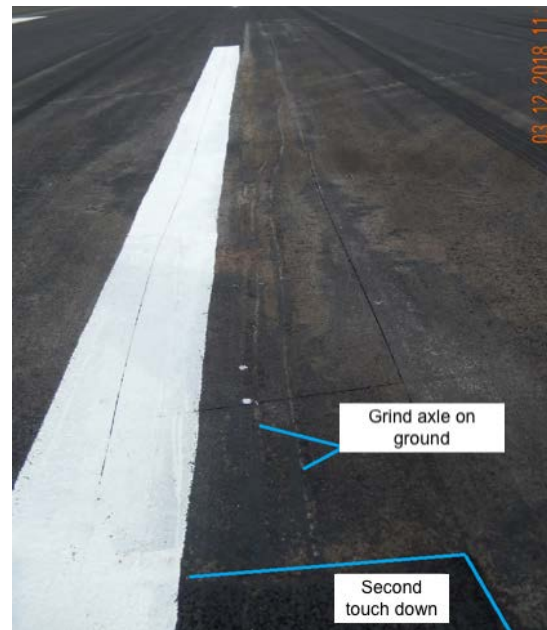
*Picture 05.*

The second mark was found at 17m after the first one and at 676m from the threshold of the runway (see *Picture 05* and *Picture 06*). This mark prolonged to the

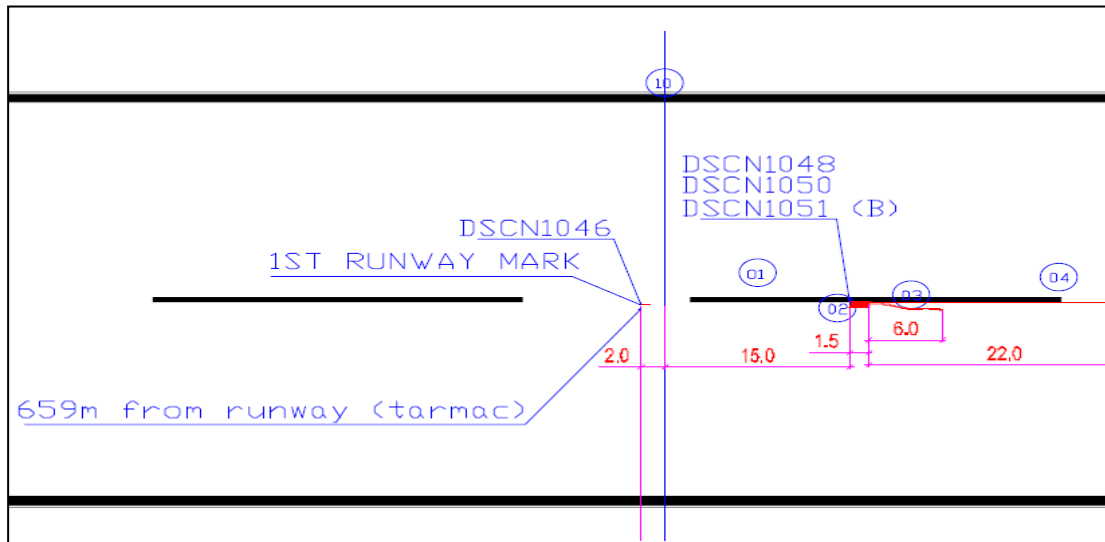
*Picture 06.*

Diagram shows the position of found broken pieces of wheels and nose landing gear (see *Picture 06*).

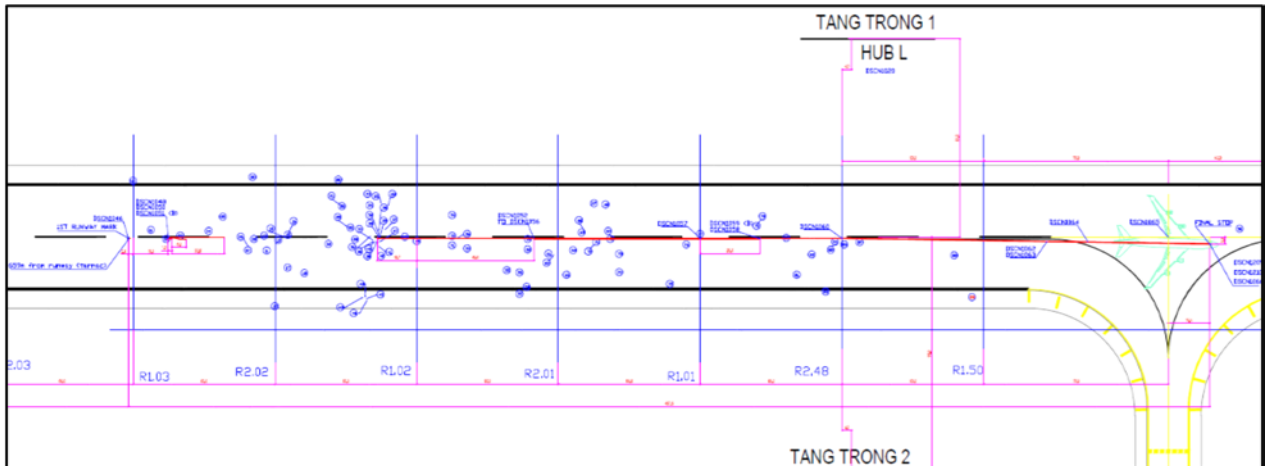
Picture 07.

point where the aircraft was completely stopped. It was 1116m from the threshold of the runway and 3m to the right of the center line of the runway (see *Picture 07*).

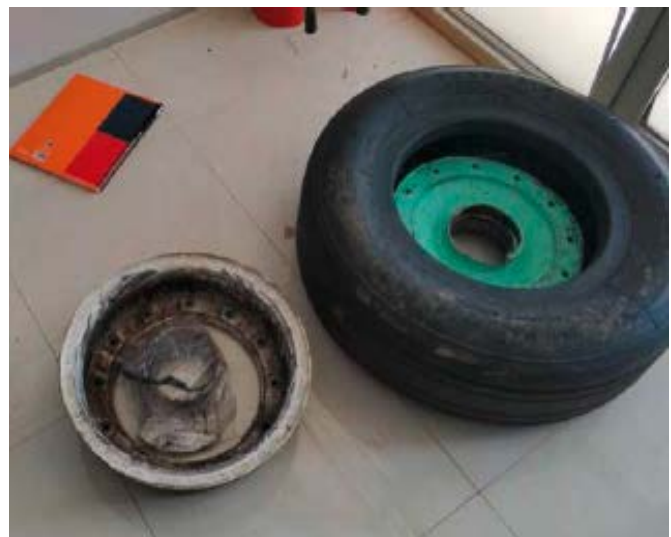
Picture 09.

- + There was no damage on the tires (no tear, no blow-out);
- + The outer wheel half & tyre were separated and the bearing hub was separately broken from the inner wheel half (see *Picture 09*);
- + Some tie bolts were found broken (see *Picture 10*).

The wheel halves and tie bolts were tested for hardness, microstructure and fracture surface examination. The results indicated that the materials were in accordance to production requirements and the fracture surfaces were consistent with failure due to overload.

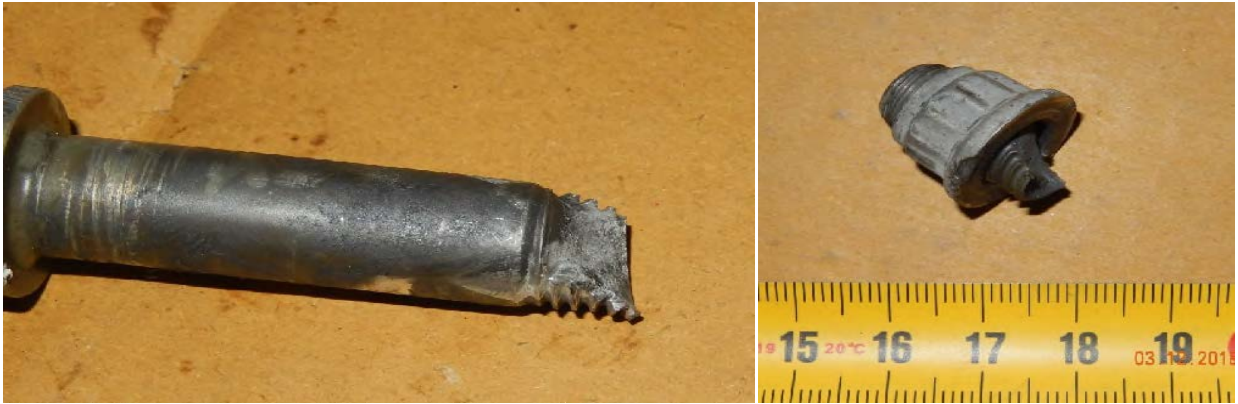
Picture 10.

- The examination result of nose gear axle and tiebolts indicated that the components were affected by a very high static impact load leading to failure due to overload. As a result, consequential damages to the wheels and aircraft fuselage were formed.

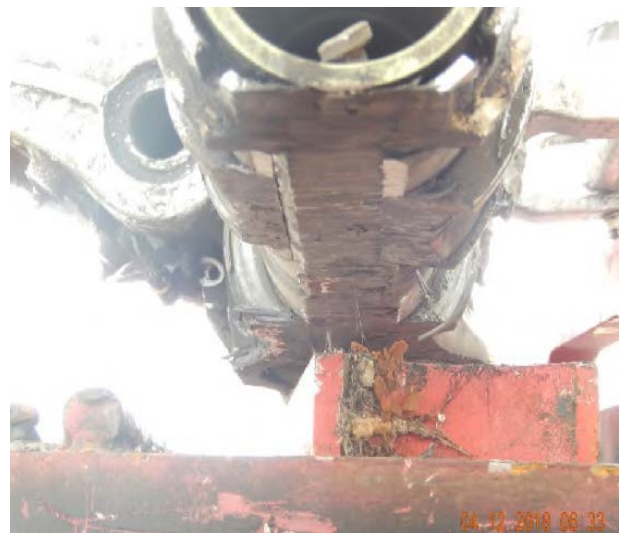
Picture 12.

- Nose landing gear (NLG) was severely damaged with grinded NLG axle (see *Picture 12*). After inspecting nitrogen pressure of nose landing gear and NLG shock absorber, the extension of NLG shock absorber was 20.4cm (normal extension is 44.9cm) (see *Picture 11* - NLG structure diagram).

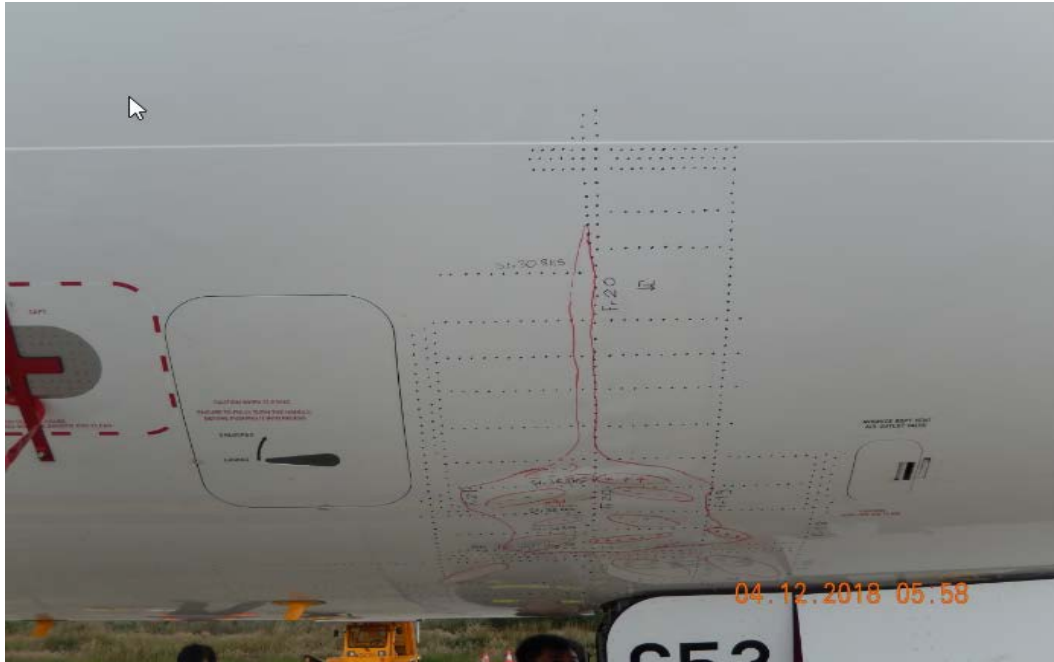
Picture 13.

- Fuselage: There was some dents at frame number 20 area at the bottom right of the fuselage (*Picture 13*).

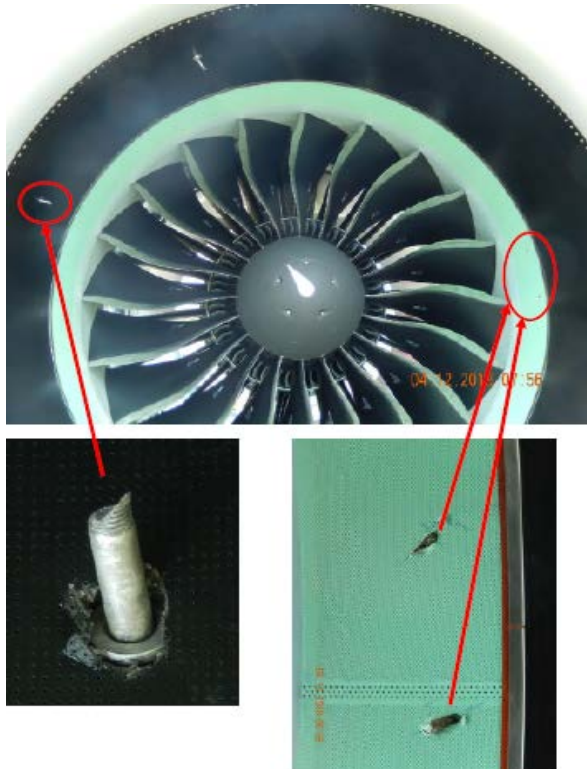
Picture 14.

- Left engine: 03 damages at the inner surface of the air inlet (see *Picture 14*), 02 fan blade (see *Picture 15*) and fan case.

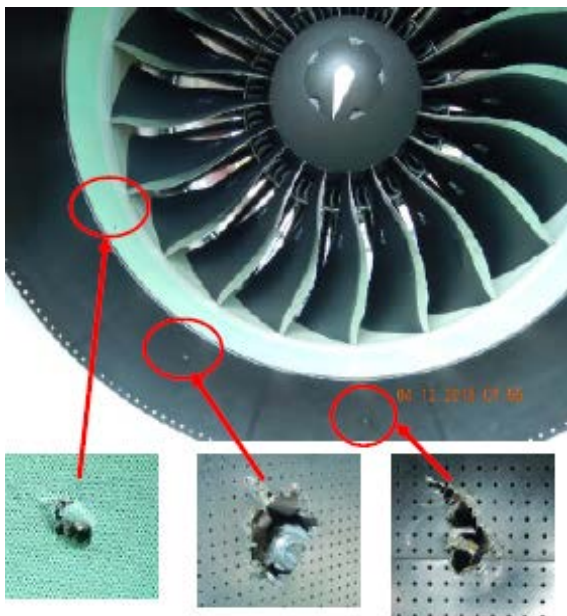
Picture 16.

- Right engine: 03 damages at the inner surface of the air inlet (see *Picture 16*) and 03 fan blade (see *Picture 17*).

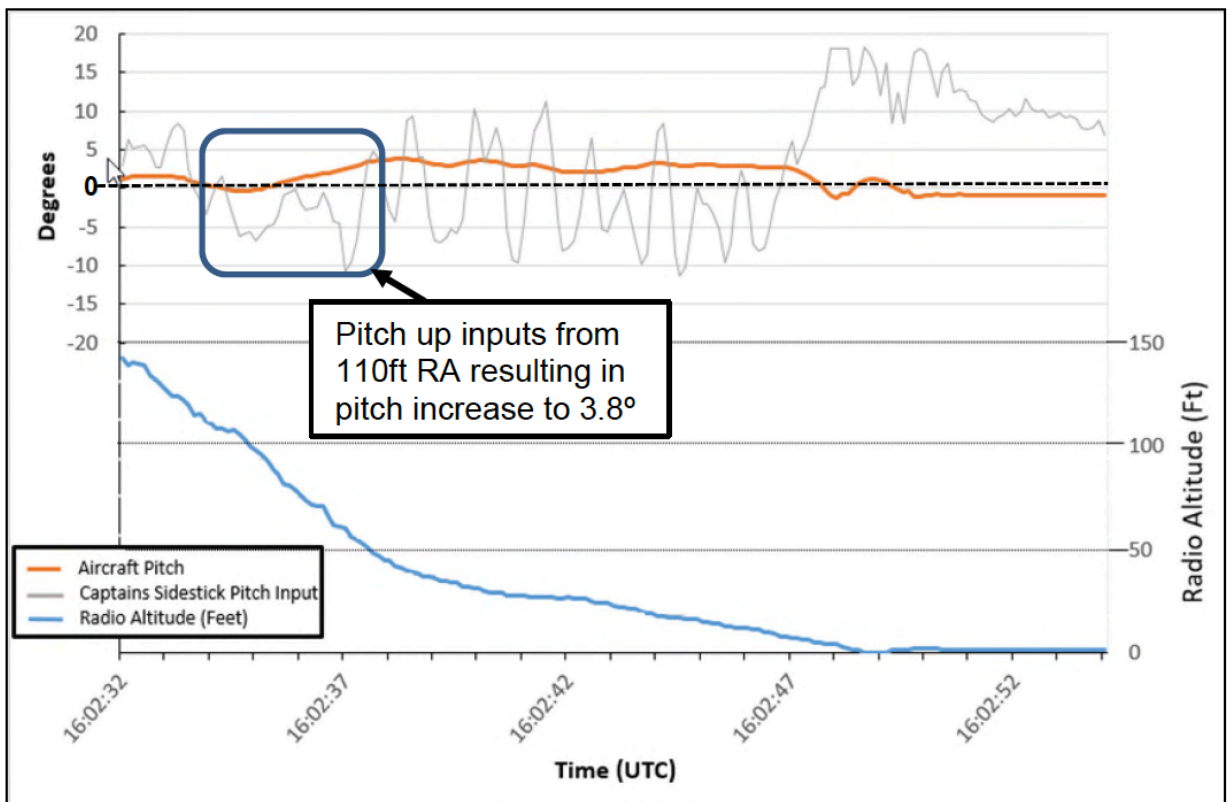
*Picture 18.*

At 16:02:34, from 110ft RA, pitch up inputs were continuously applied to the captain sidestick, up to  $10^{\circ}$  (about 2/3 of full back stick) caused aircraft pitch increased from  $0.2^{\circ}$  nose down to  $3.8^{\circ}$  nose up. Descent rate started to decrease from -640fpm, and CAS reduced from 139kts to 131kts (the approach speed target was 134 kts).

Analysis: The continuously applied sidestick input caused the aircraft pitch up to  $3.8^{\circ}$ . Thus descent rate and aircraft descent rate reduced and aircraft speed decreased below its target. Consequently, the engaged autothrust had to increase engine thrust to maintain target speed (see *Picture 18*).

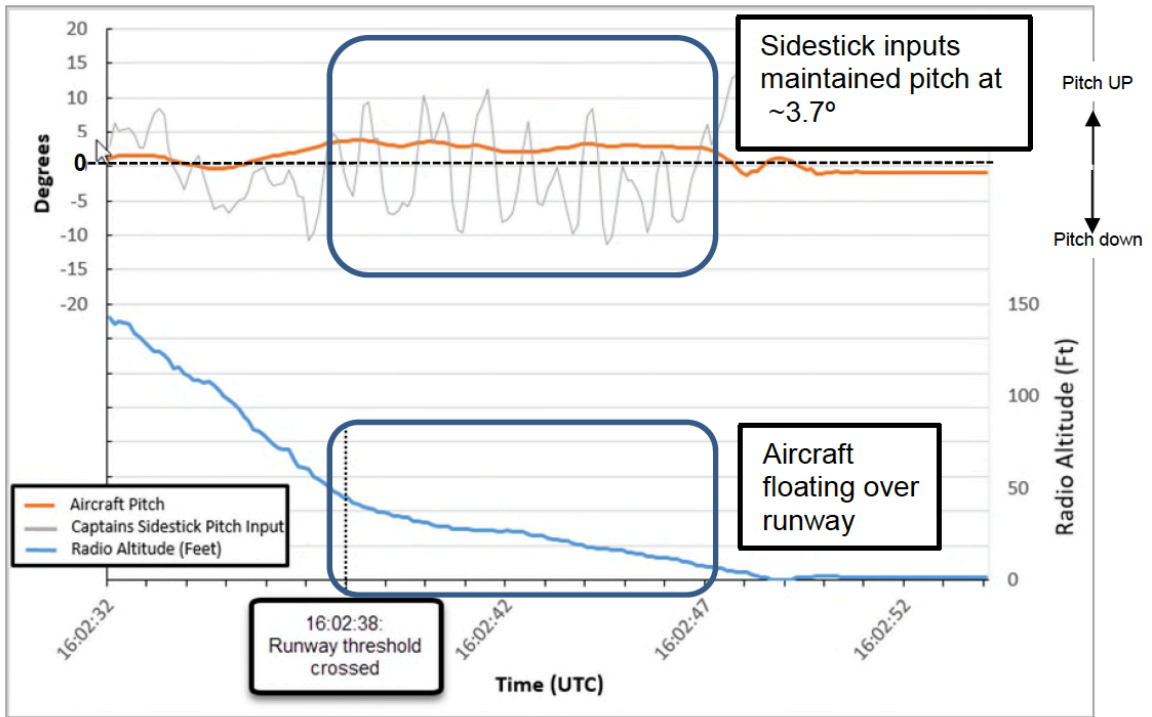
Picture 19.

From 16:02:39 to 16:02:47, aircraft floated over runway with  $3.7^{\circ}$  pitch-up (see *Picture 19*).

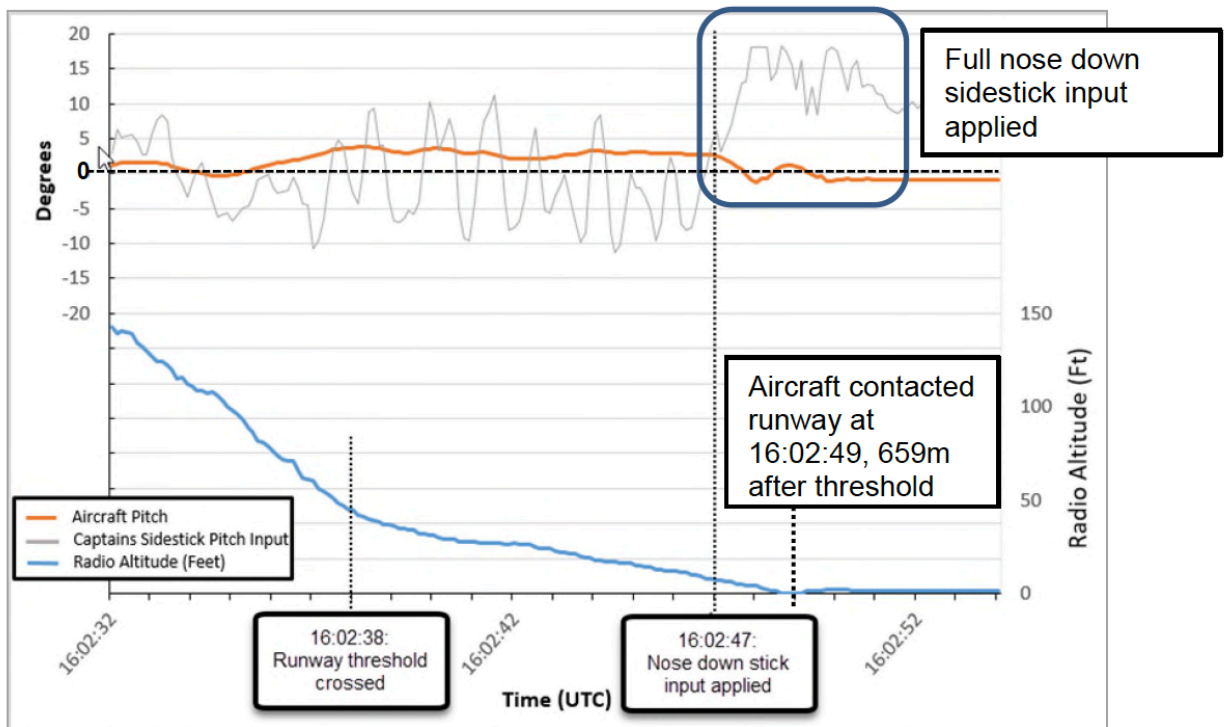
Picture 20.

At 16:02:47, The aircraft was at 9ft RA with a pitch of 2.80 nose up and a rate of descent of 320 fpm (see Picture 20). At this value, the aircraft would normally touchdown within the next few seconds. Captain pushed the sidestick full forward.

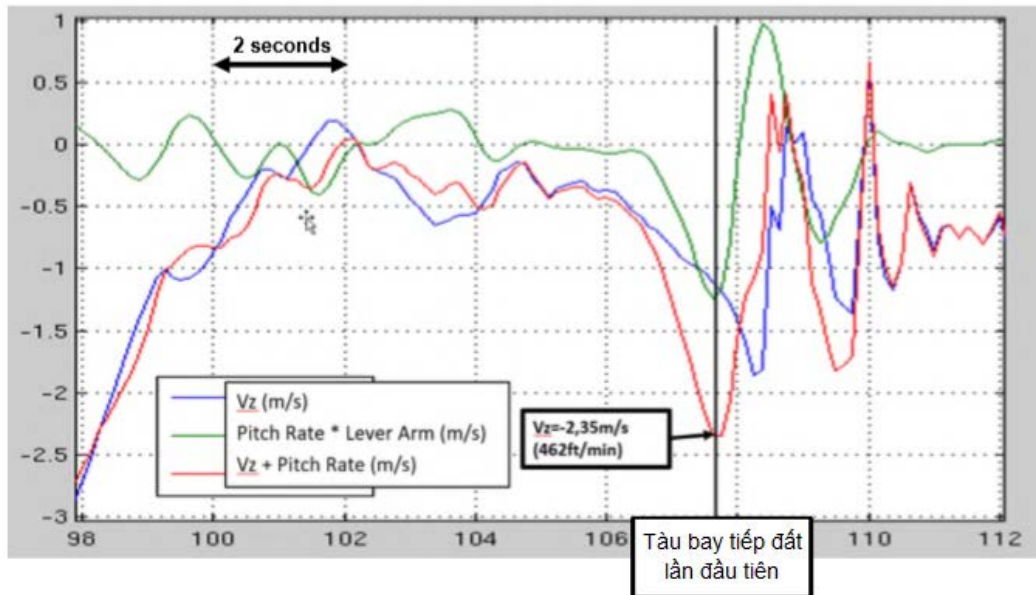
Picture 22.

At touch down moment, aircraft descent rate and NLG descent rate due to pitch rate had the same magnitude. Therefore, pitch down command effectively doubled the descent rate of NLG, resulting in a higher load on NLG at touch down (see *Picture 22*).

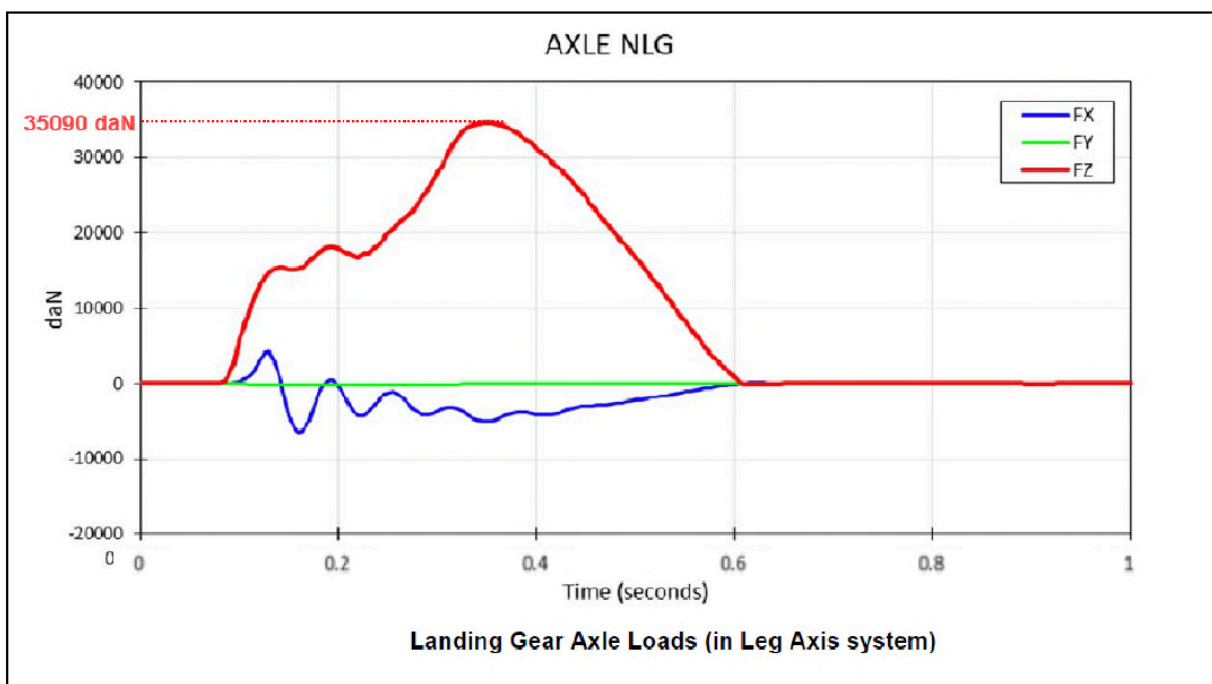
Picture 23.

Load simulation was performed to get the baseline of the loads based on undamaged NLG and without tire bottoming (See *Picture 23*). It provided a load exerted on the NLG of 35090 daN. However, both NLG and tires were damaged in the actual incident, so the NLG load should be higher than the baseline simulation load.

Compared with the critical buckling load of NLG shock absorber which is 28548daN, the baseline simulation load of 35090 daN exceeds this limit. Thus shock absorber has bore a high load at NLG touch down moment.

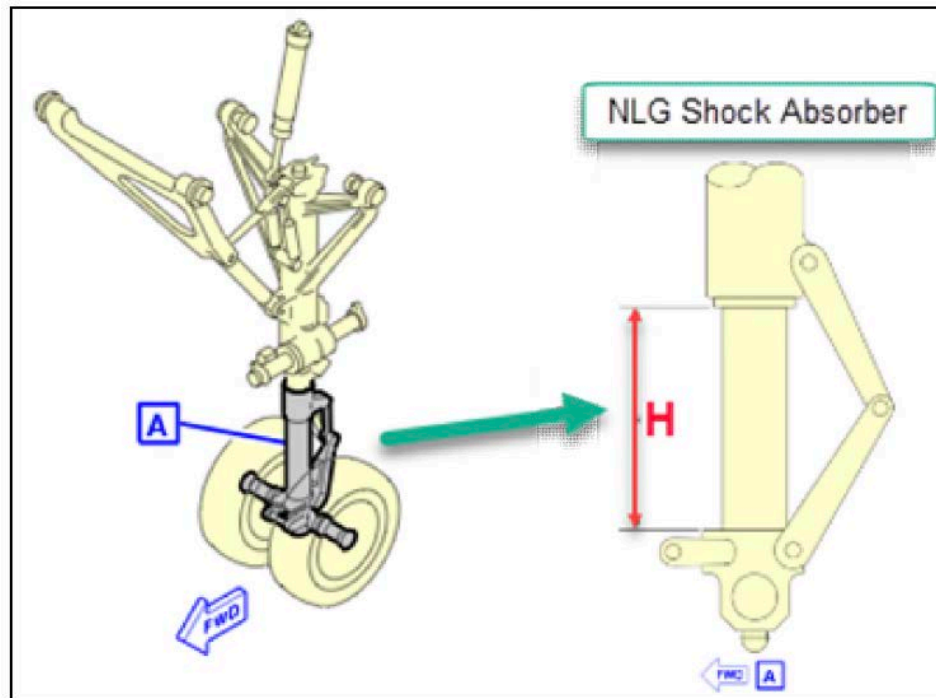
*Picture 24.*

Besides, the length **H** of the shock absorber was measure at 20.4cm (see *Picture 24*). The length **H** of normal shock absorber is 44.9cm when the NLG is fully extended. It means that the NLG had buckled so the damping capability of shock absorber was decreased and NLG had to bear higher load than the baseline simulation load.
