**FINAL REPORT<sup>1</sup>**

**INVESTIGATION RESULT OF SERIOUS INCIDENT**

**VIETNAM AIRLINES UNCONTAINED ENGINE**

**AIRBUS A321 MSN 5306 (VN-A392)**

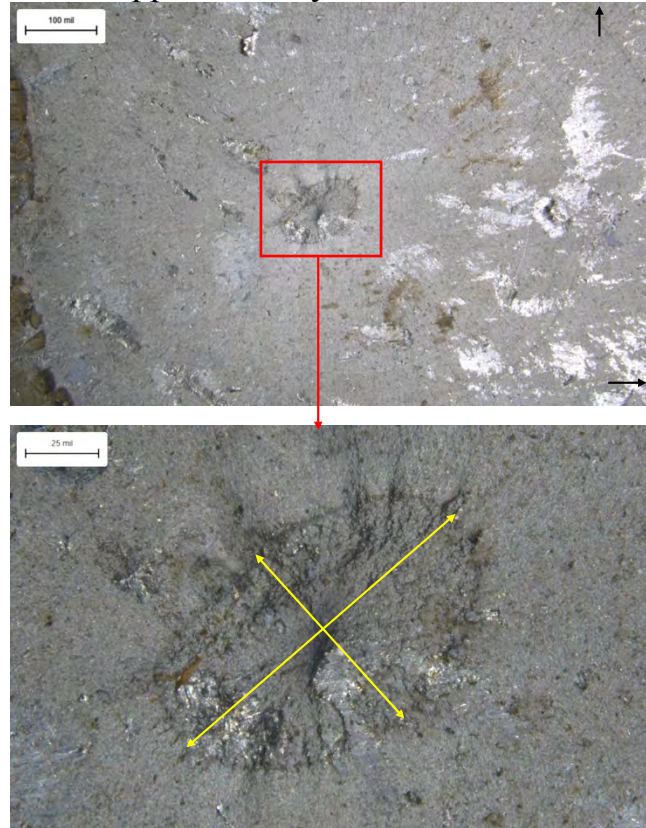
*Picture 32*

Further visual and binocular review of the fracture surface identified cyclic markers throughout the crack progression surrounding the oval shaped origin area. The oval shaped origin region appeared rougher textured compared to the surrounding

area. This region measured approximately 0.120" x 0.075"

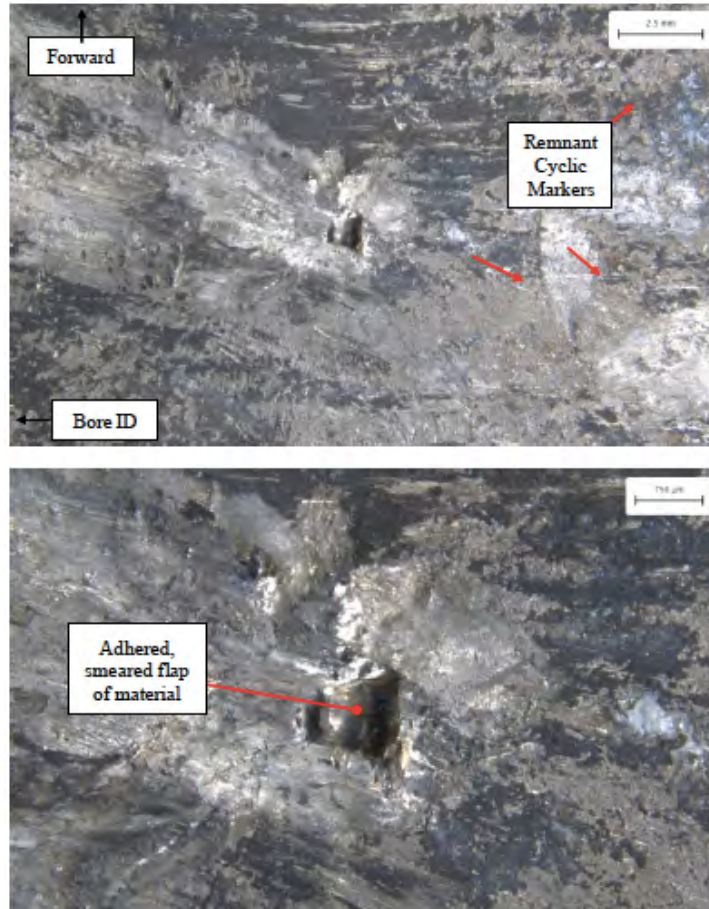
*Picture 37*

The Fracture A surface in the bore area on Fragment 2 was sectioned from the remainder of the hub via wire EDM. Binocular microscope examination of the fracture surface identified significant smearing and mechanical damage. The origin area was not readily apparent; however, remnant cyclic markers were observed throughout the progression. An adhered, smeared flap of material was observed in

the vicinity of the origin area.

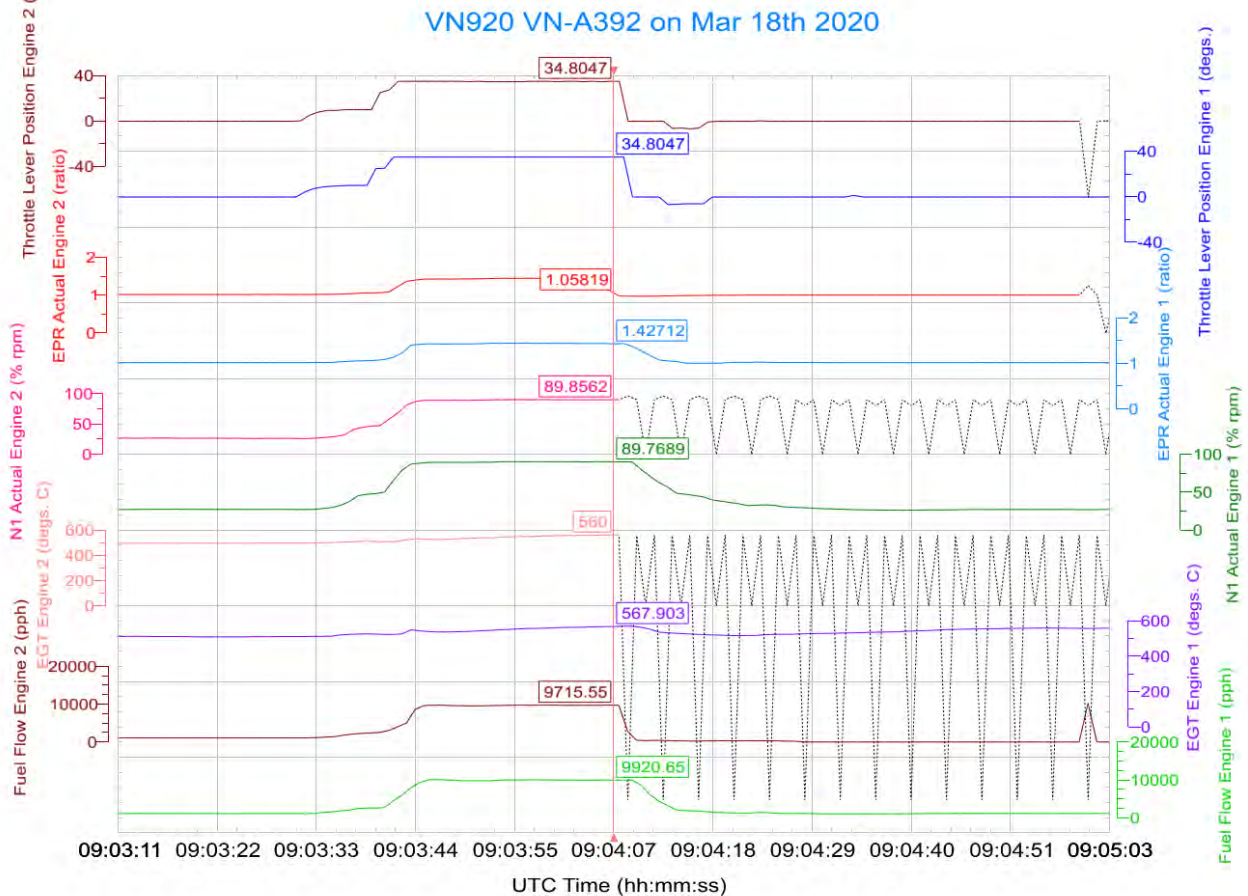
Picture 42

- After 09:04:07, Engine #2 parameters were NCD (Invalid) due to the Engine #2 damage.

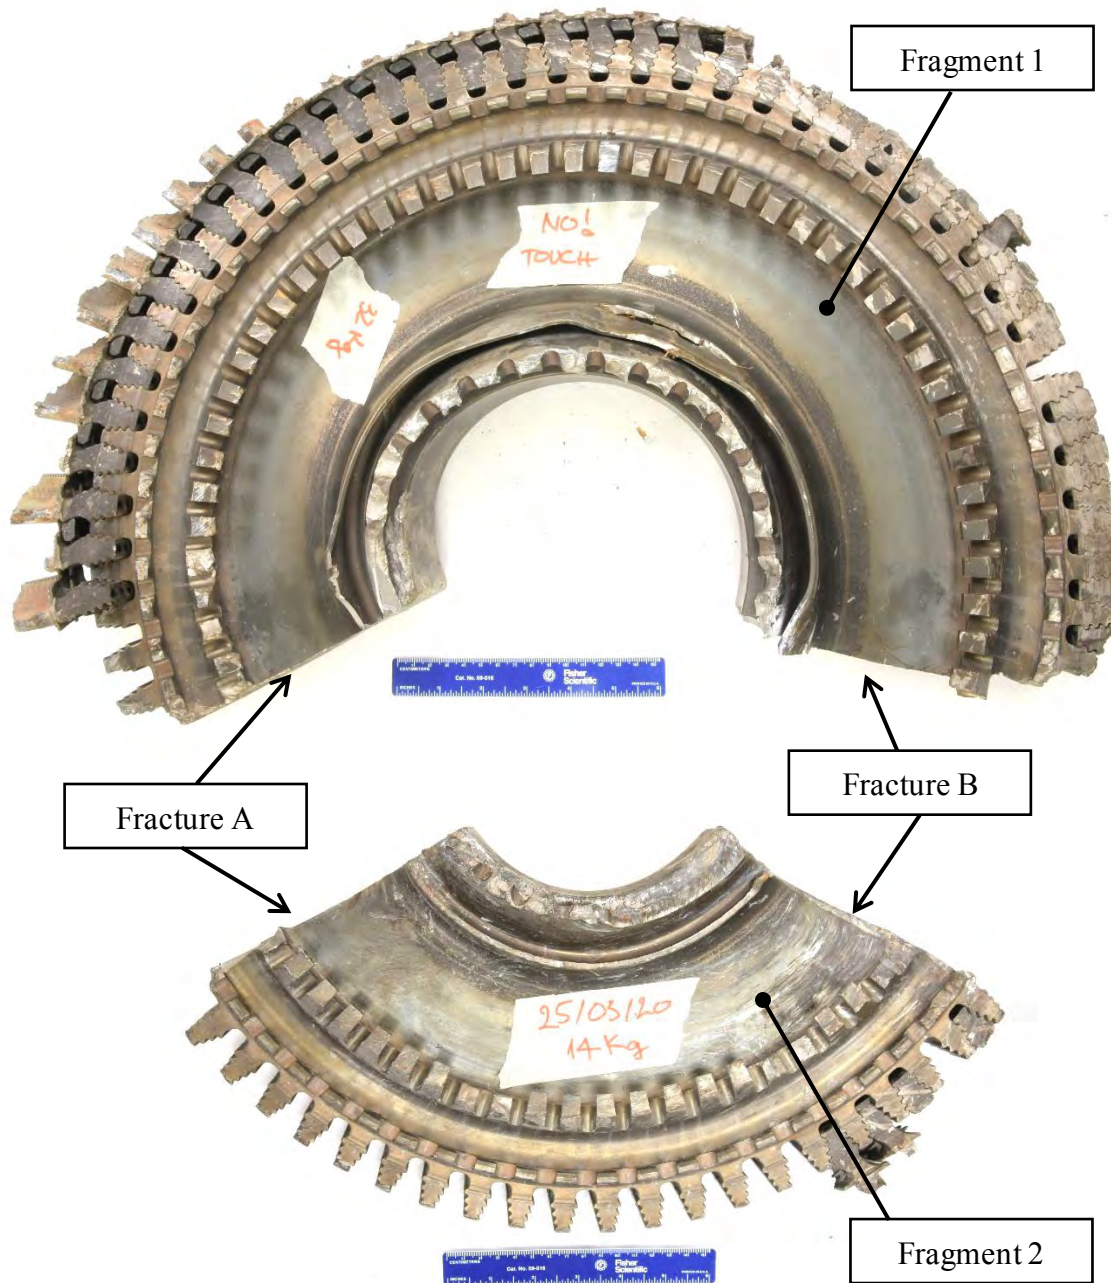
Figure 1: Overall images showing the forward sides of Fragments 1 and 2 in the as-received condition. Fracture surfaces A and B on each part are notated as shown.

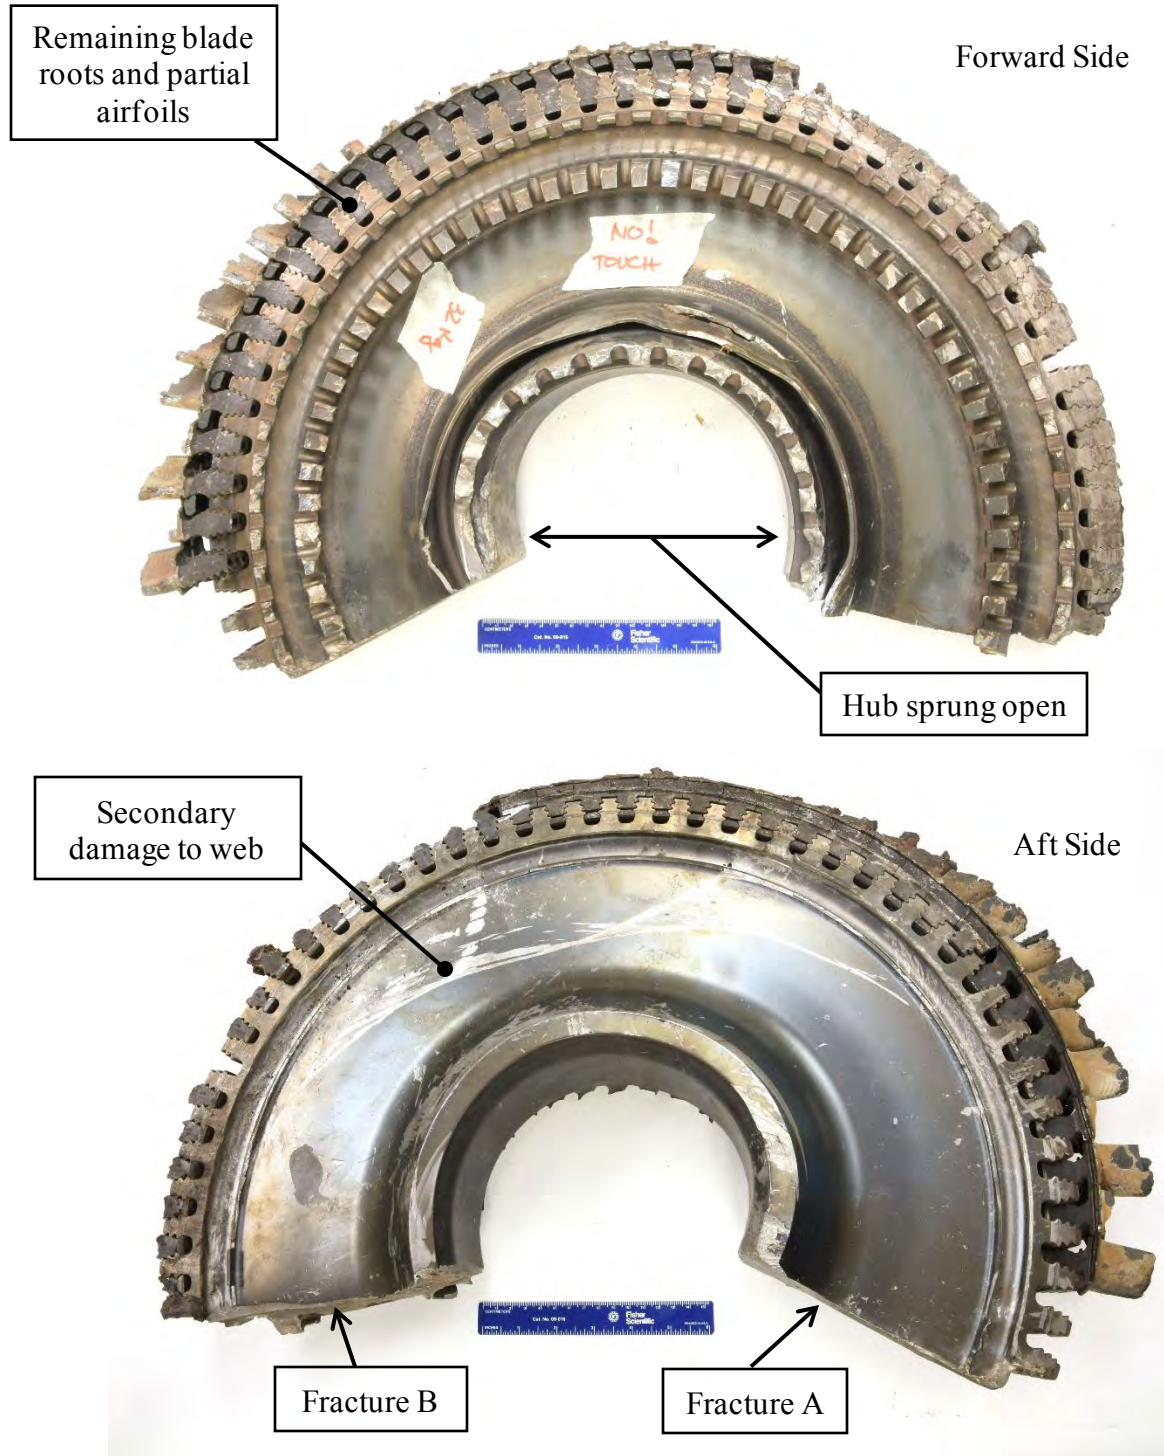
Figure 2: Forward (top) and aft (bottom) sides of Fragment 1. Secondary damage was observed on both sides of the hub.

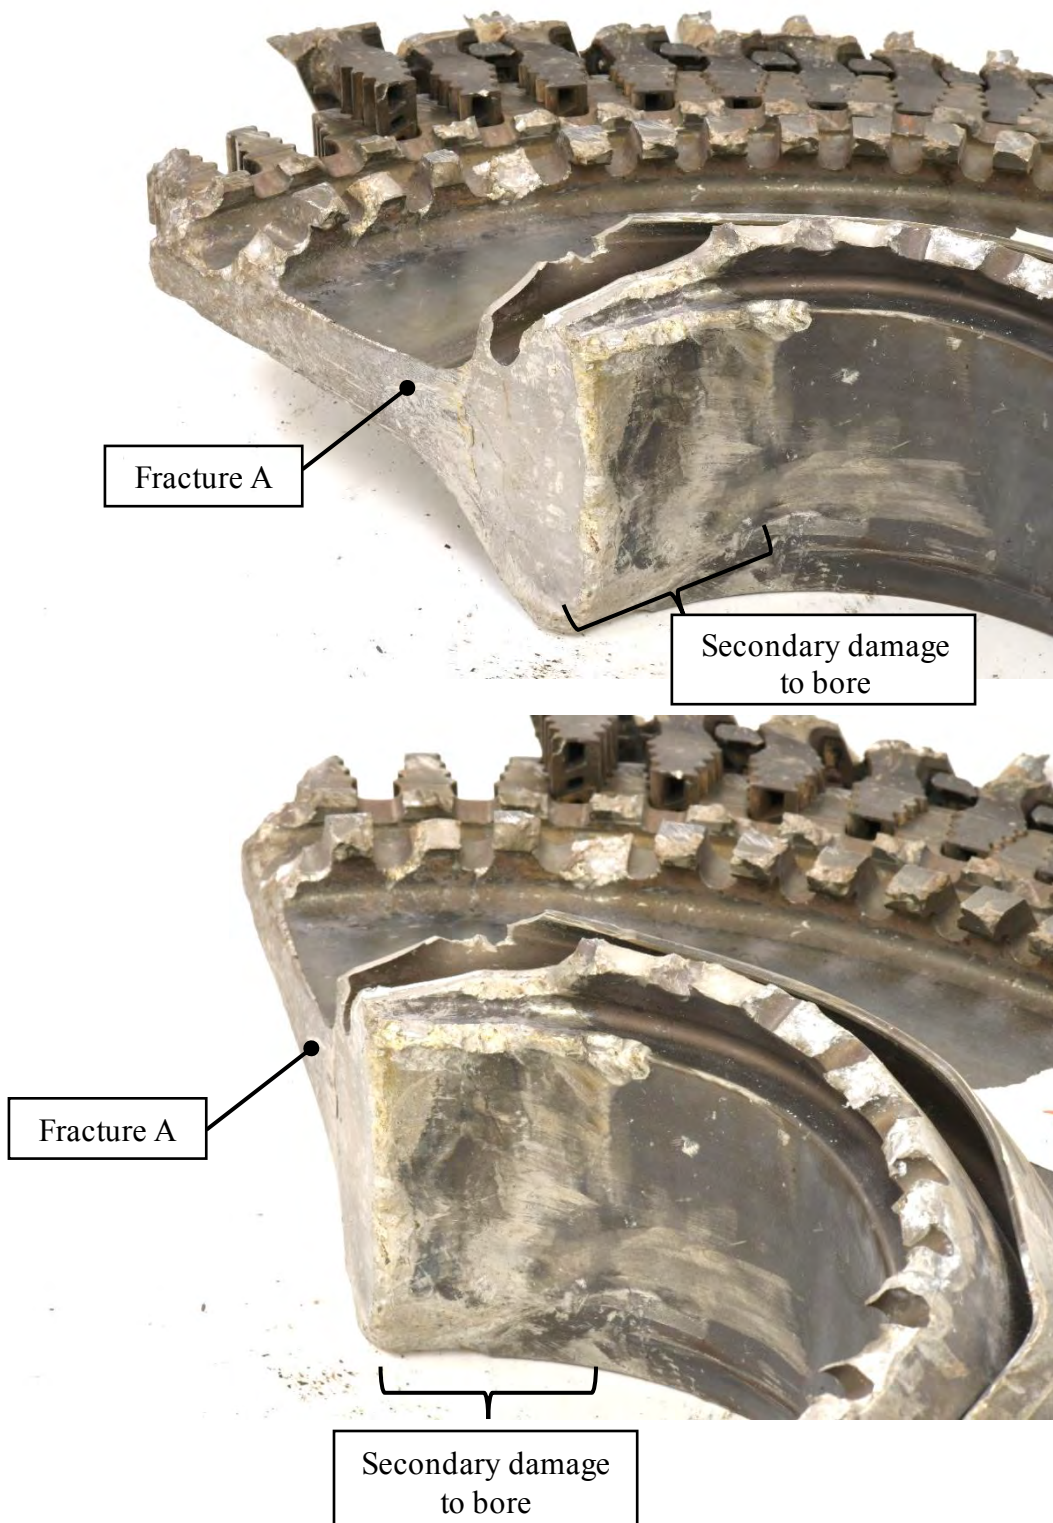
Figure 3: Images showing damage to the bore and hub section at the Fracture A end of Fragment 1.

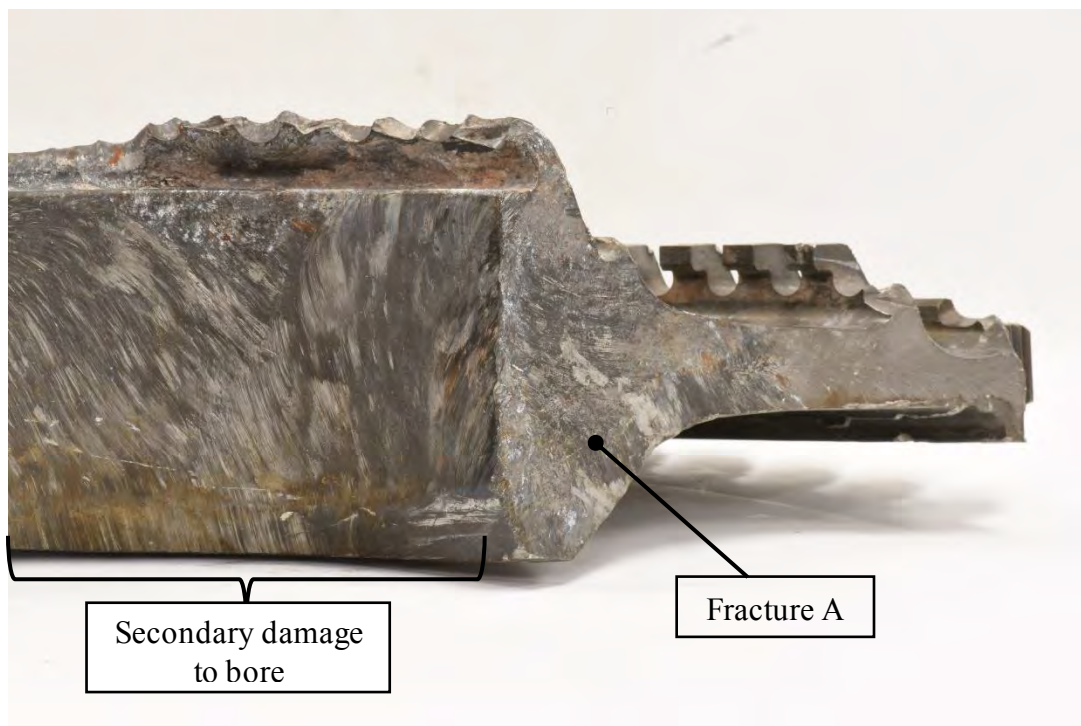
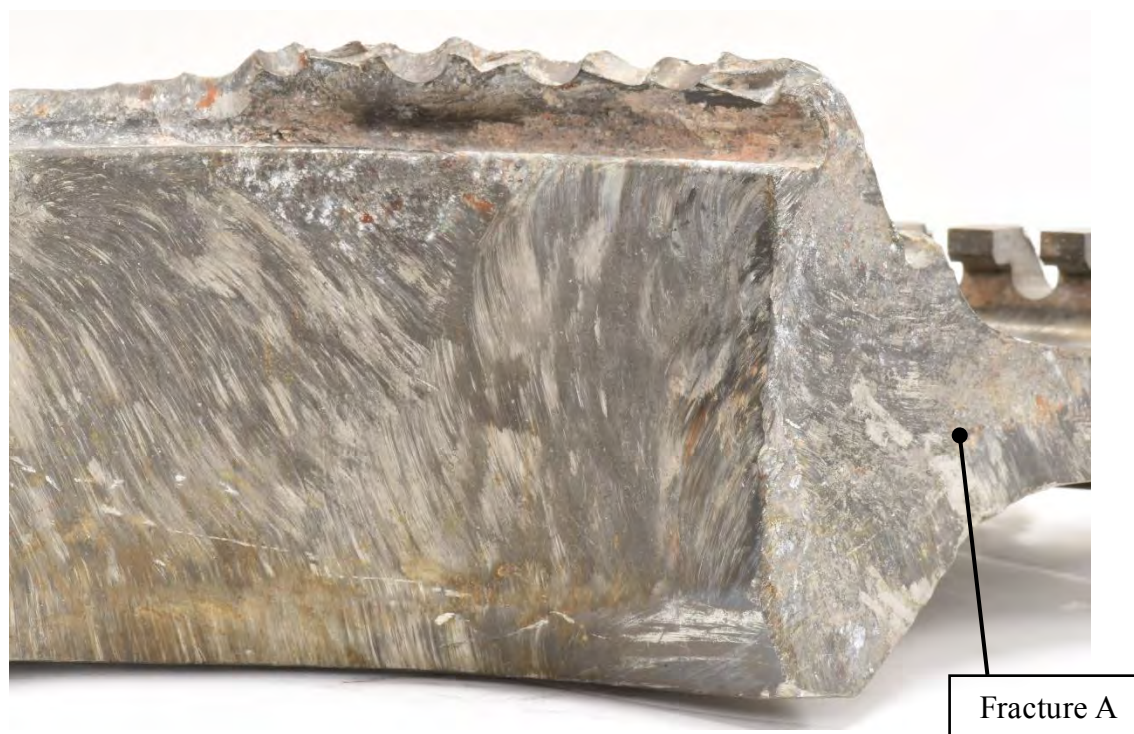
Figure 7: Images showing damage to the bore at the Fracture A side of Fragment 2.

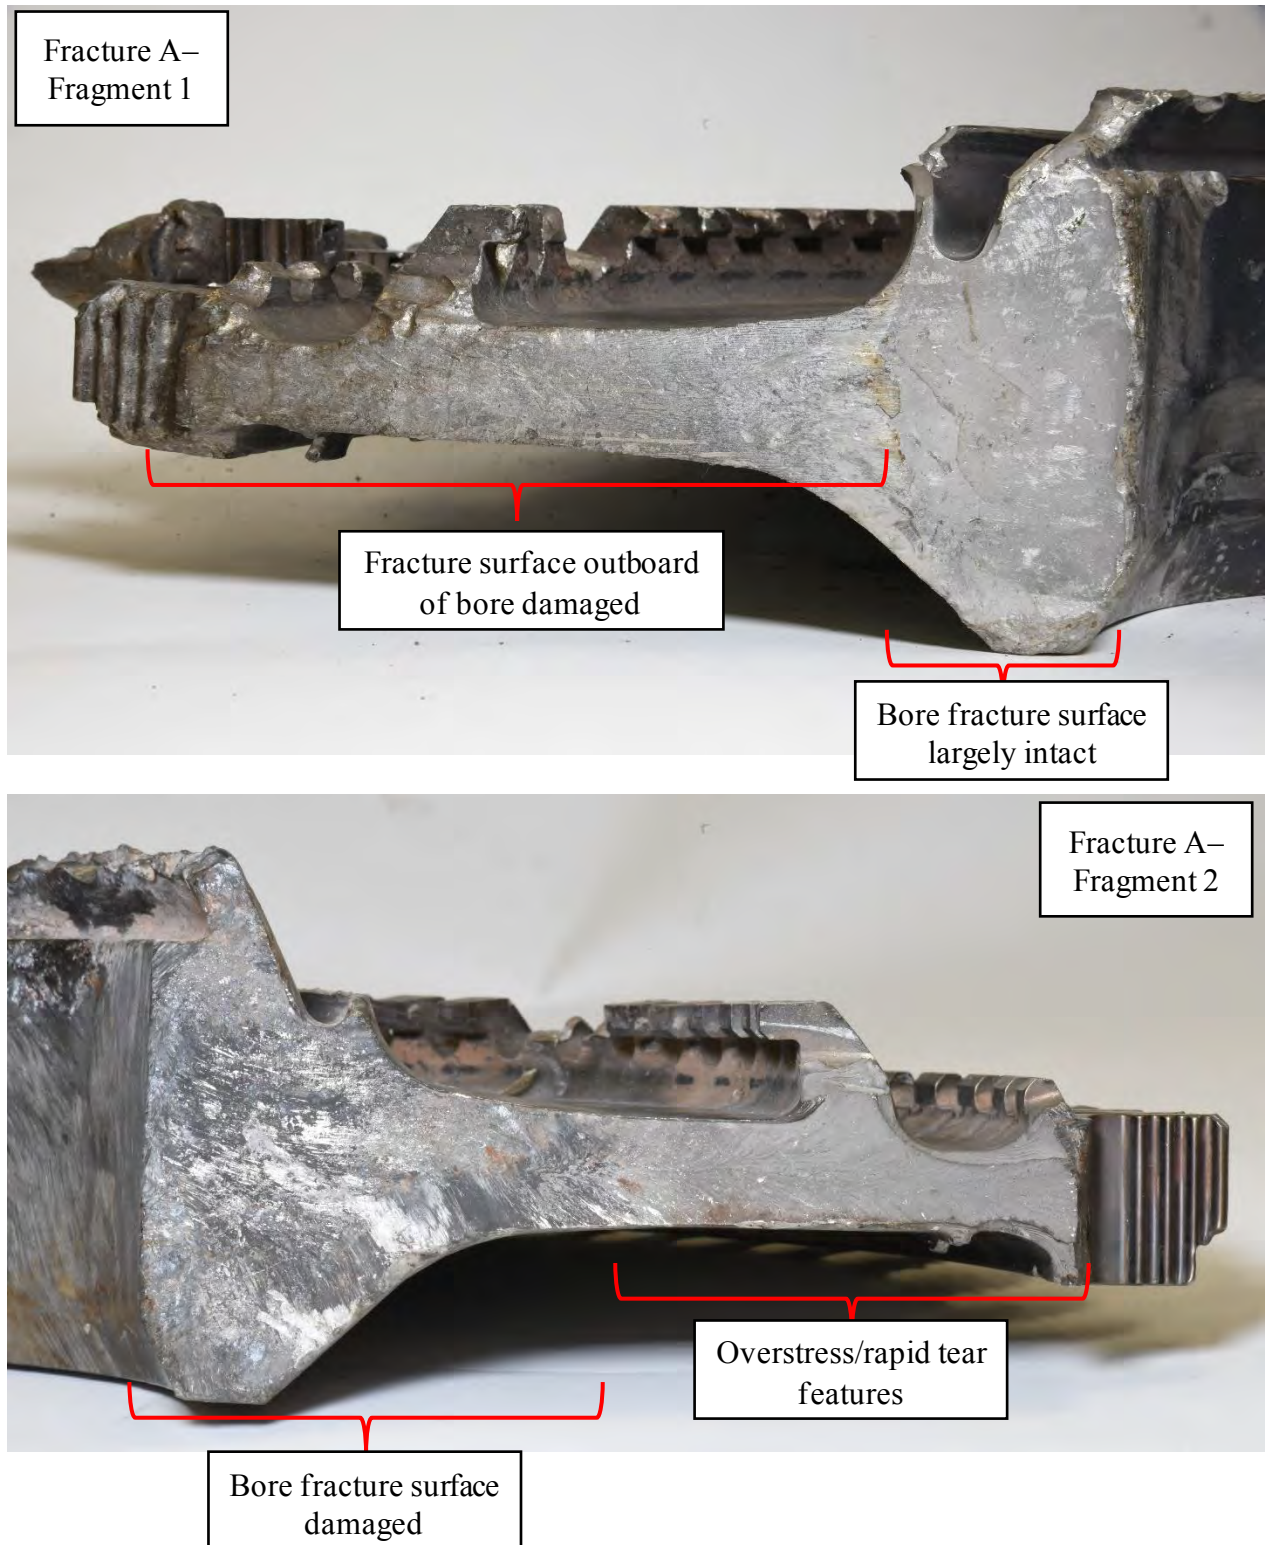
Figure 9: Mating sides of Fracture A on Fragment 1 (top) and Fragment 2 (bottom). The fracture appeared relatively planar in the axial-radial plane in the bore area.

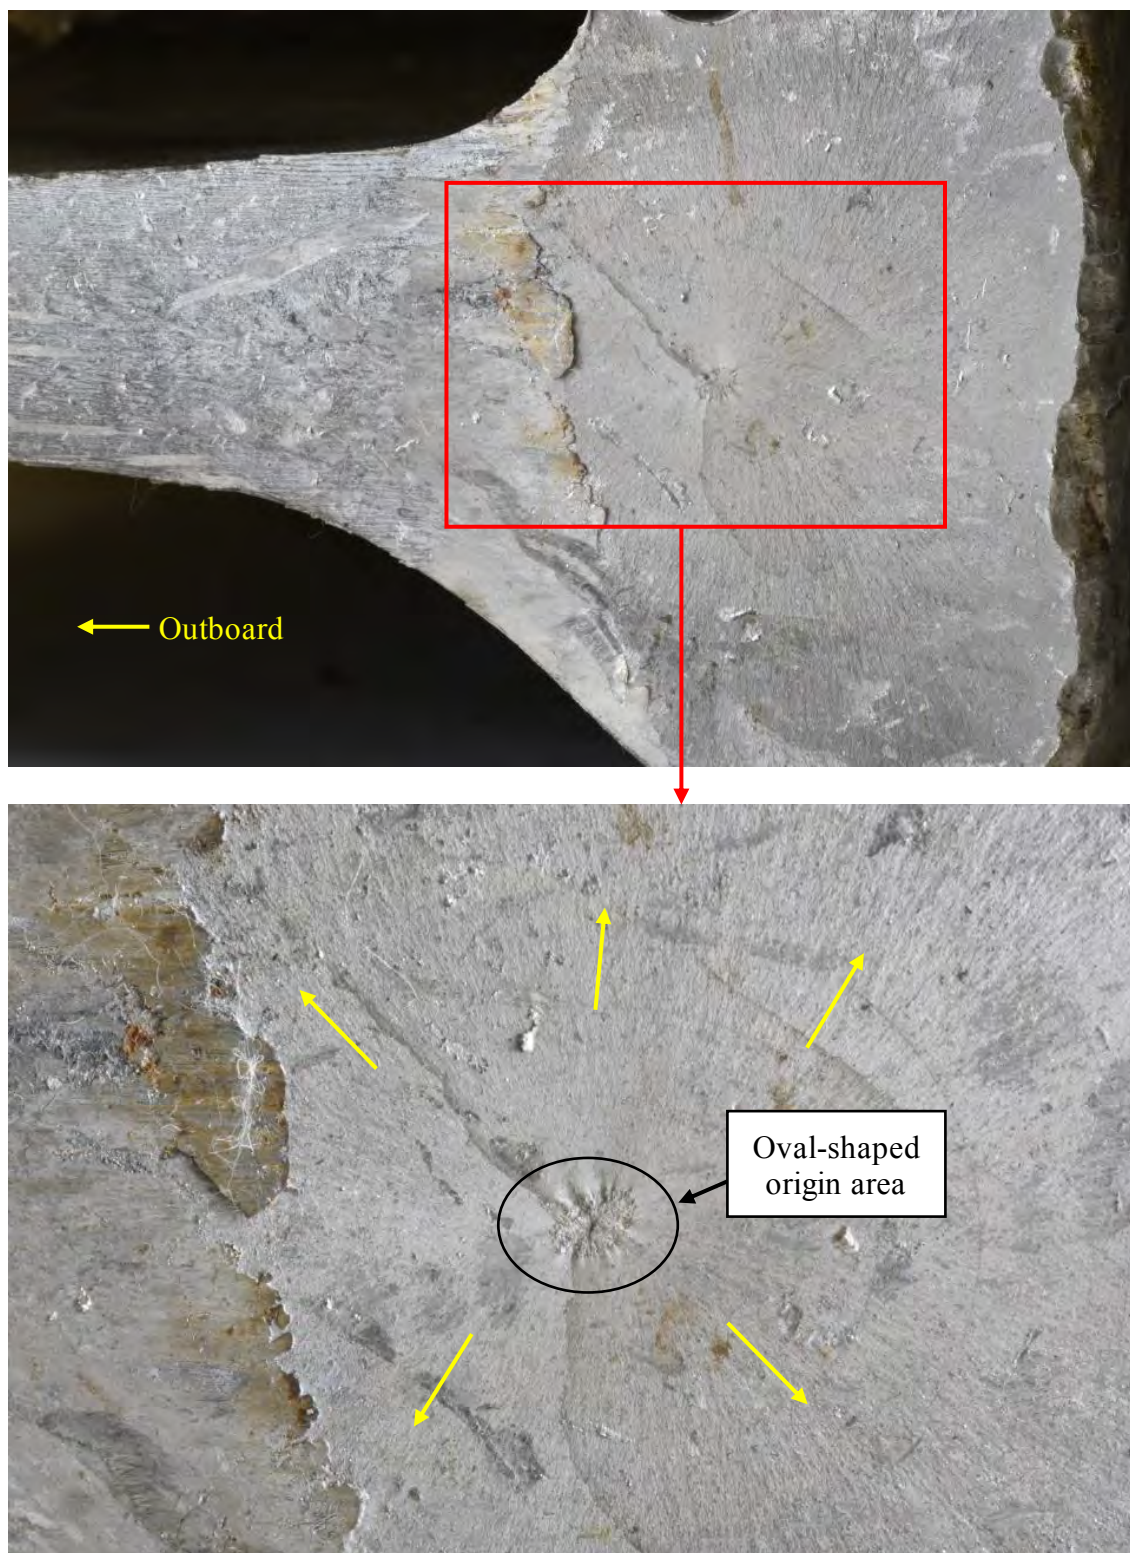
Figure 10: Origin area on the Fragment 1 side of Fracture A. Yellow arrows indicate general direction of fracture progression.

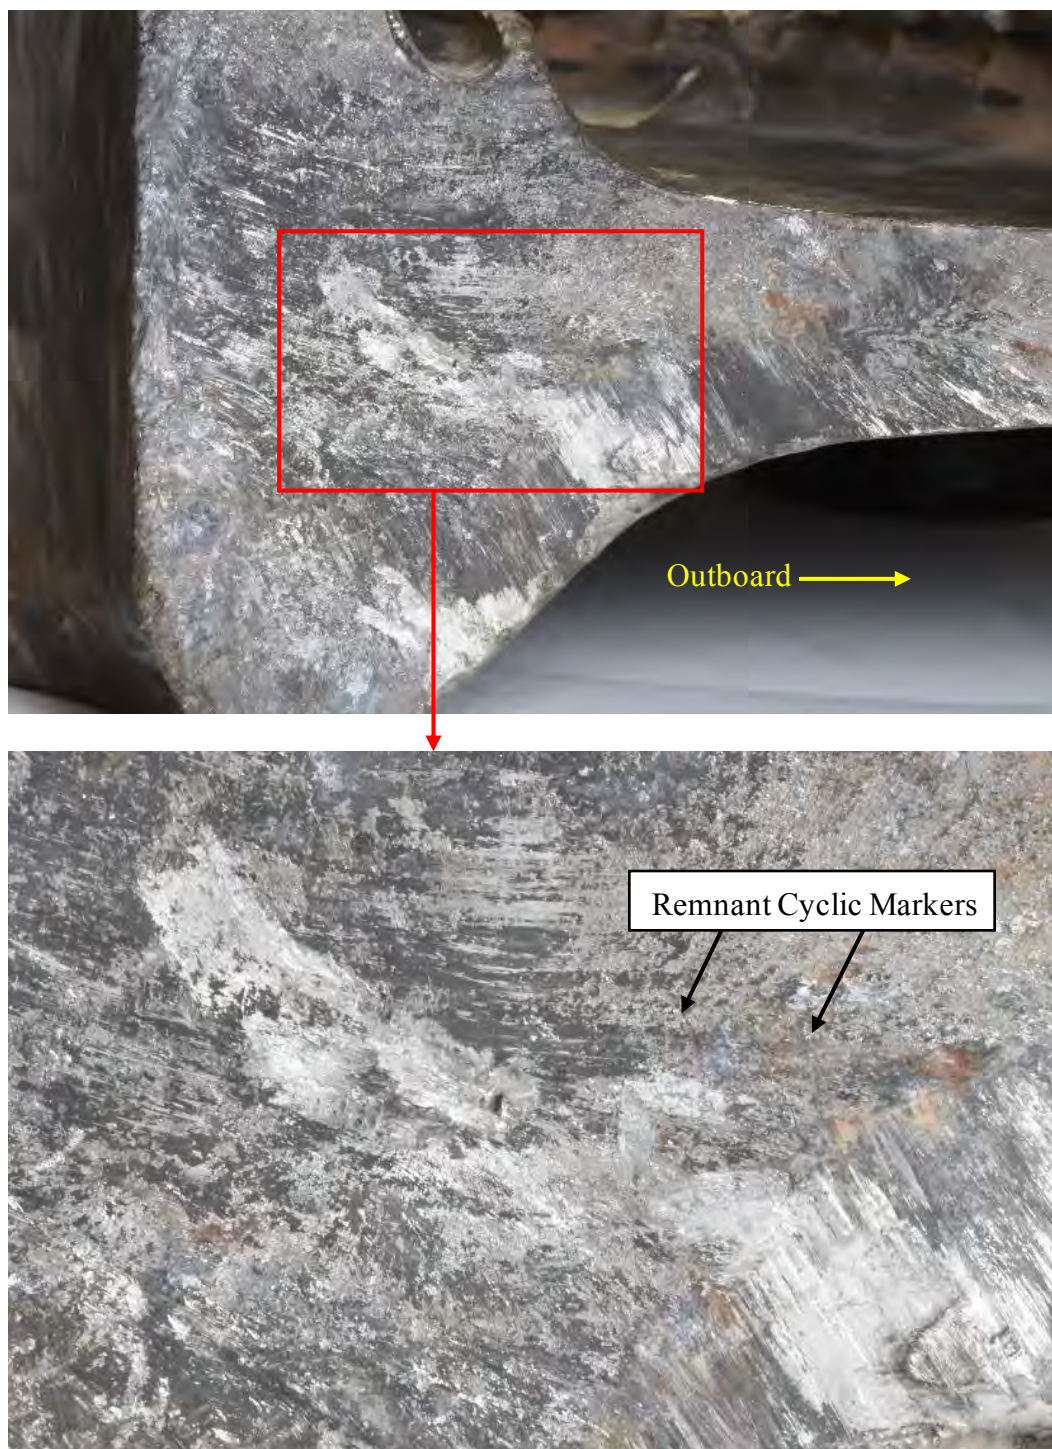
Figure 11: Origin area on the Fragment 2 side of Fracture A; the fracture surface was smeared/damaged; however, remnant cyclic markers were observed.

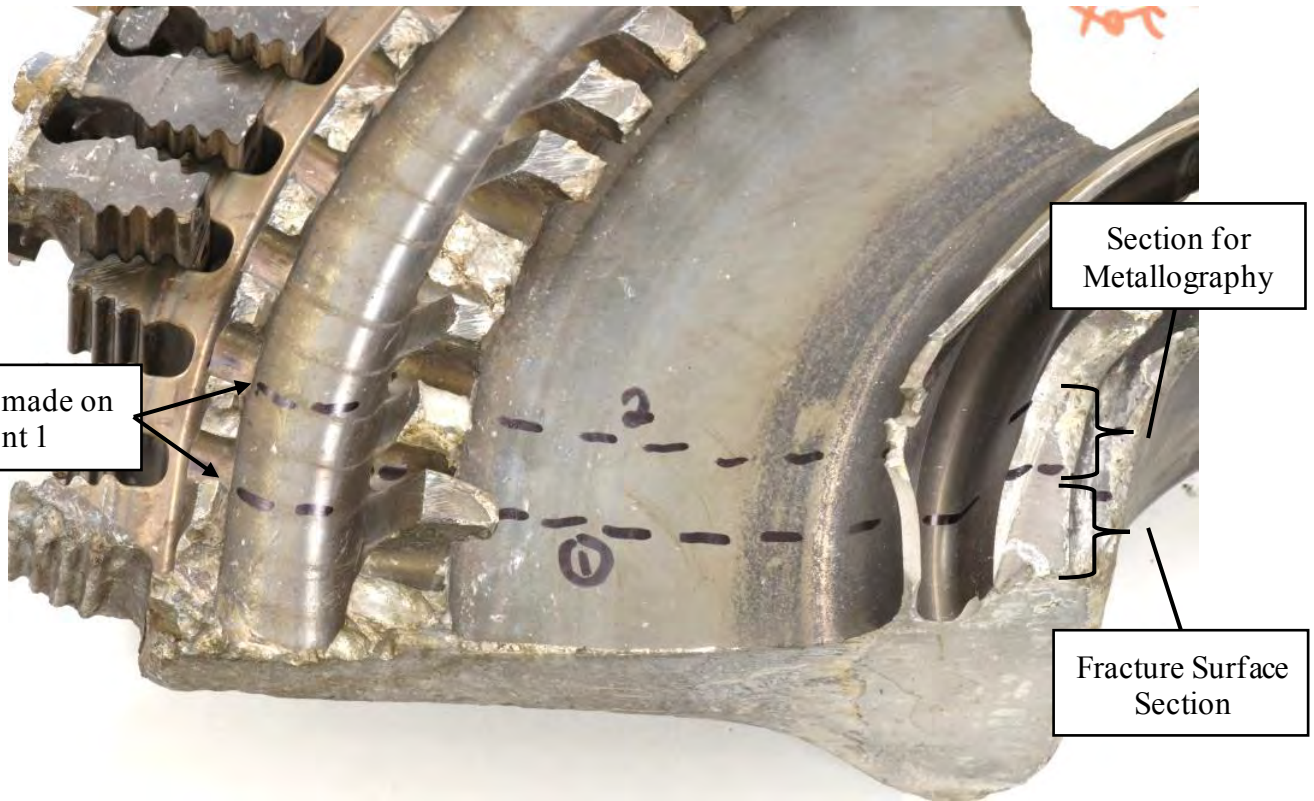
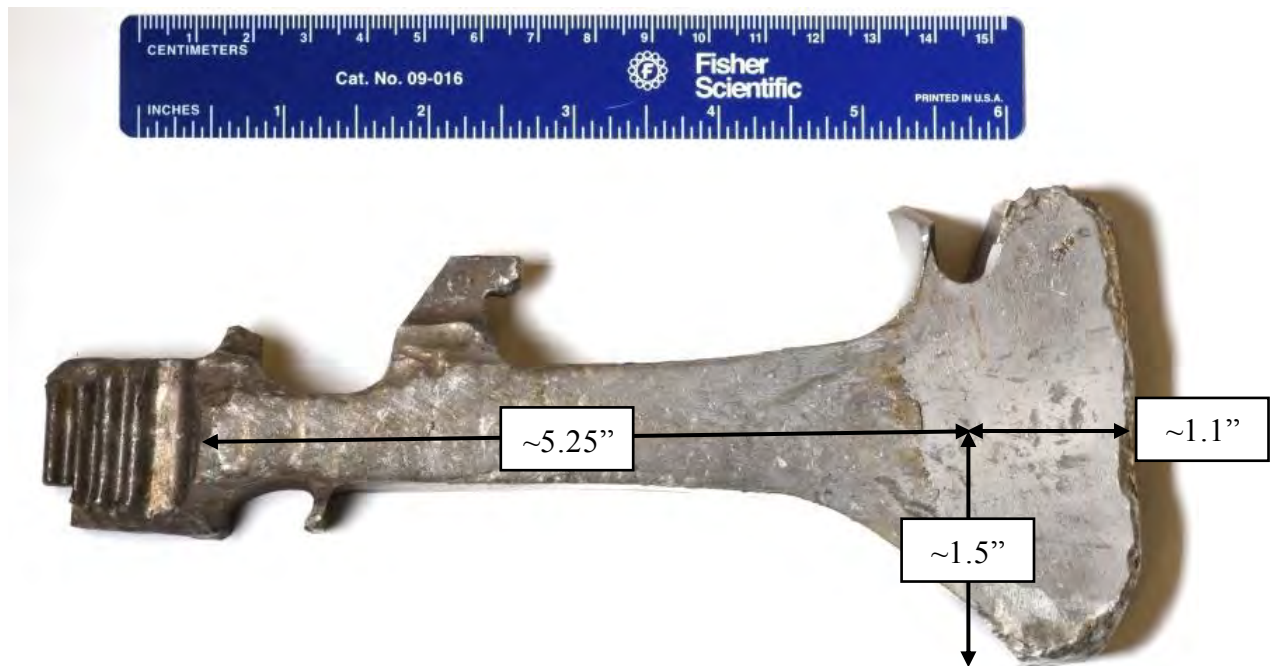
Figure 13: The Fracture A surface on Fragment 1 was sectioned from the remainder of the hub. Approximate dimensions to oval shaped origin area shown above.

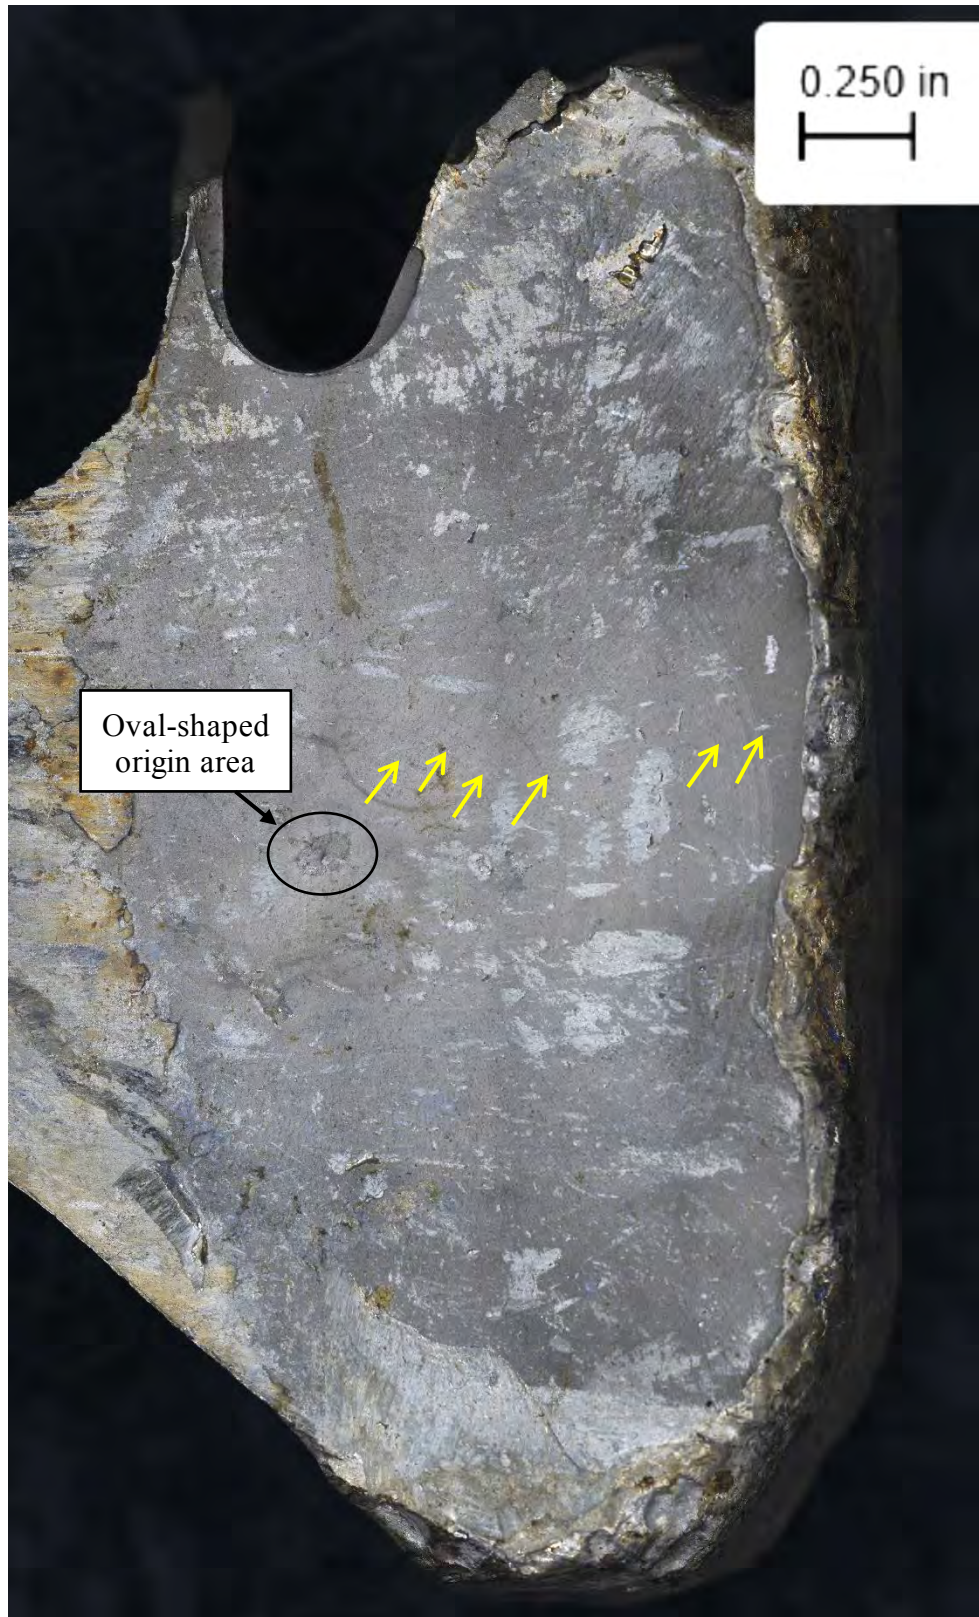
Figure 14: Bore area on Fragment 1 Fracture A. Cyclic markers emanating from the oval shaped origin area were observed (some notated by yellow arrows).

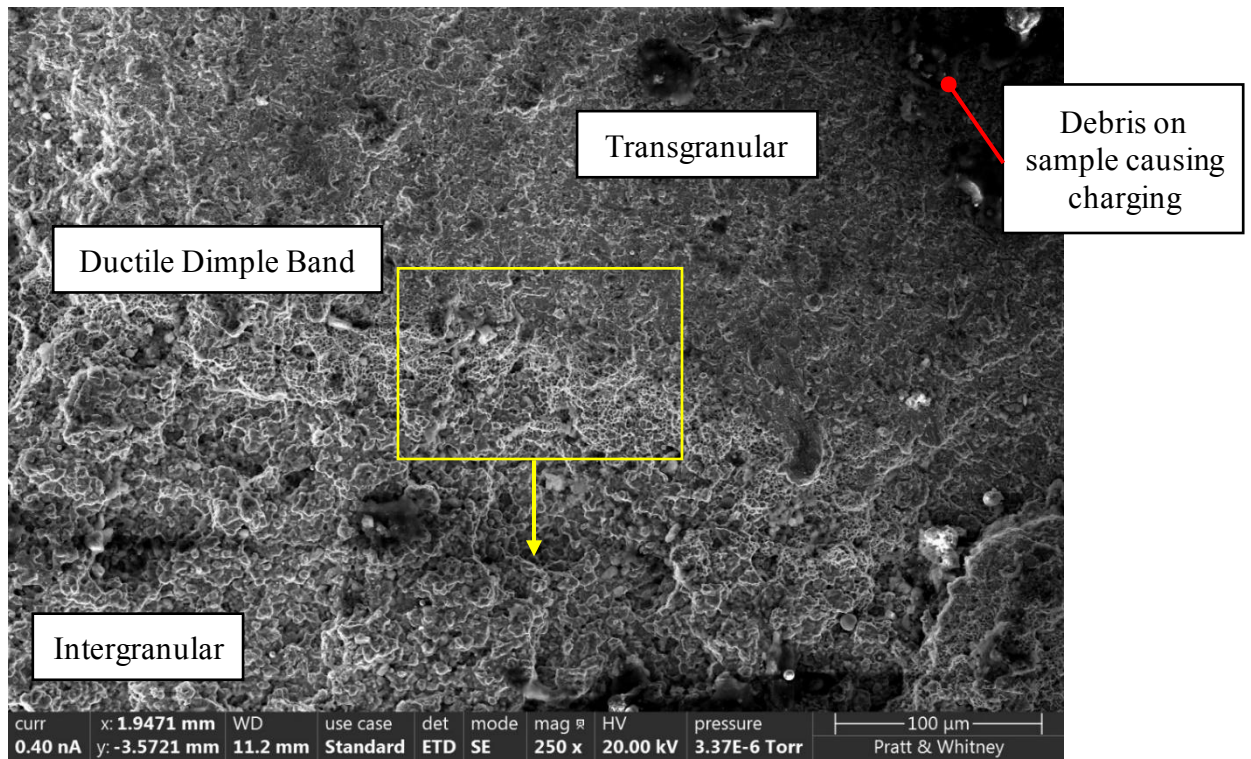
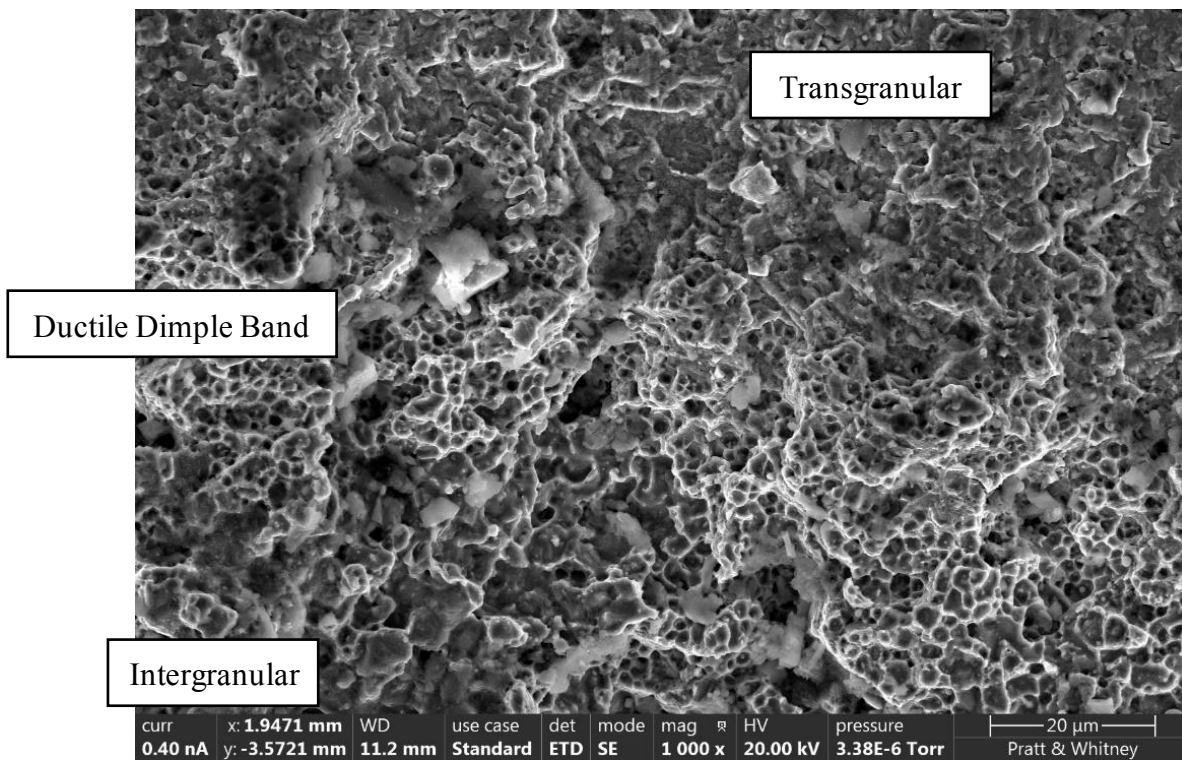
Figure 20: SEM images showing intergranular, ductile dimple, and transgranular features observed at the perimeter of the 0.120" x 0.075" origin area, following water and isopropanol rinse.

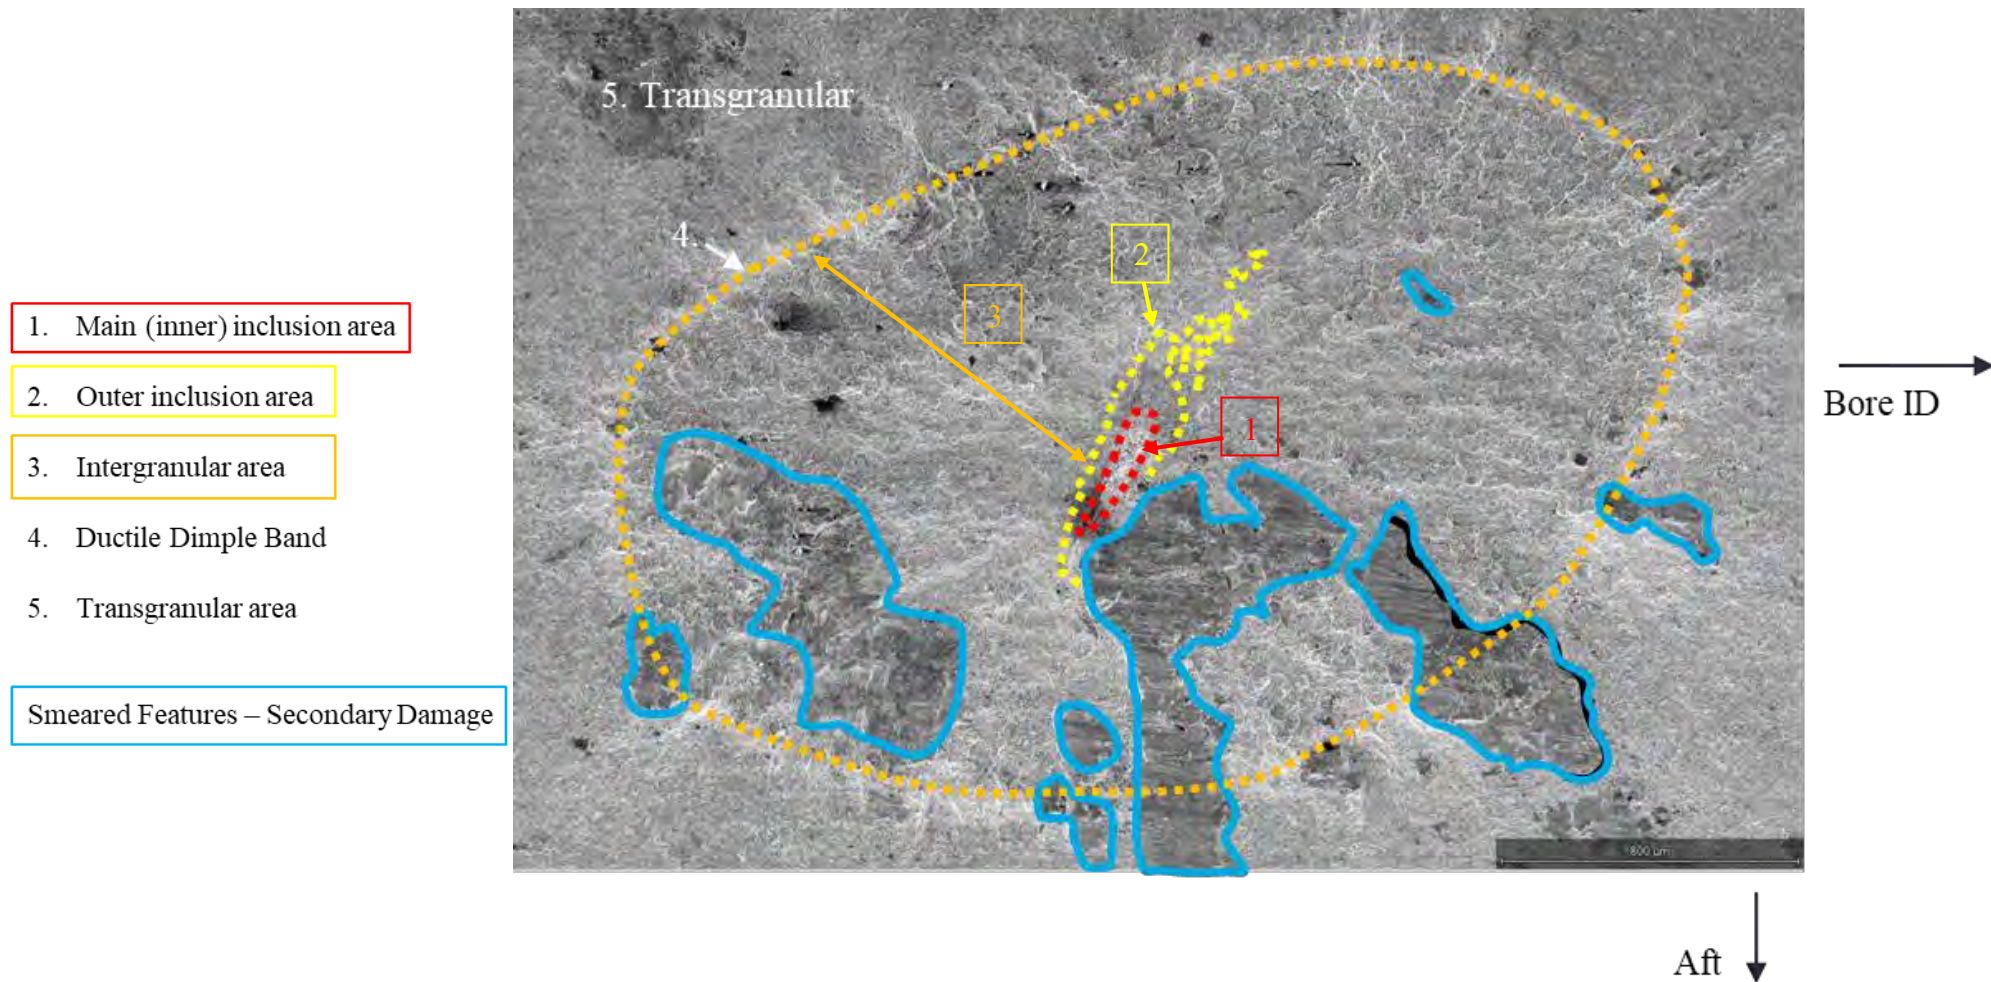
Figure 21: SEM map showing the 5 main regions observed within and adjacent to the origin area. In addition to the five regions of crack progression, areas of secondary damage were observed.
