**FINAL REPORT<sup>1</sup>**

**INVESTIGATION RESULT OF SERIOUS INCIDENT**

**VIETNAM AIRLINES UNCONTAINED ENGINE**

**AIRBUS A321 MSN 5306 (VN-A392)**

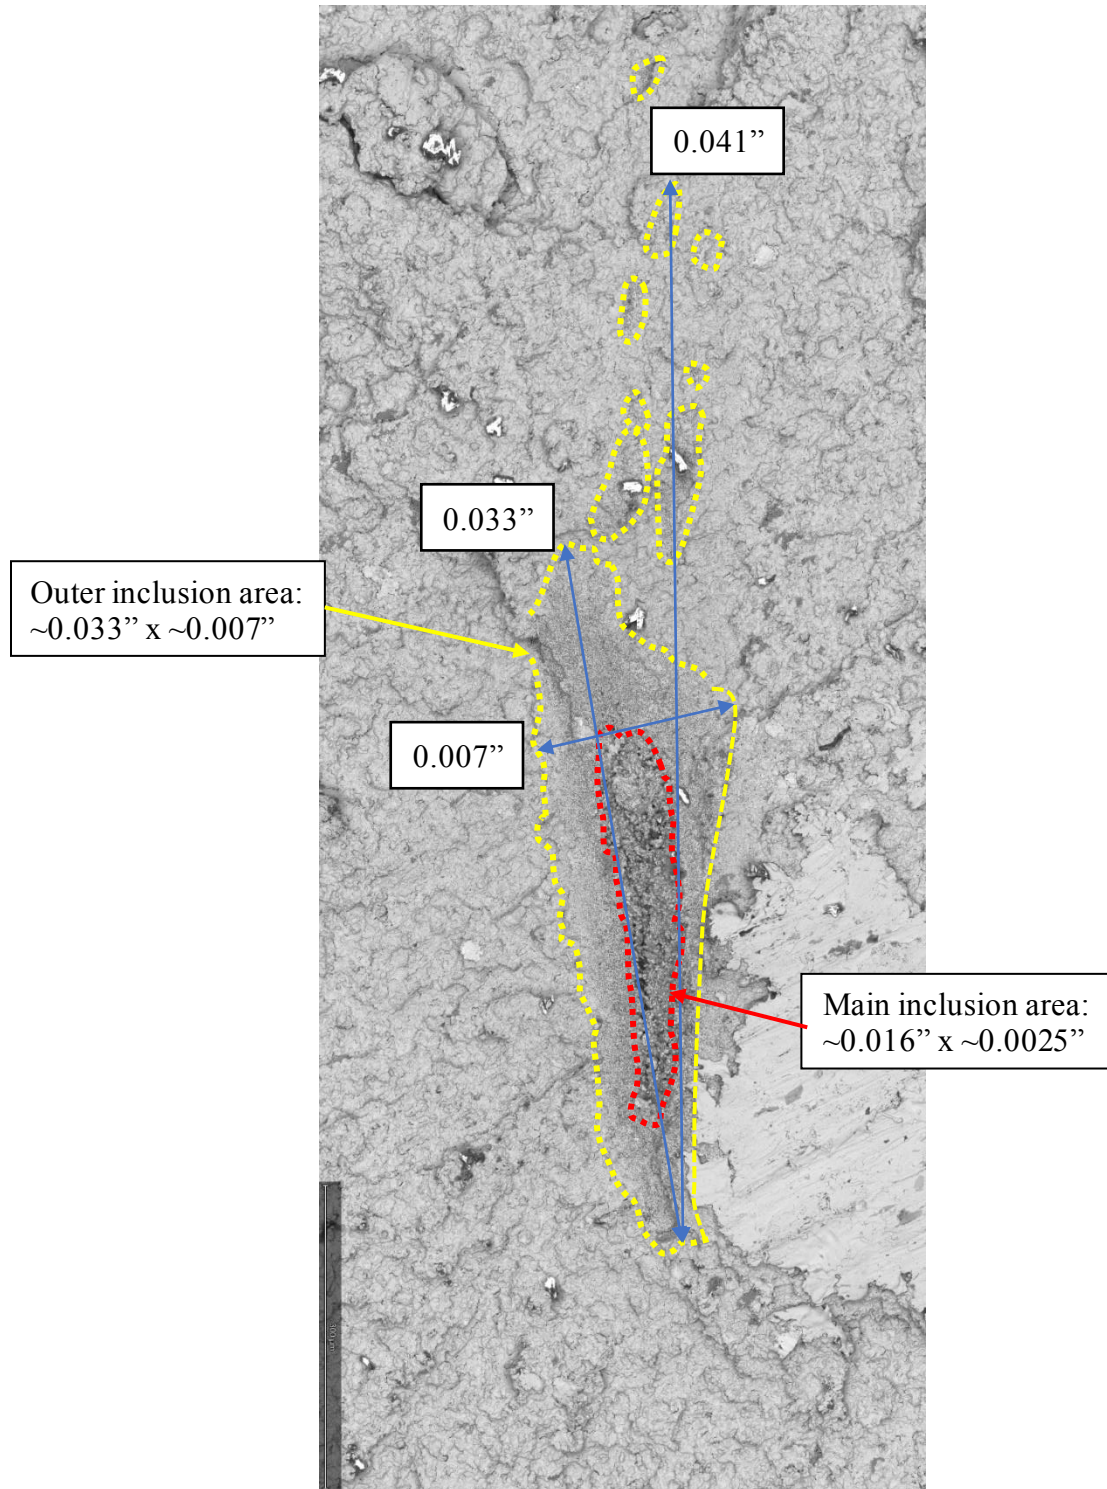
The main inclusion area consisted of a concentrated area of voids and foreign particles. This area measured 0.016” x 0.0025” on the fracture surface (Figures 22-23).

Figure 22: Map of the main (red dashed lines) and outer (yellow dashed lines) inclusion area, rotated from Figure 21. The main inclusion area consisted of a concentrated area of voids and foreign particles while the outer inclusion area was a non-continuous region of dispersed particles.

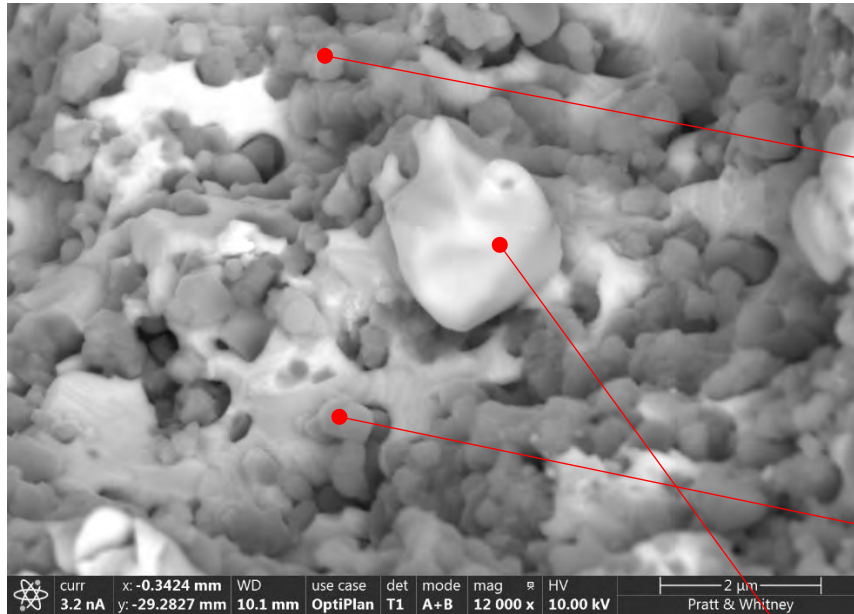
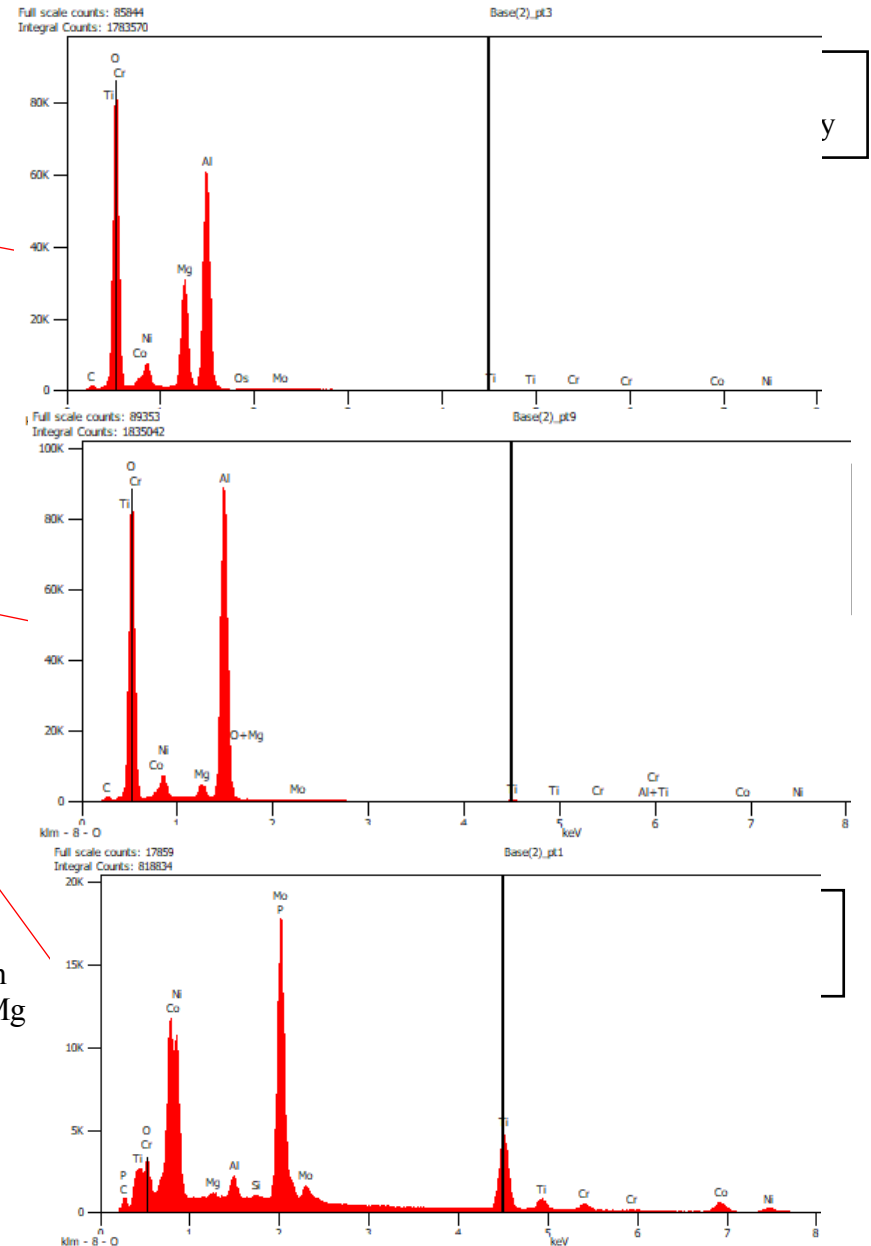
Figure 24: Typical particle chemistries observed in the inner inclusion area included the Al-Mg-O type (top right), the Al-O with much less Mg type (middle right), and the P-Ti-Ni-Co type (bottom right).

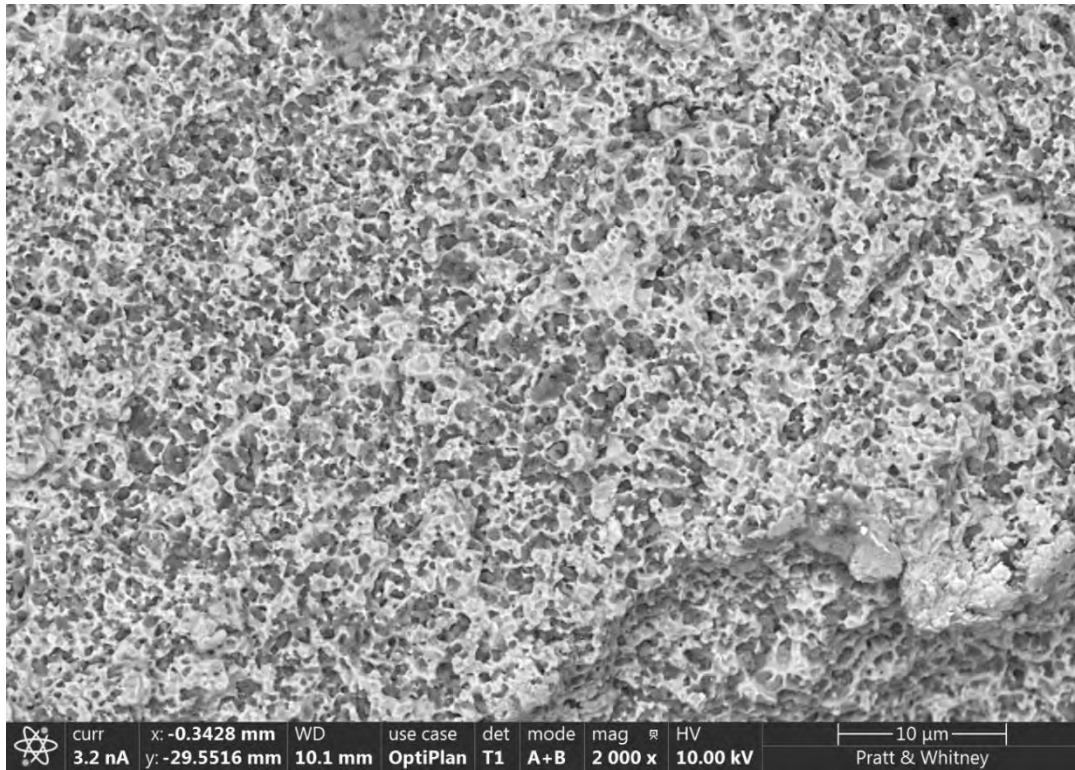
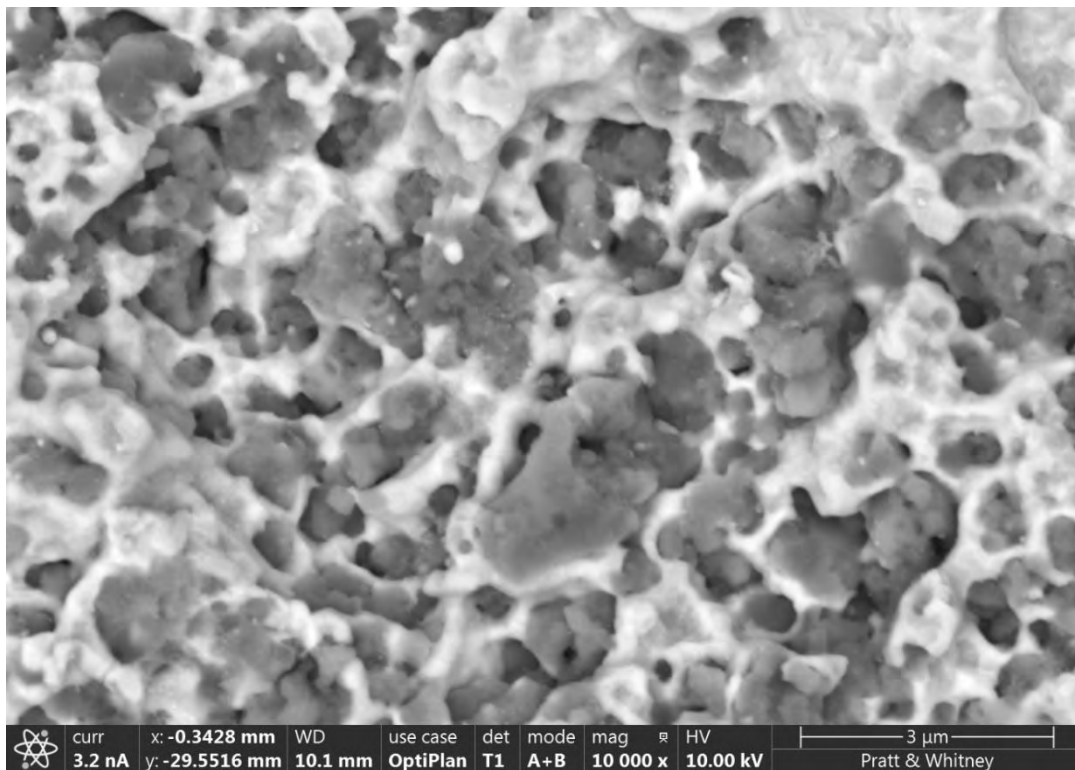
Figure 25: SEM images showing fracture appearance within the outer inclusion area. Features appeared ductile surrounding the inclusion particles.

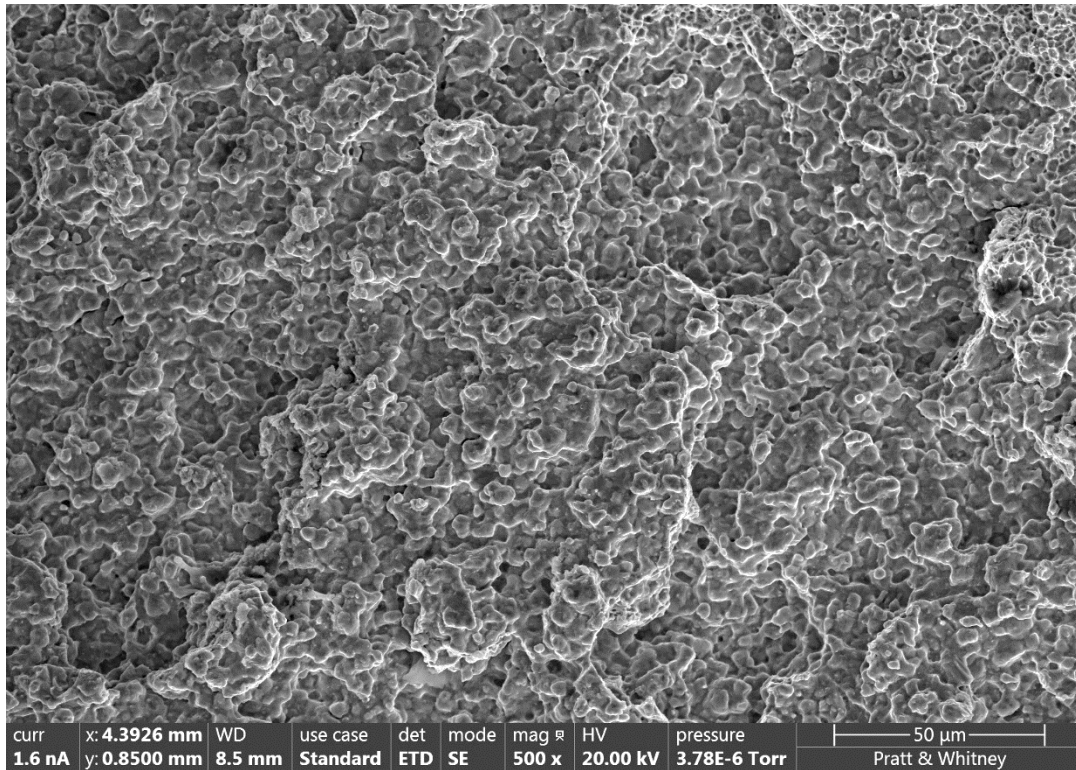
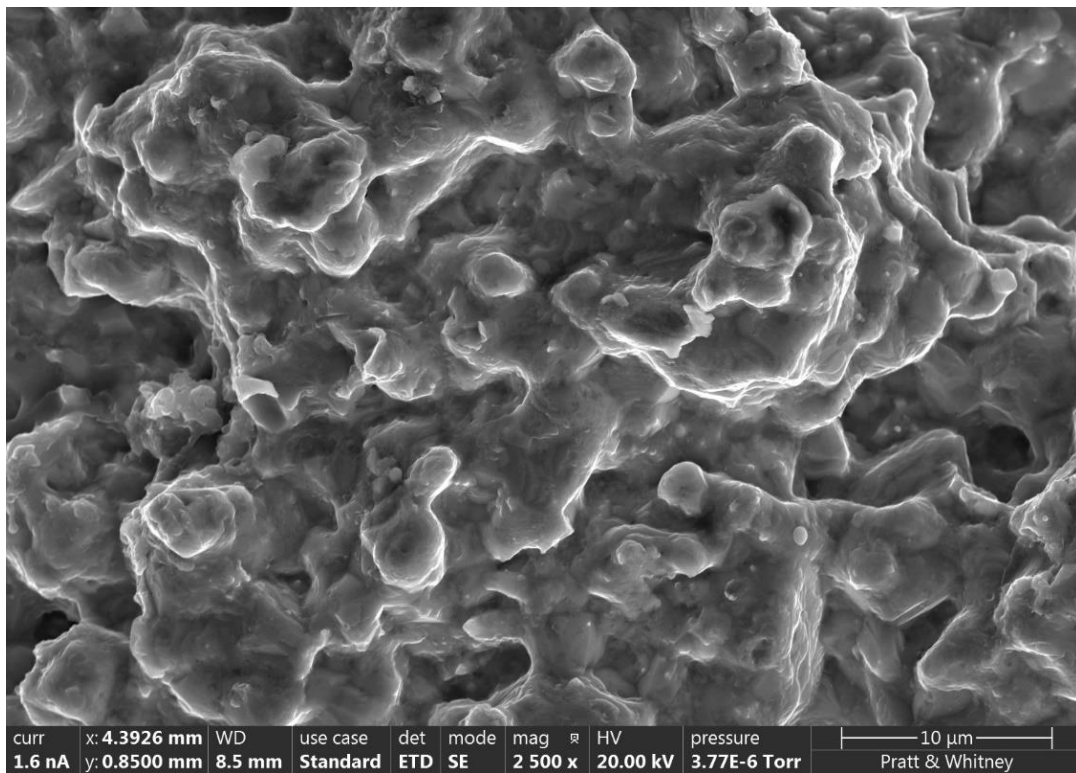
Figure 27: SEM images showing intergranular features observed.

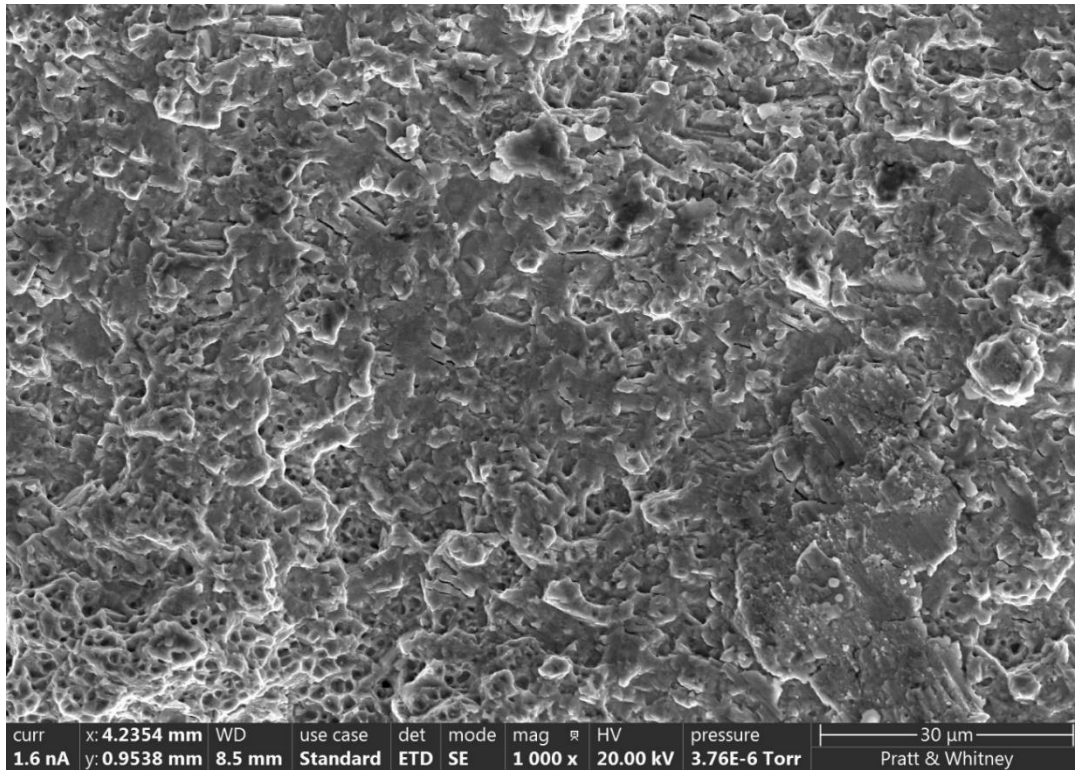
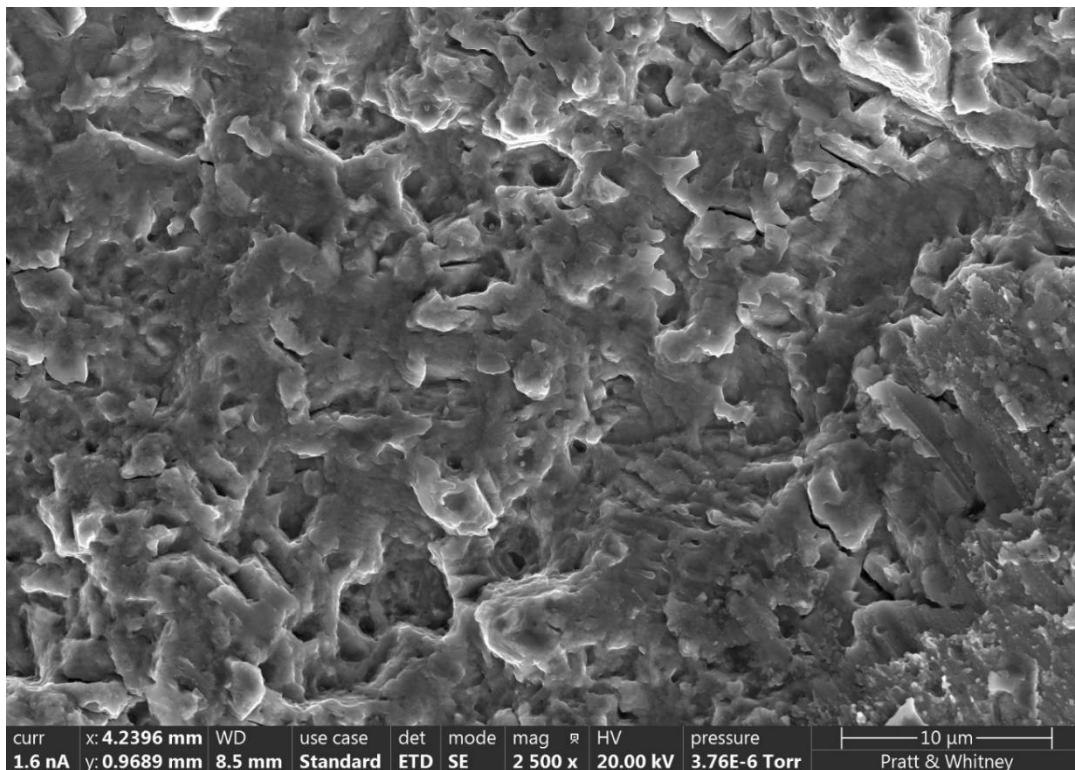
Figure 29: SEM images of transgranular progression outside the origin area. Progression was a mixture of striations and ductile dimple features.

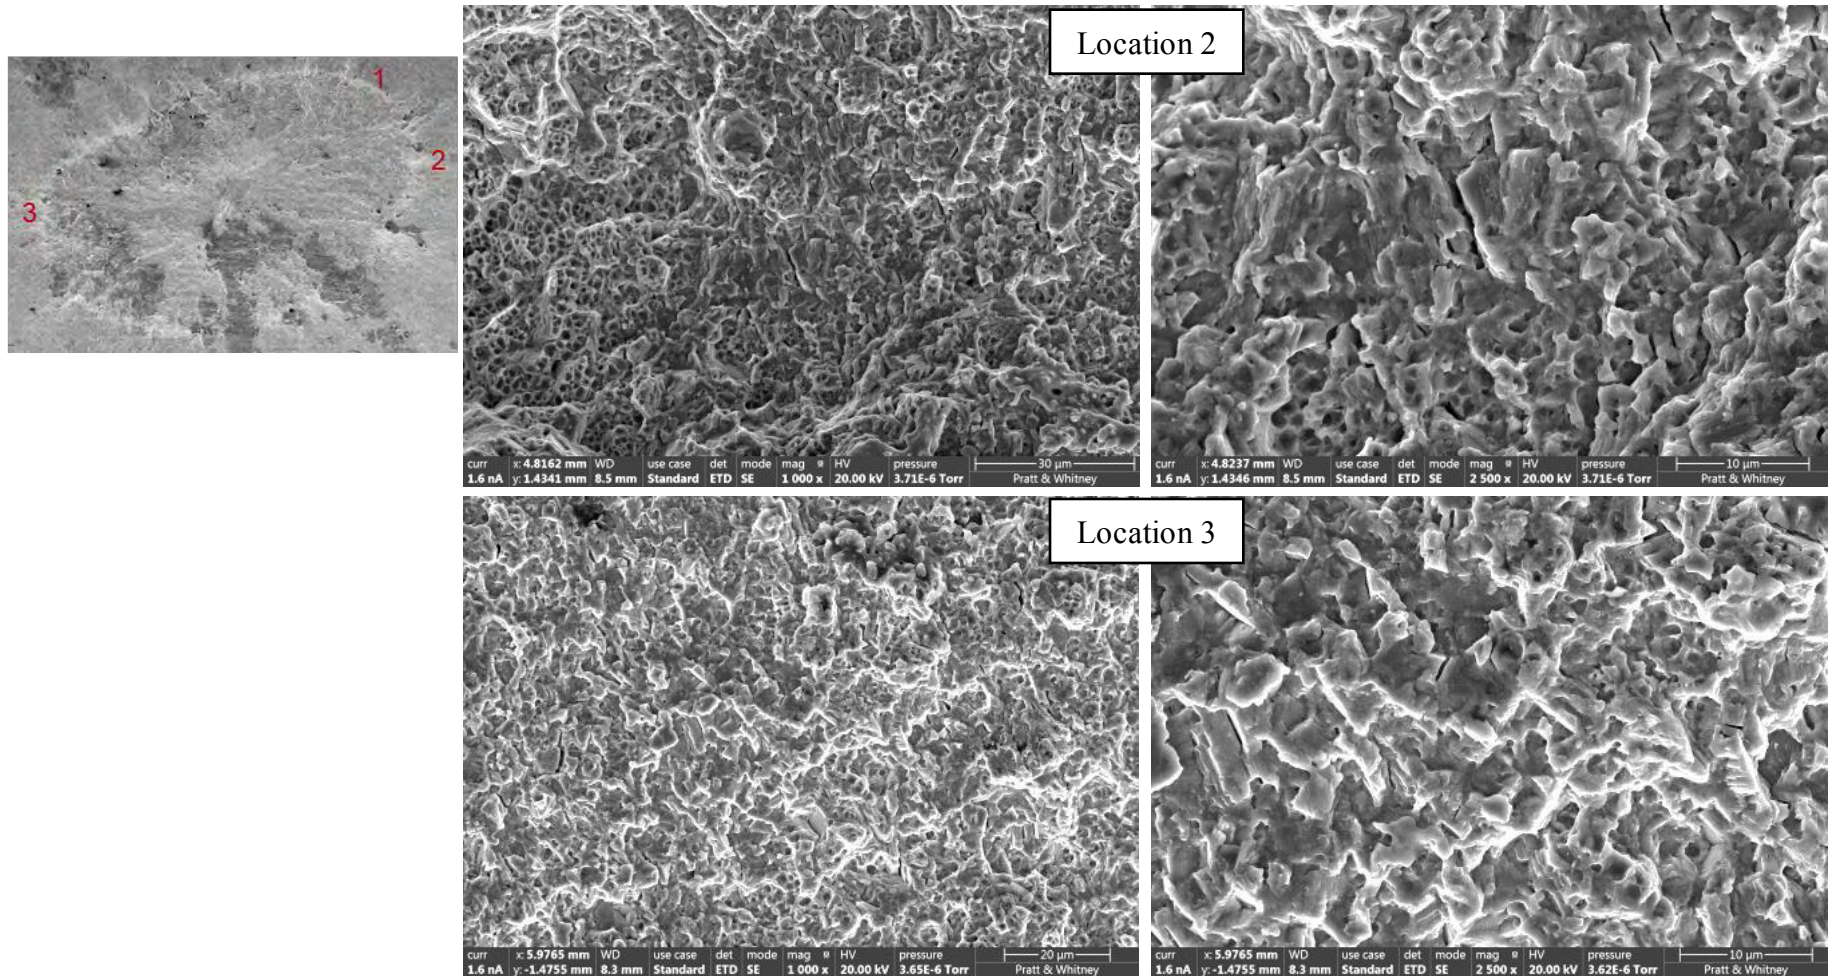
Figure 30: Additional regions of transgranular cracking (striations and ductile dimples) immediately outside of the oval-shaped origin area, as shown at upper left.

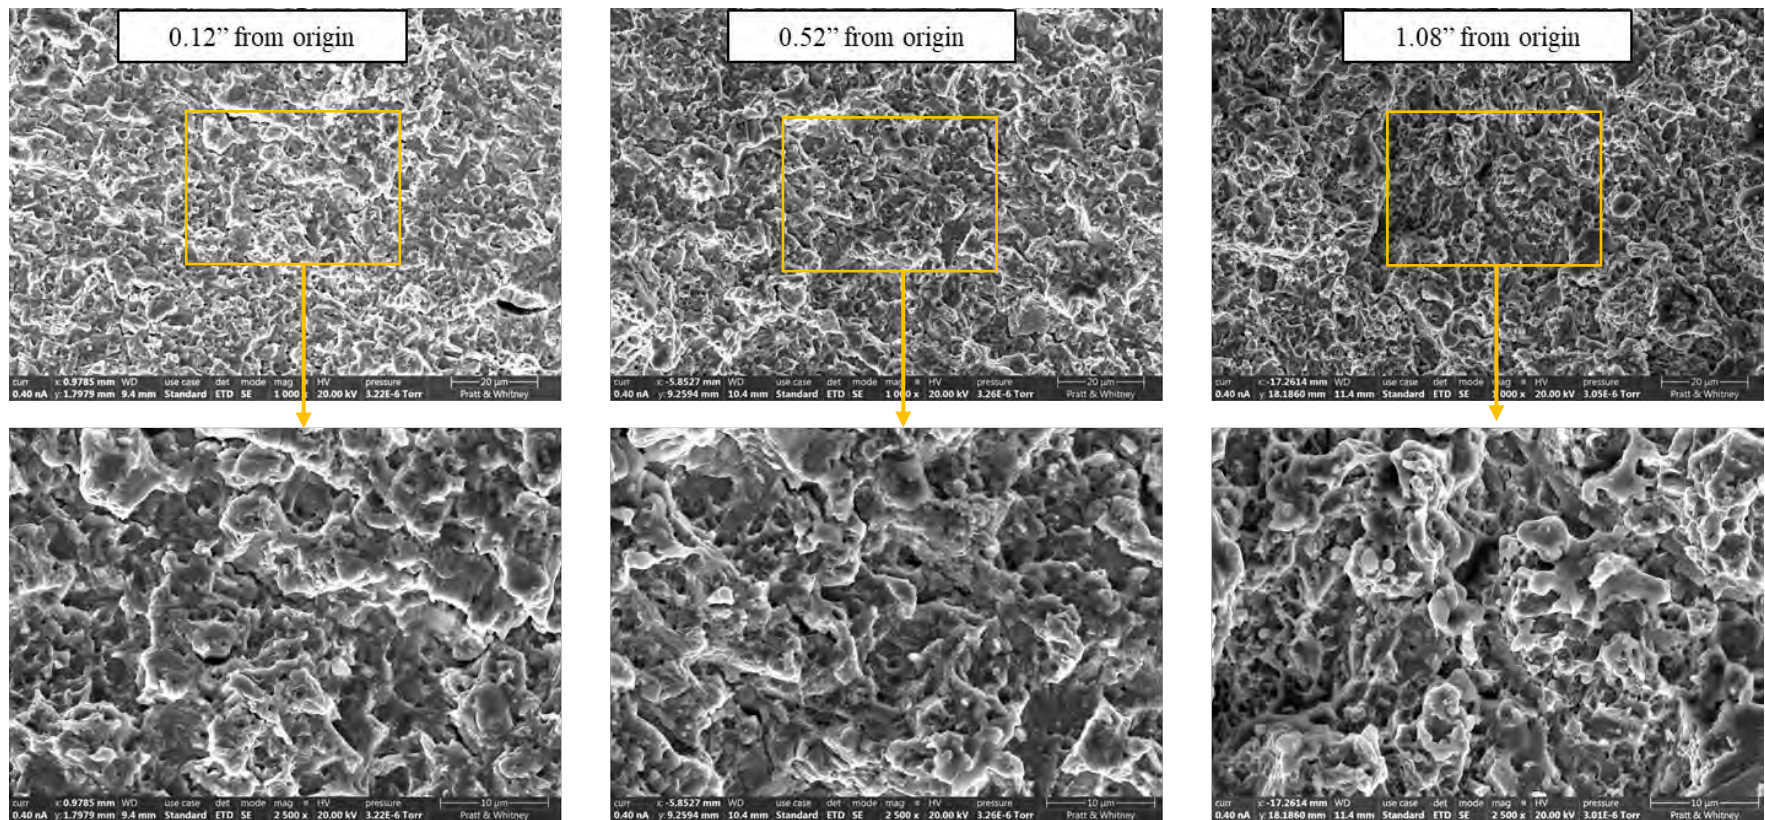
Figure 31: SEM images showing transgranular progression further away from the origin. Further away from the origin, crack features were dominated by ductile dimples.

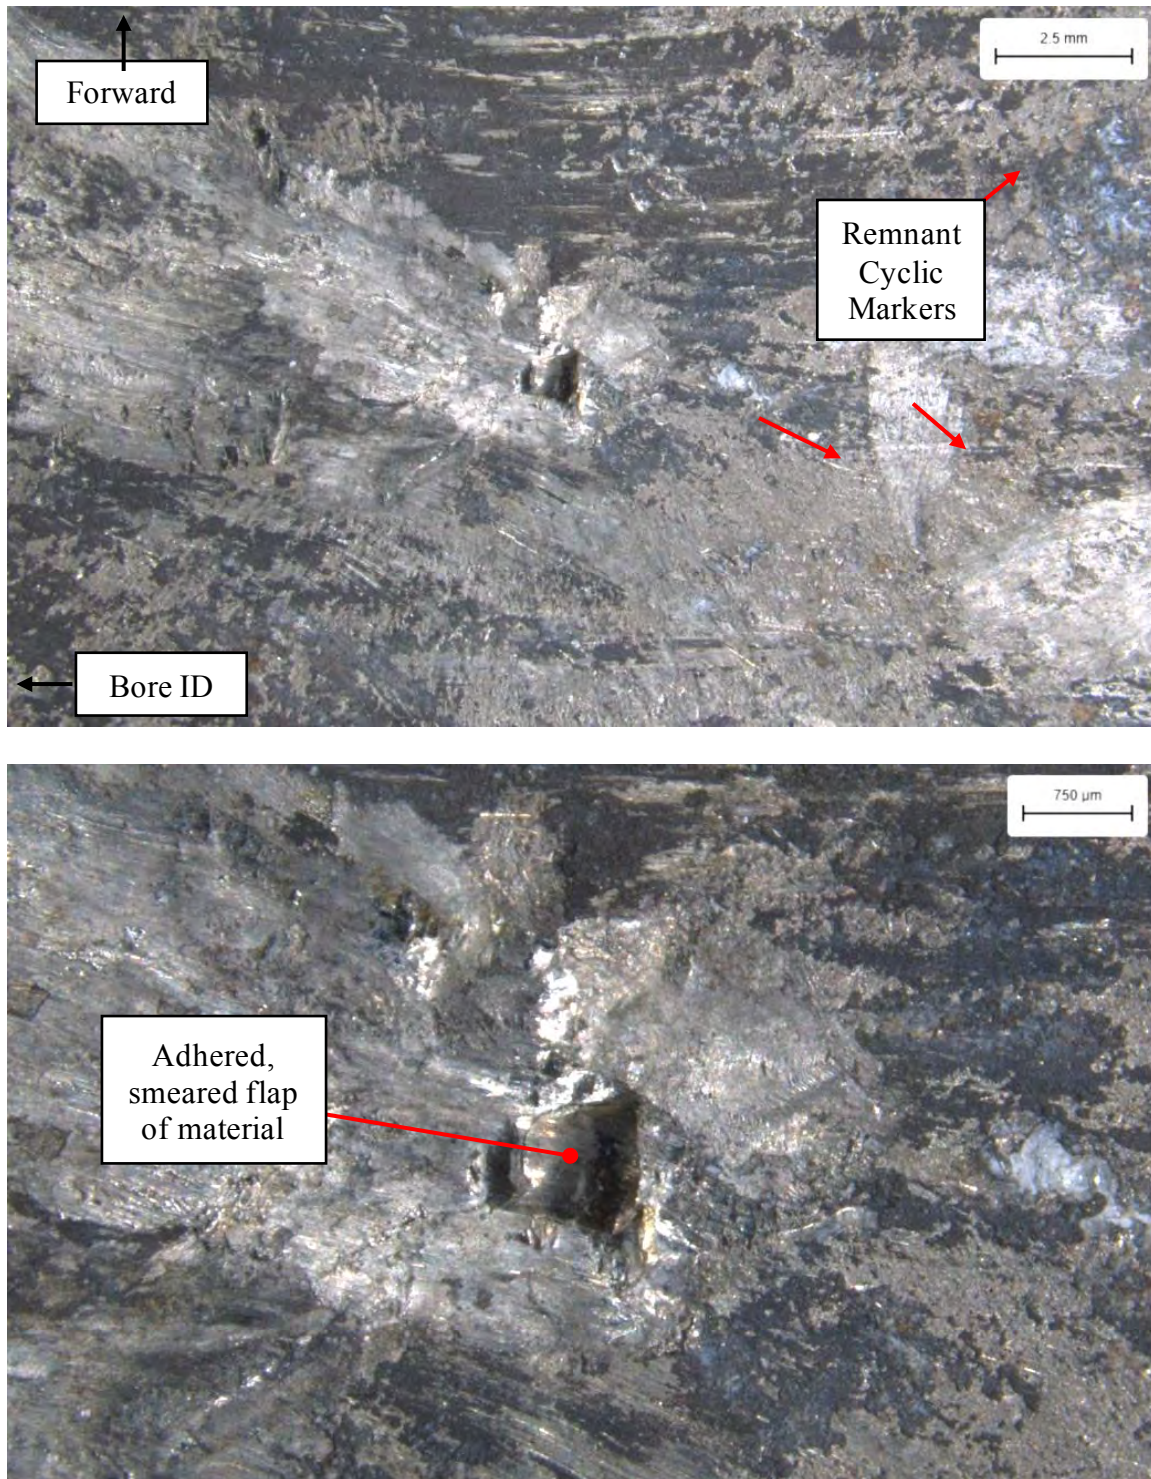
Figure 34: Origin area on the Fragment 2 side of Fracture A; the fracture surface was smeared, however remnant cyclic markers were observed. An adhered, smeared flap of material was observed near the presumed origin area.

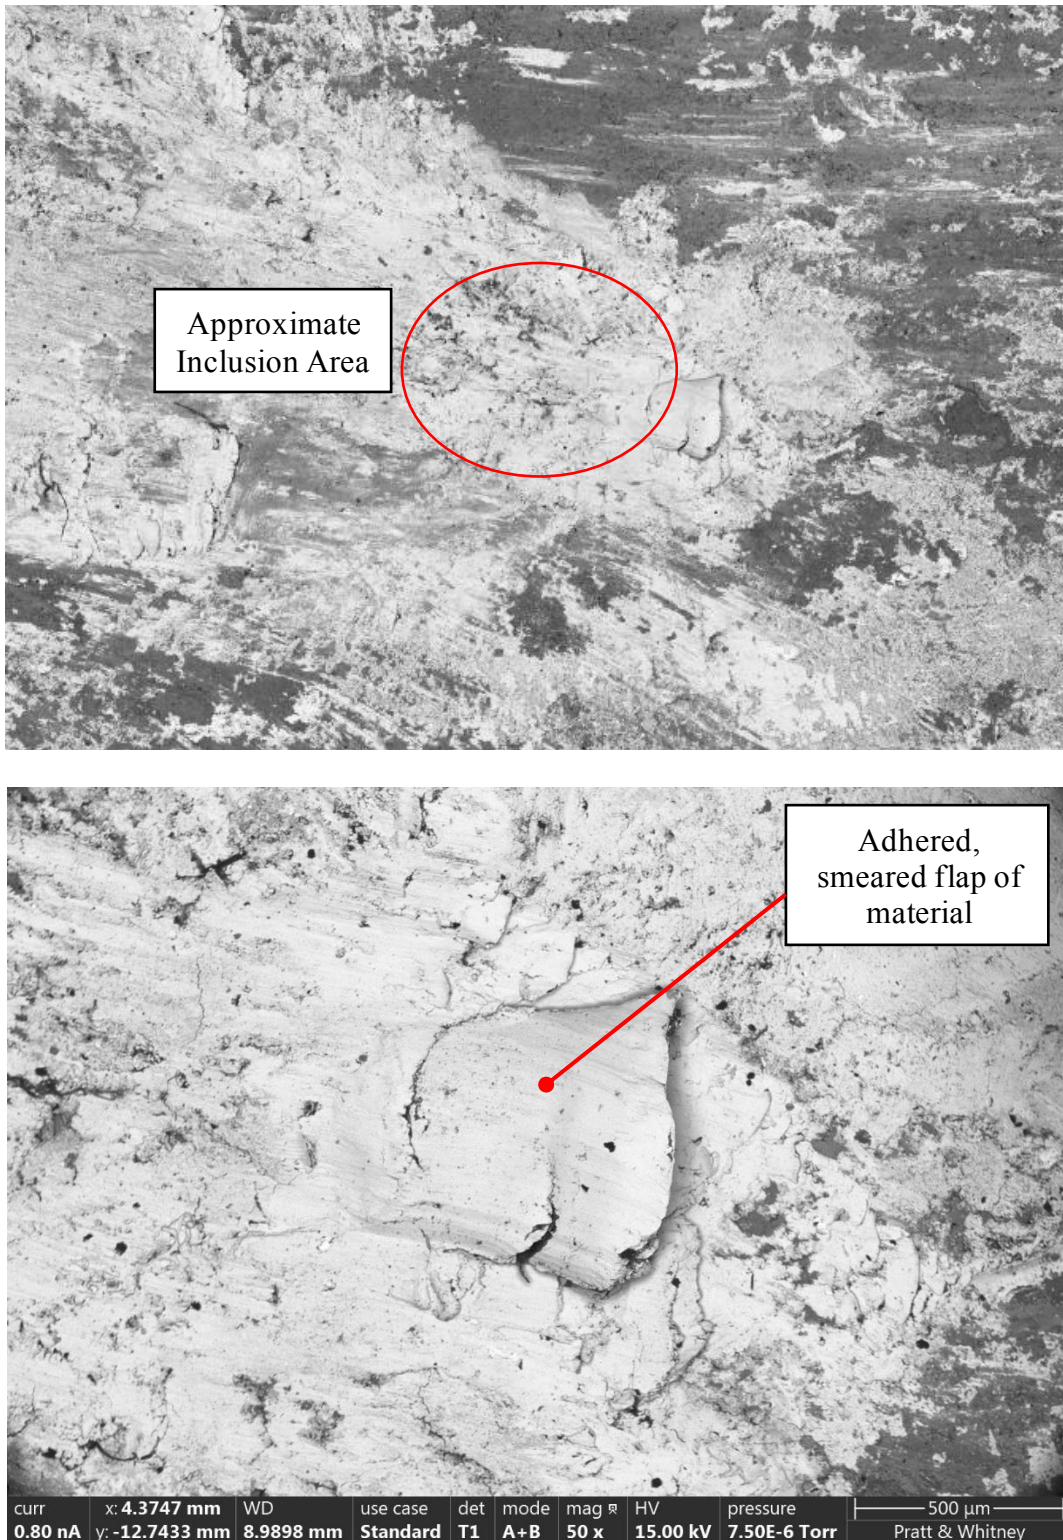
Figure 37: SEM images of Fragment 2 fracture surface. No original fracture features were observed within the origin area; the surface was smeared due to secondary damage.

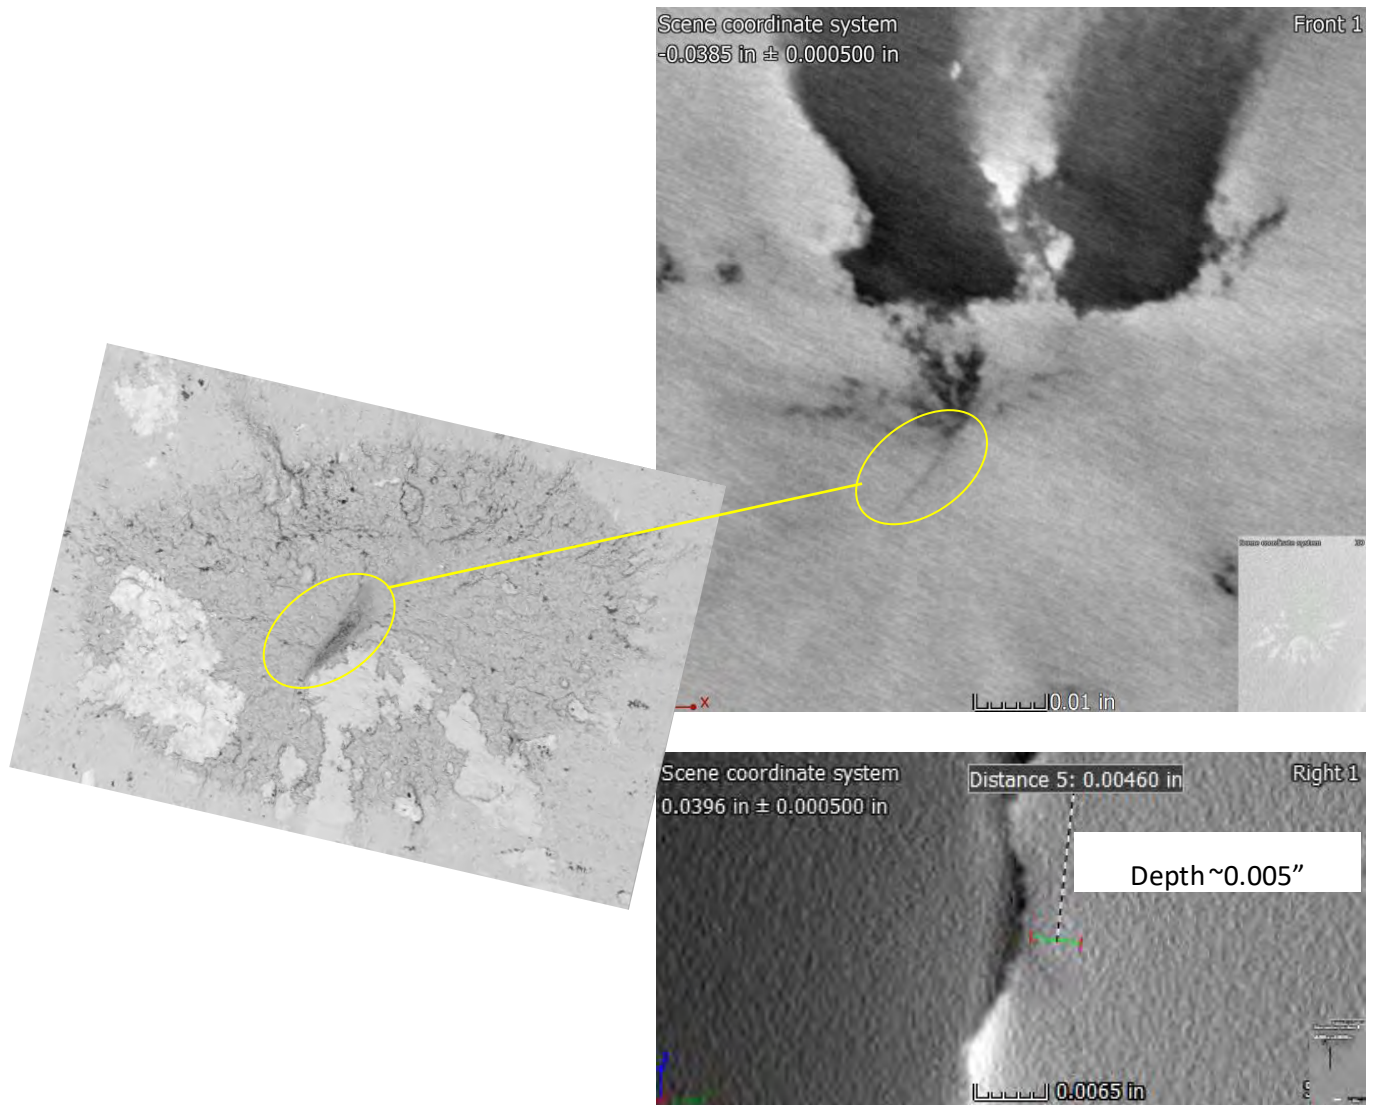
Figure 40: Micro CT scan images after sectioning the Fragment 1 origin area to a 0.1” thick section. The focus scan at the origin area identified a region extending approximately 0.005” – 0.007” into the sample at the location of the inclusion that exhibited a difference in density when compared with the surrounding base metal. No other indications were found within the rest of the scan.

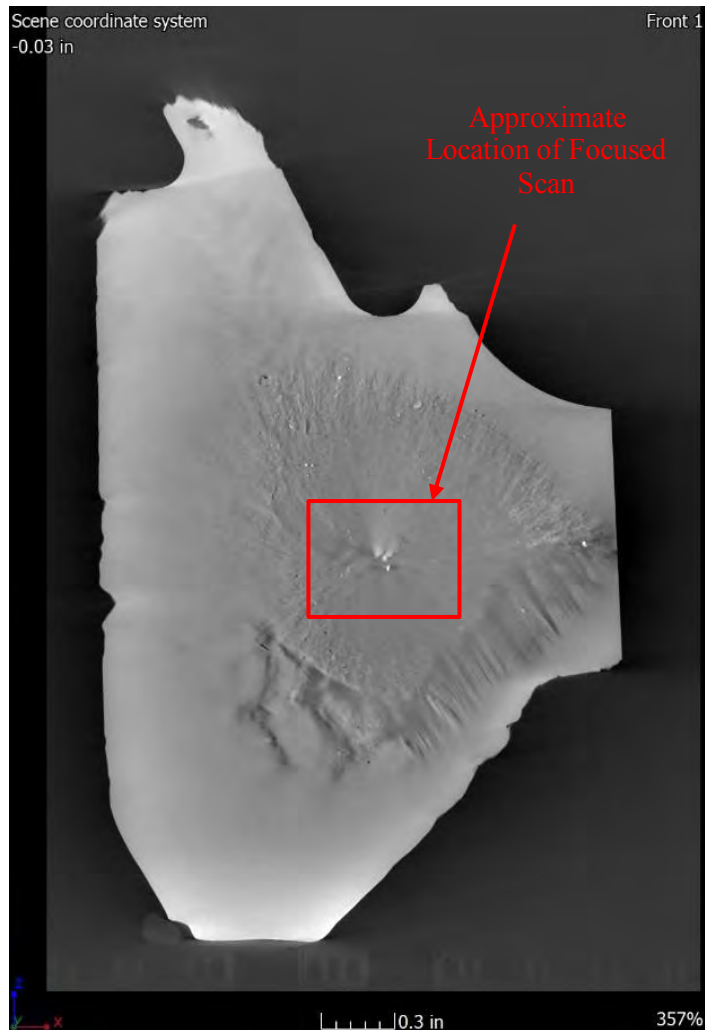
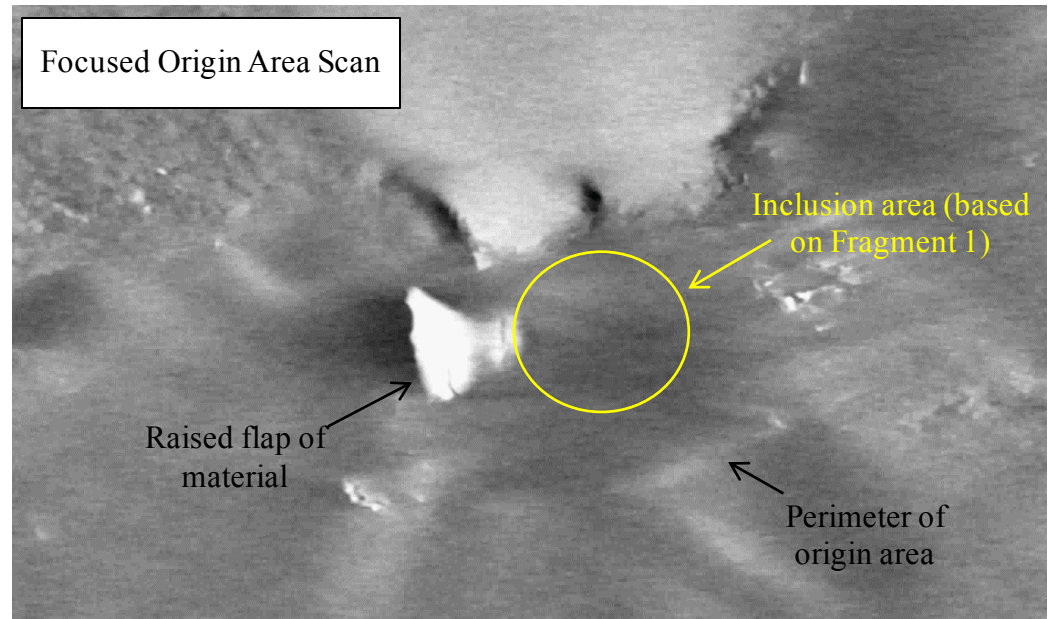
Figure 41: Micro-CT scans from the Fragment 2 origin area. No evidence of the inclusion was identified; secondary damage to the fracture surface may have obscured the evidence of the inclusion.

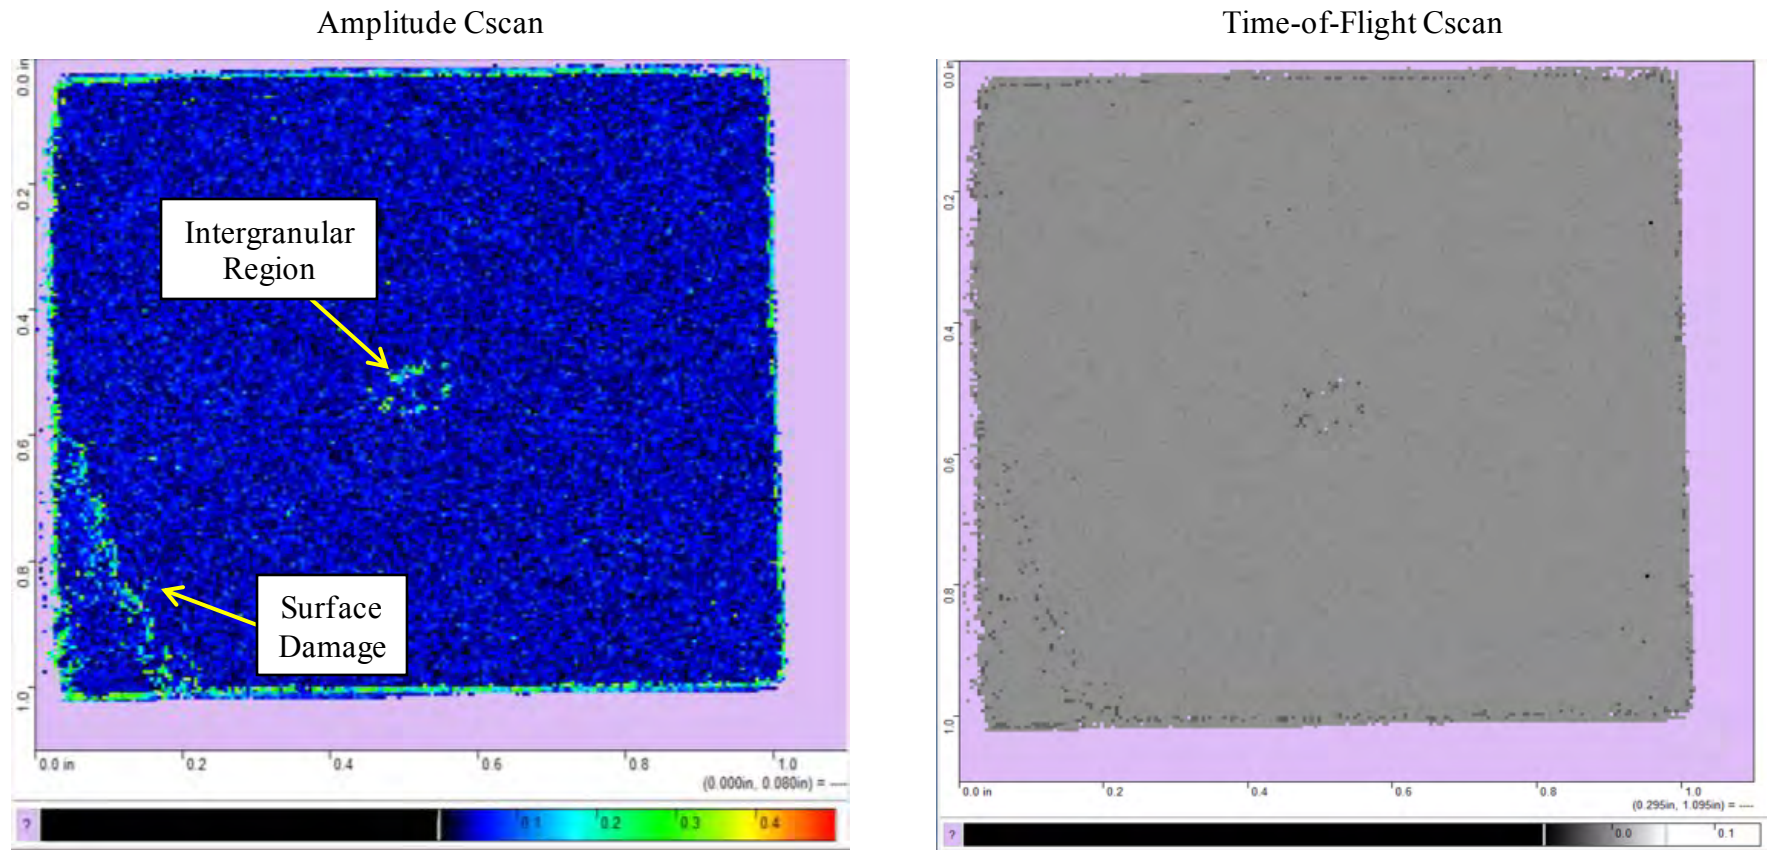
Figure 42: Results of the ultrasonic (UT) scans on the 0.1” thick section of Fragment 1. Indications were found that correlated with the perimeter of the intergranular region; no other indications were observed.

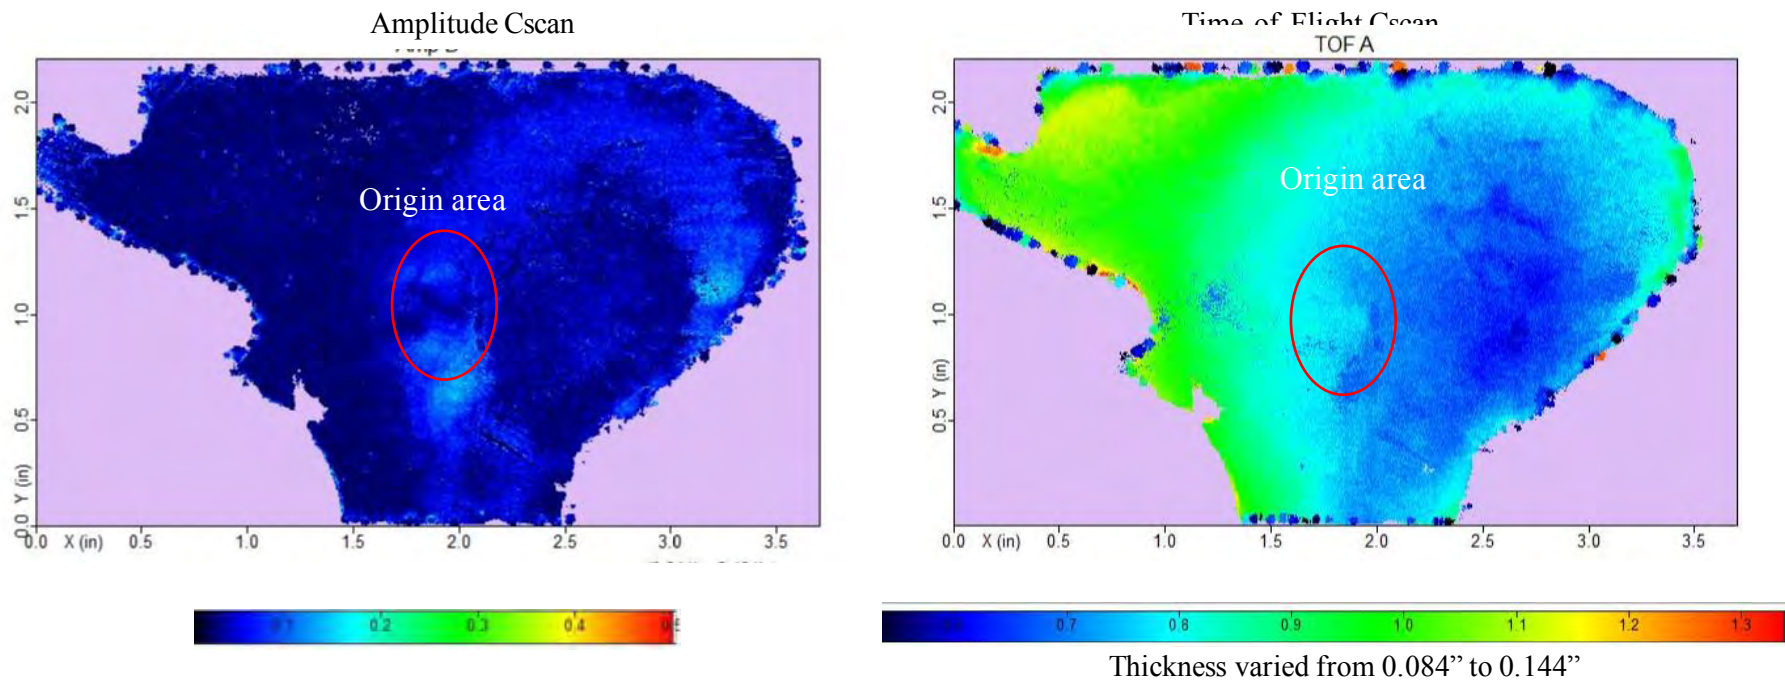
Figure 43: Results of the ultrasonic (UT) scans on the 0.1" thick section of Fragment 2. No indications associated with the known inclusion location were observed.

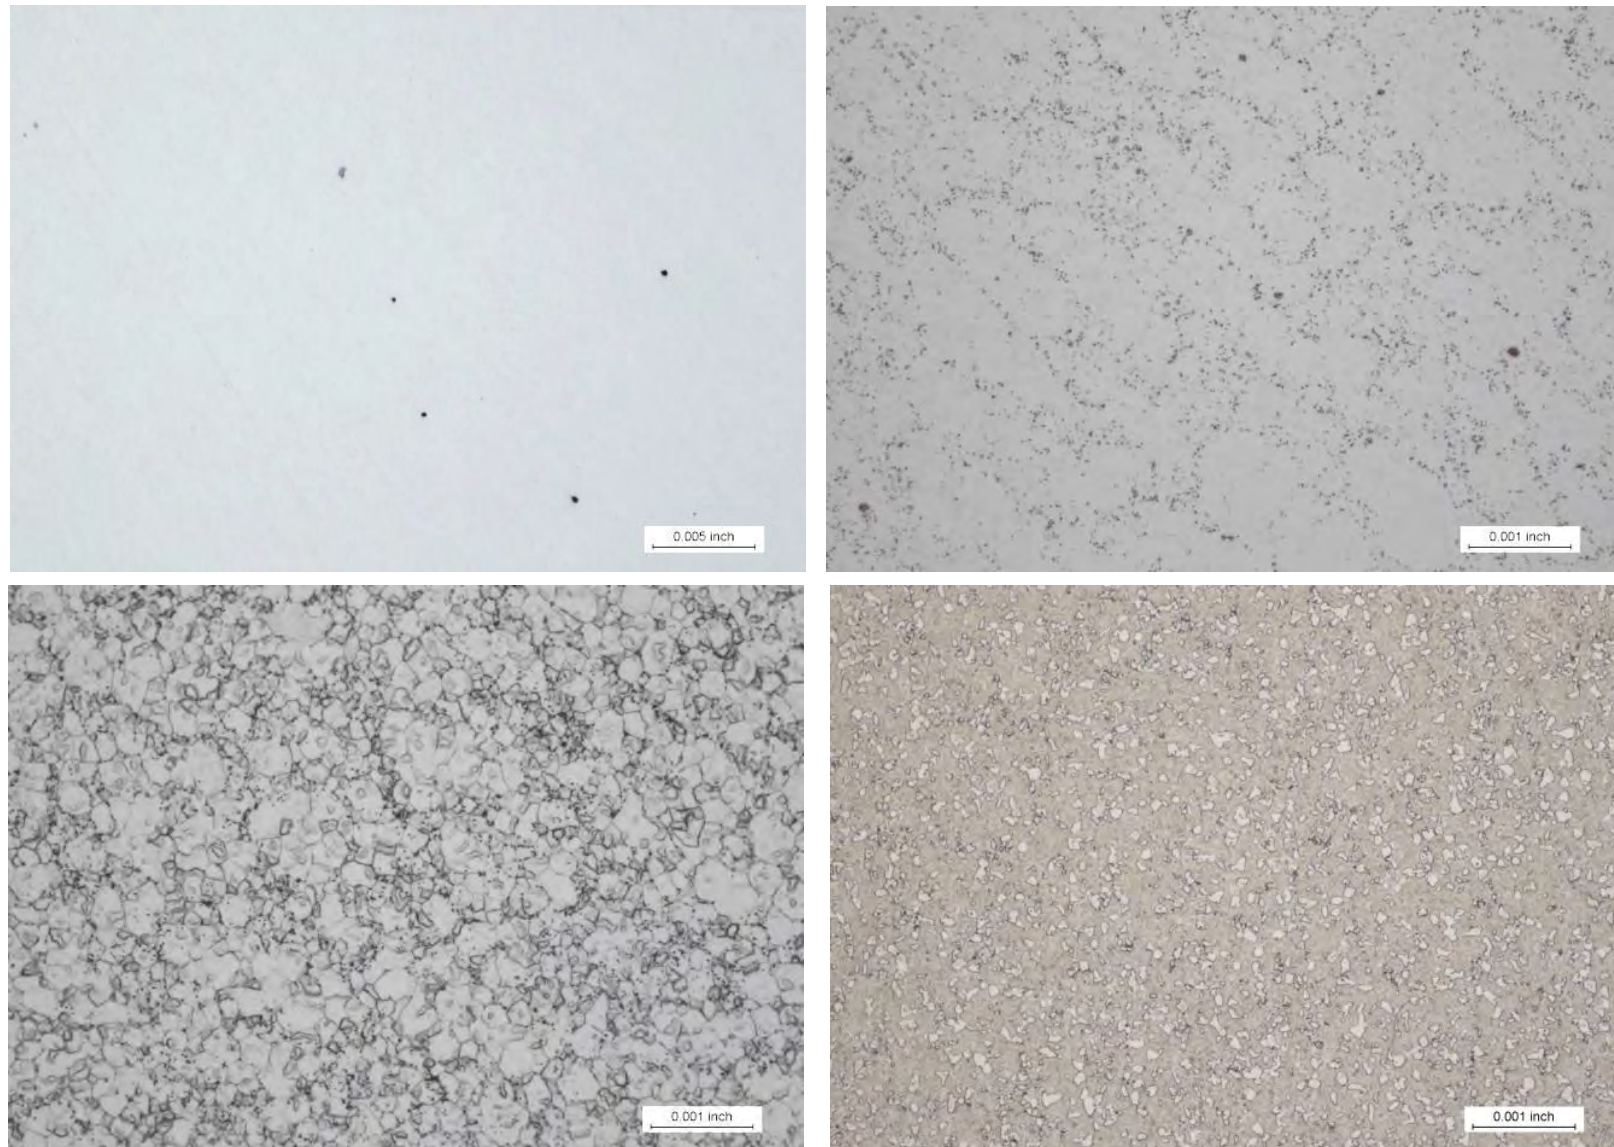
Figure 44: Bulk microstructure appearance in the bore approximately one to two inches away from the origin area. The distribution of gamma prime phase, grain size, distribution of carbides, and amount of micro-porosity all conformed to the material requirements.
