**FINAL REPORT<sup>1</sup>**

**INVESTIGATION RESULT OF SERIOUS INCIDENT**

**VIETNAM AIRLINES UNCONTAINED ENGINE**

**AIRBUS A321 MSN 5306 (VN-A392)**

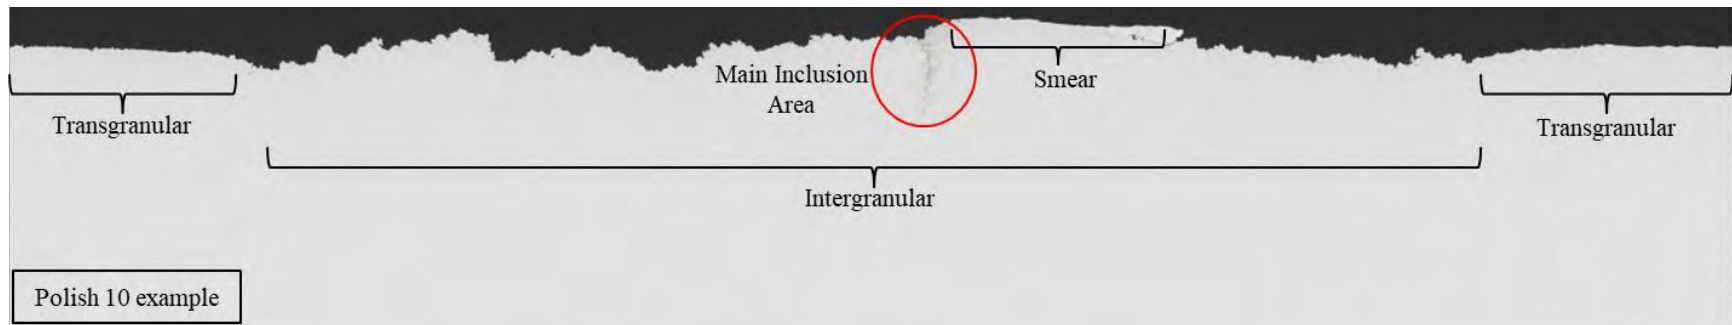
Figure 46: Photomicrograph showing the inclusion area, intergranular, and transgranular features observed within the cross section on Polish 10.

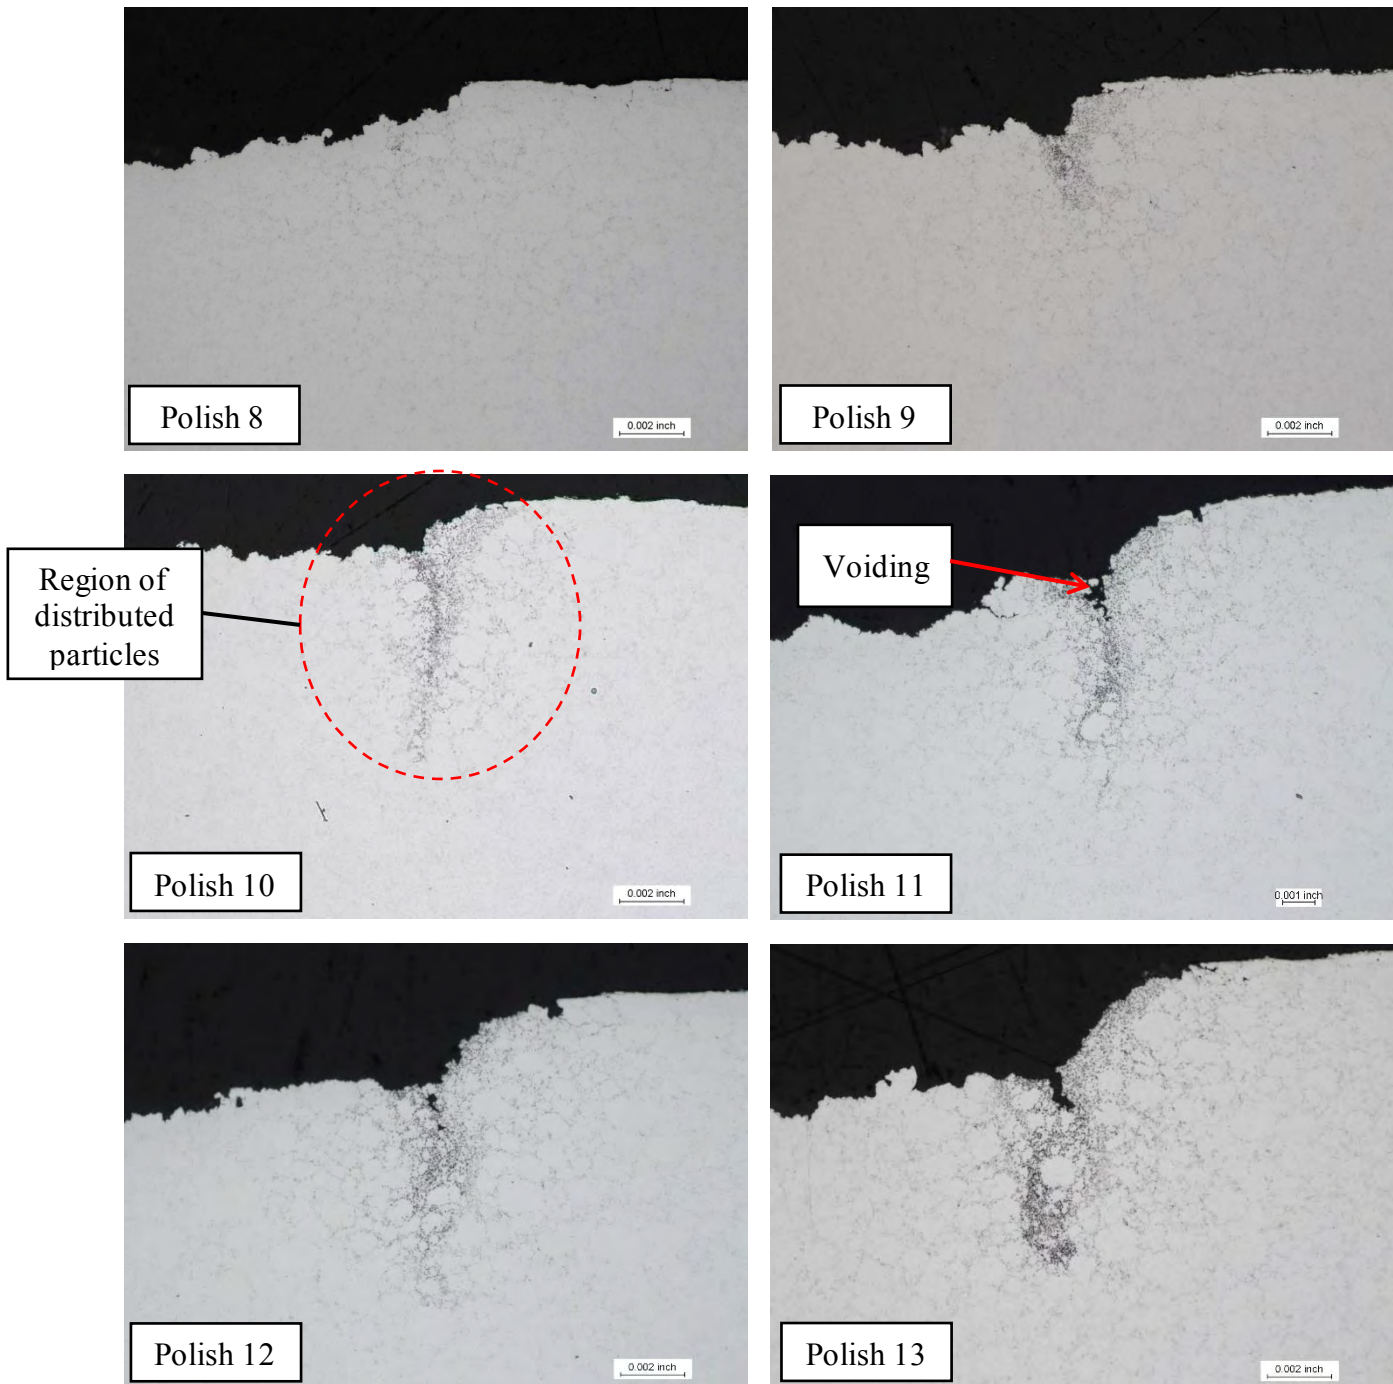
Figure 47: Serial polish steps 8-13 through the Fragment 1 fracture surface. The inclusion was visible as a region of distributed particles, or particle cloud (dark gray/black particles, above). Voiding was observed starting at Polish 11.

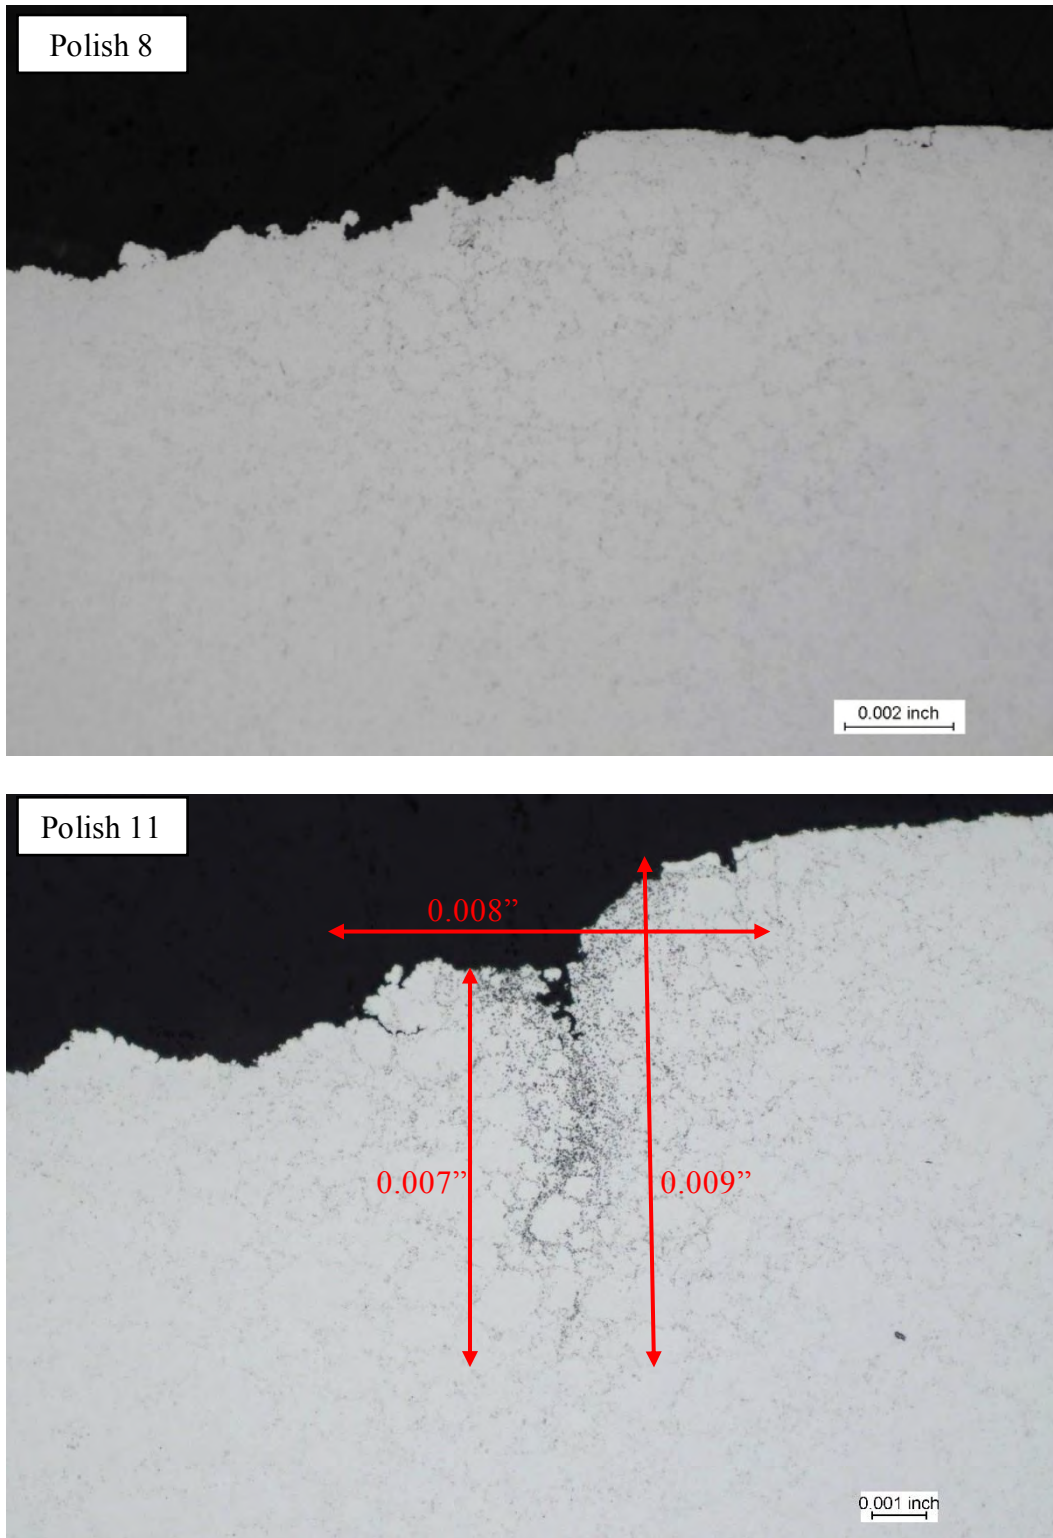
Figure 48: Polishes 8 (top) and 11 (bottom). The inclusion was first visible at Polish 8. Maximum size of the particle cloud at Polish 11 was 0.008\"/>

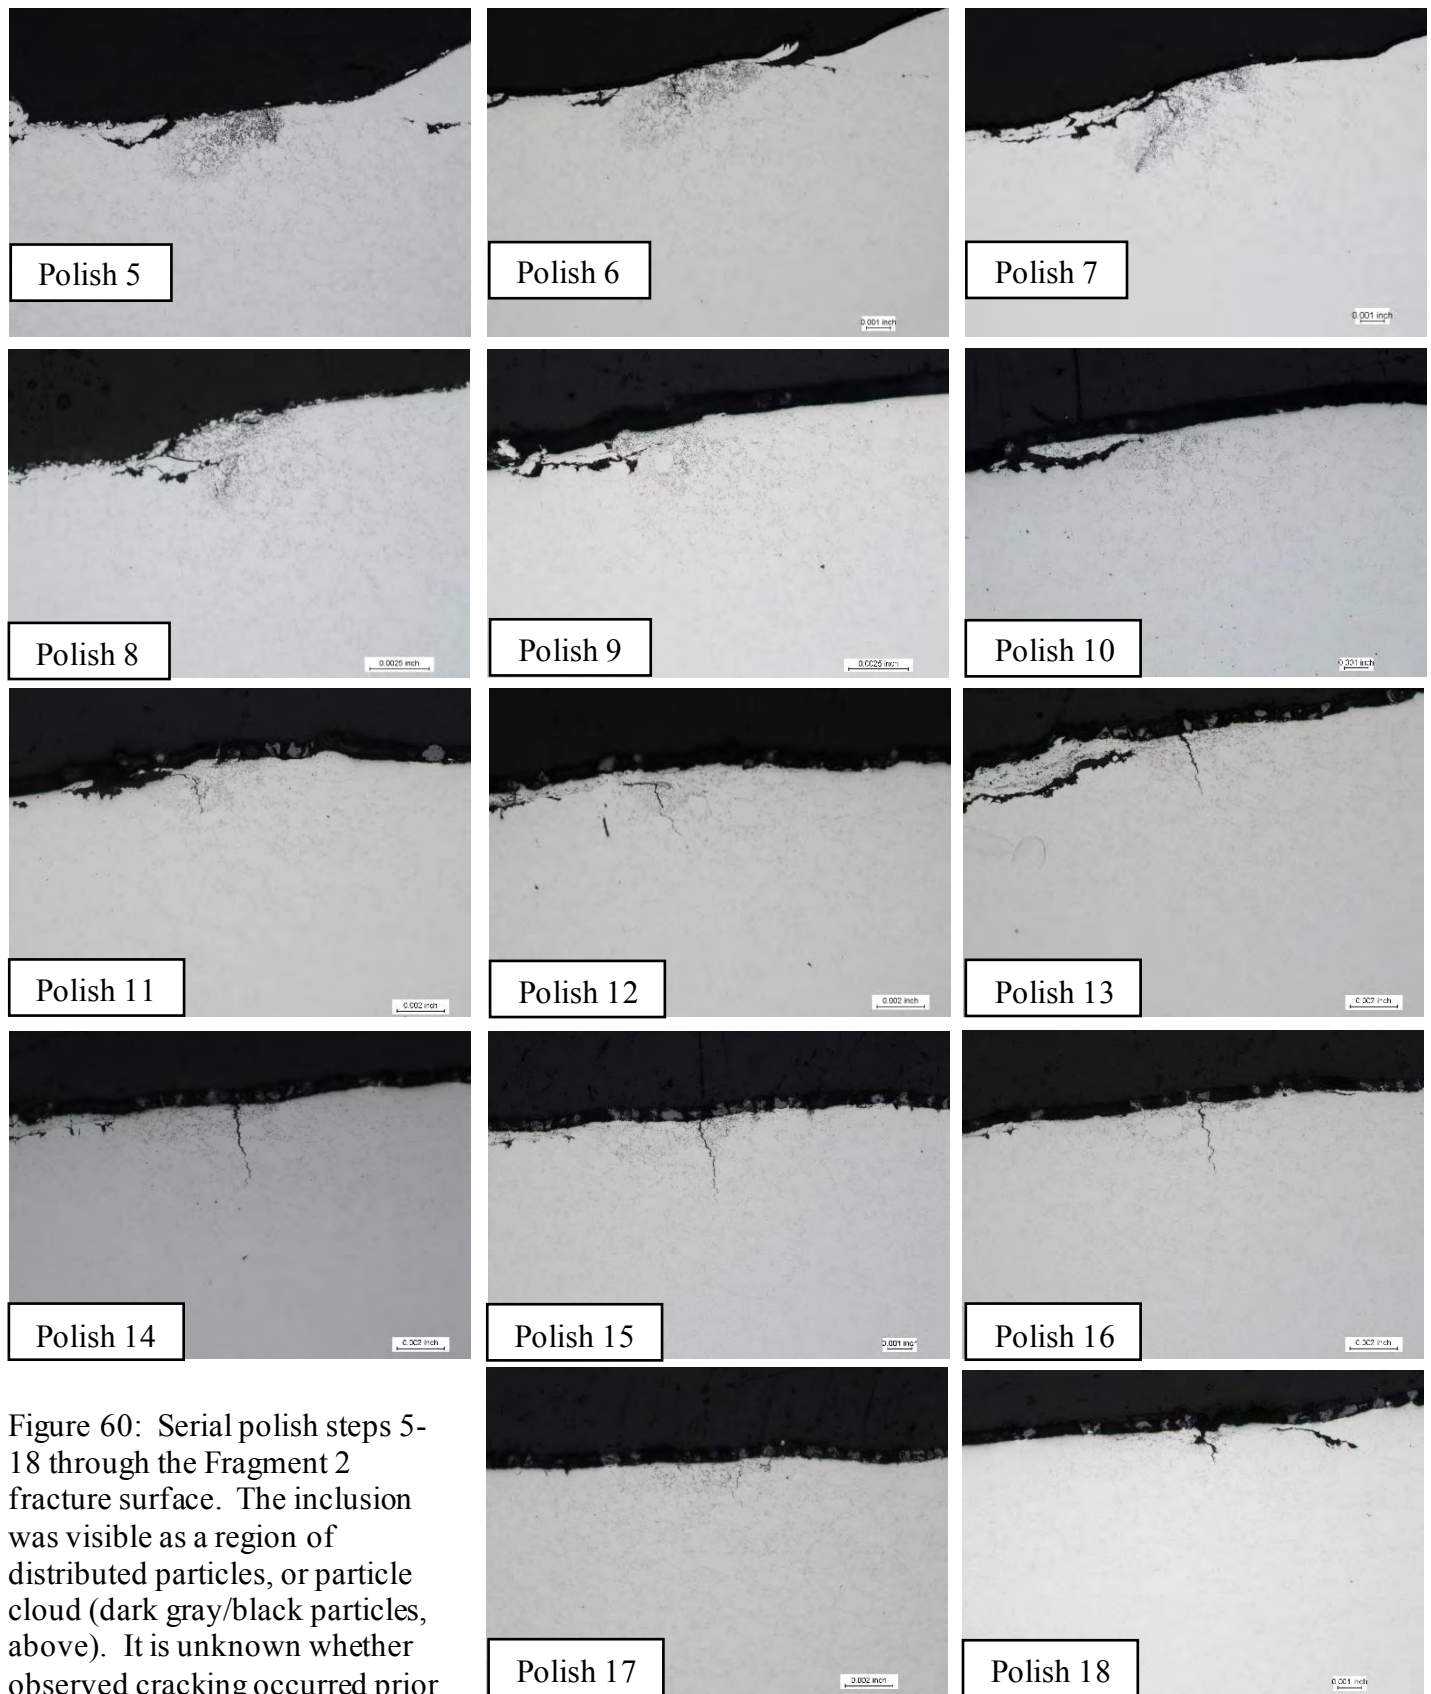
Figure 60: Serial polish steps 5-18 through the Fragment 2 fracture surface. The inclusion was visible as a region of distributed particles, or particle cloud (dark gray/black particles, above). It is unknown whether observed cracking occurred prior to or as a result of the event.
