CIVIL AVIATION AUTHORITY OF VIETNAM

FINAL REPORT¹
INVESTIGATION RESULT OF SERIOUS INCIDENT
ON 29/12/2018 AT CAM RANH INTERNATIONAL AIRPORT

Hanoi, March 2019

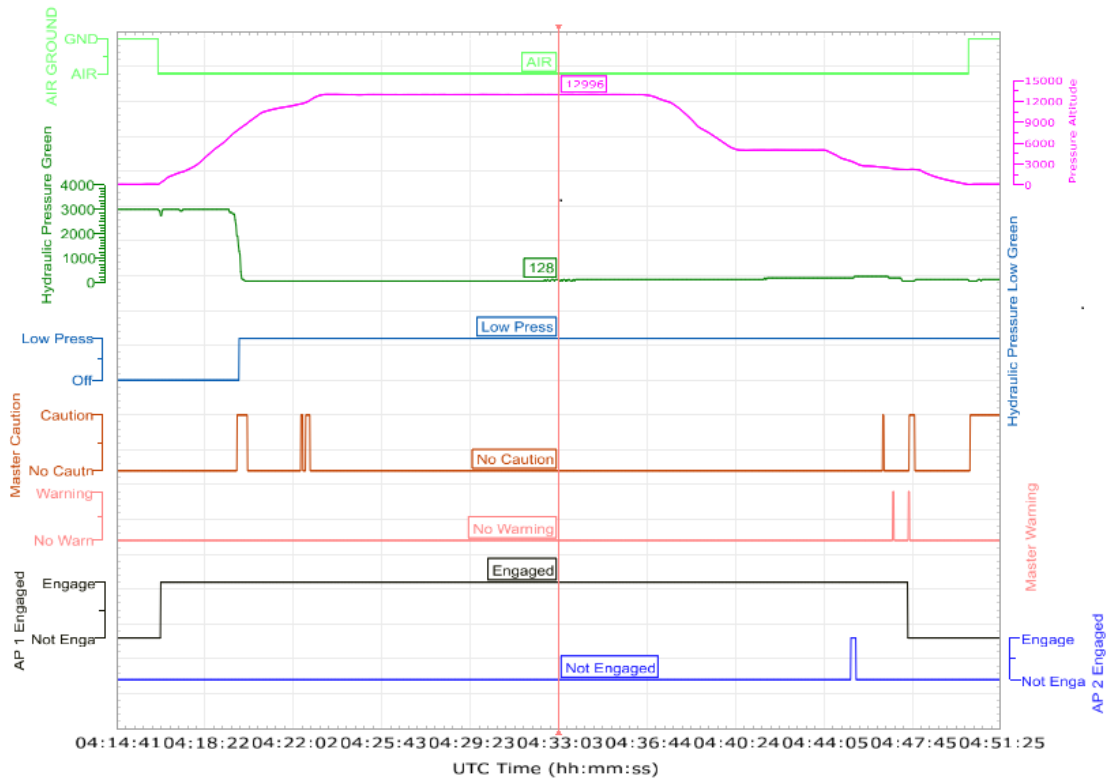
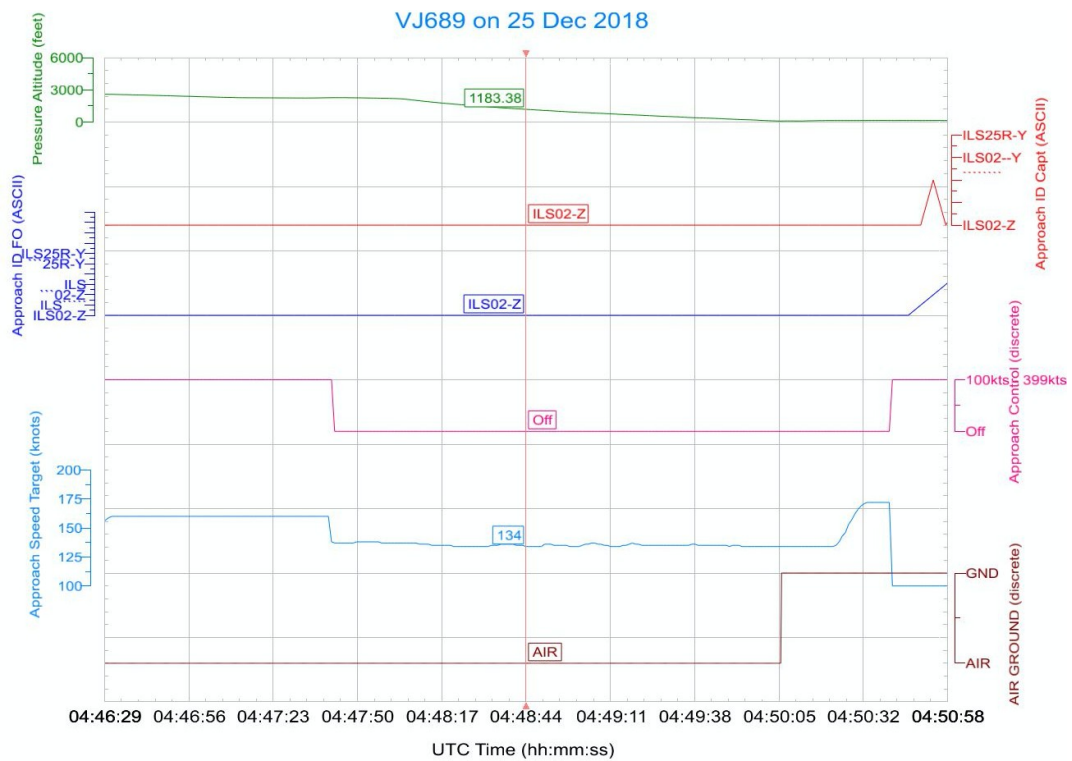
FLIGHT VJ689 25thDec2018

According to Flight Data Recorder data and Airfasc data, it showed that the crew did not follow any specific landing approach method (Instrument Flight Rules (IFR) or Visual Flight Rules (VFR)). Specifically, during the intermediate approach phase (IF), before turning onto the final approach segment, the crew armed the approach mode but did not activate the ILS approach, resulting in the LOC and ALT G/S signals appearing on the Primary Flight Display (PFD) for only 2 seconds. Subsequently, the data showed that the crew switched to heading mode and selected a non-automatic altitude to initiate descent (Open Descent). During the final approach segment, the crew disengaged autopilot 1 (AP1) at 04:47:33 when the aircraft was above 2200ft to descend (as the aircraft was higher than the standard glide path at an altitude of 2268ft).

At altitudes of 1873ft and 1097ft, the crew successively disengaged flight director 1 and 2. At this point, the localizer deviation was -2.35 dots.

At 115ft altitude, an audible warning sounded indicating the aircraft's altitude was below the required glide path of the ILS Z R02 approach (GLIDESLOPE, GLIDESLOPE), with a deviation of -2.8 dots.

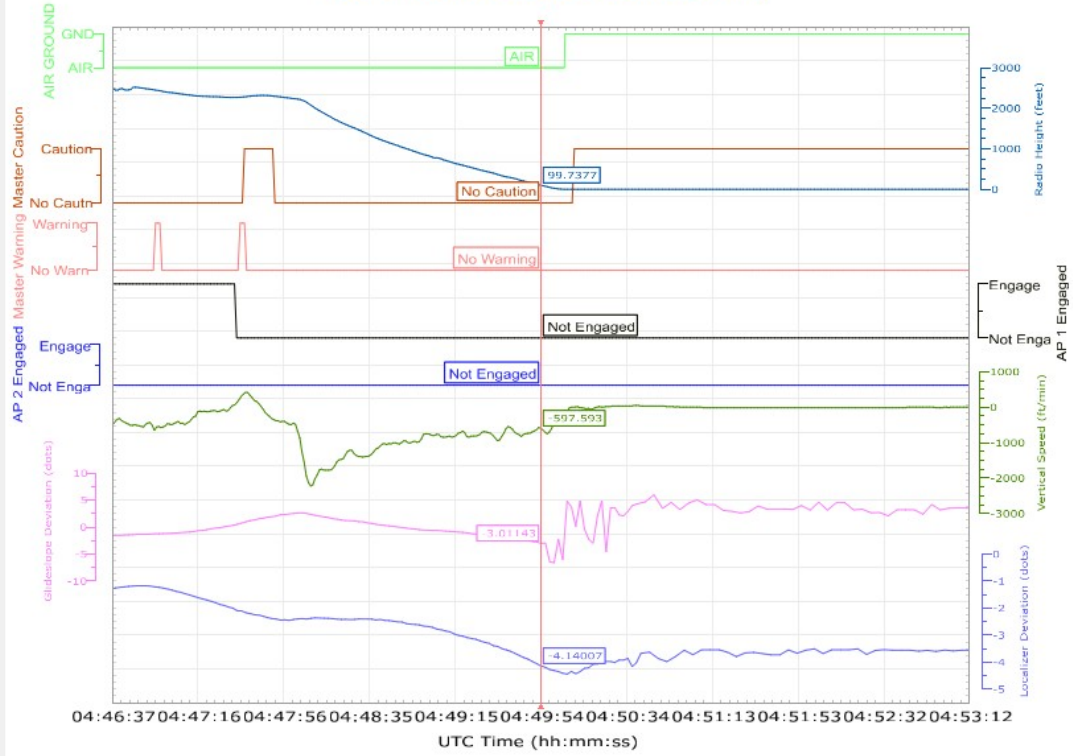
FLIGHT VJ689 25thDec2018 at Landing

At 11:49 AM, the aircraft was at 100ft altitude with a localizer deviation of -

4.1 dots.

At 11:50 AM, the aircraft touched down and landed on the runway that was not in use (to the right of runway 02).

According to cockpit voice recorder data, it showed that when the aircraft was preparing to flare at approximately 20ft altitude, the crew realized they had landed on the unused runway but did not initiate a go-around procedure as required, although it was still possible to execute a go-around (prior to reverse thrust deployment).
