CIVIL AVIATION AUTHORITY OF VIETNAM

**FINAL REPORT<sup>1</sup>**  
**INVESTIGATION RESULT OF SERIOUS INCIDENT**  
**HARD LANDING ON NOSE LANDING GEAR**  
**AIRBUS A321 MSN 8199 (VN-A653)**  
**FLIGHT VJ356 ON NOVEMBER 29<sup>TH</sup> 2018**

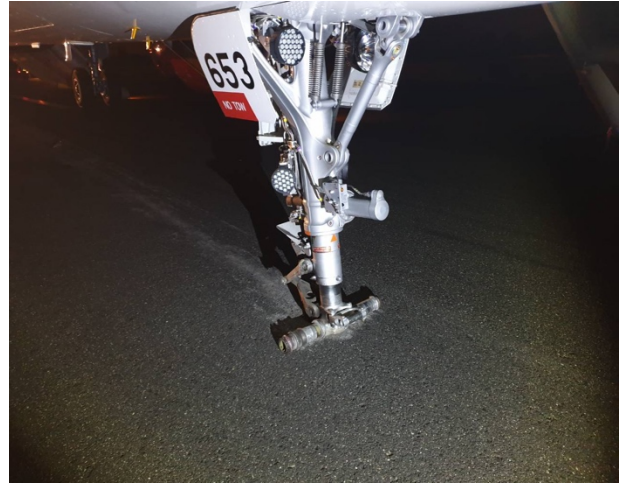
*Picture 02.*

At 16:02, the aircraft landed on RWY 09 at BMV airport, Buon Me Thuat city. In touch-down and deceleration process, 02 nose wheels fractured and separated from the nose landing gear. After completely stopped on the runway, the aircraft was incapable to move (see *Picture 01*). Flight crews carried out emergency procedure and evacuated passengers based on operation procedure. The total of 207 passengers were safely evacuated (see *Picture 02*).

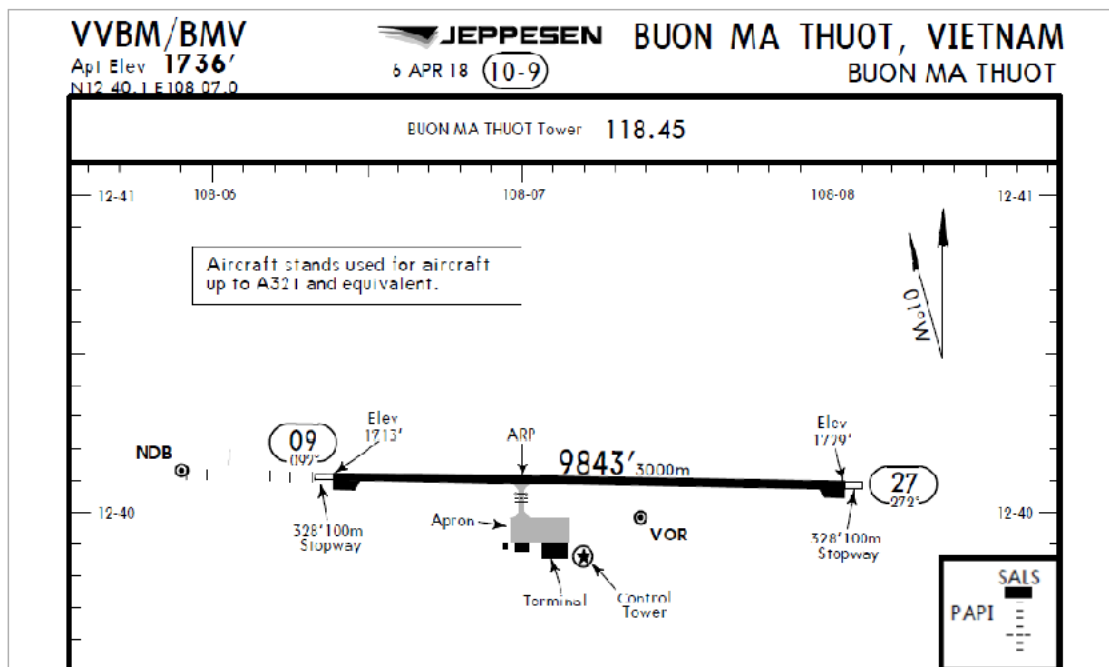
*Picture 03.*

The runway has a curvature of 23ft along its length. The threshold of runway 09 is at an elevation of 1713ft. This rises to 1736ft at the taxiway exit (approx. 1/3 along runway length) and then drops away to 1729ft at the end of the runway (See *Picture 03*).

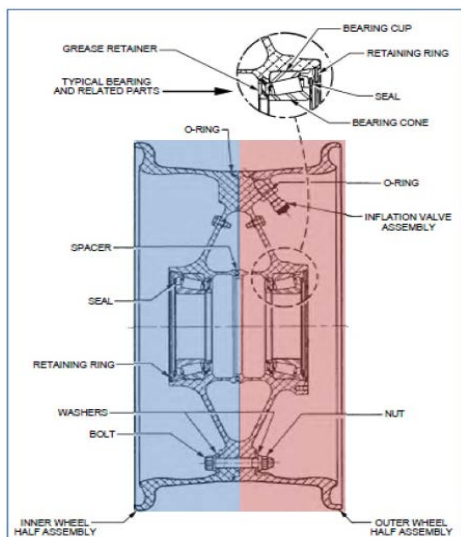
Picture 08.

- 02 separated nose landing gear wheels were found with condition as follow (see *Picture 08* – diagram of nose wheel assembly)

- + There was no damage on the tires (no tear, no blow-out);
- + The outer wheel half & tyre were separated and the bearing hub was separately broken from the inner wheel half (see *Picture 09*);
- + Some tie bolts were found broken (see *Picture 10*).

The wheel halves and tie bolts were tested for hardness, microstructure and fracture surface examination. The results indicated that the materials were in accordance to production requirements and the fracture surfaces were consistent with failure due to overload.

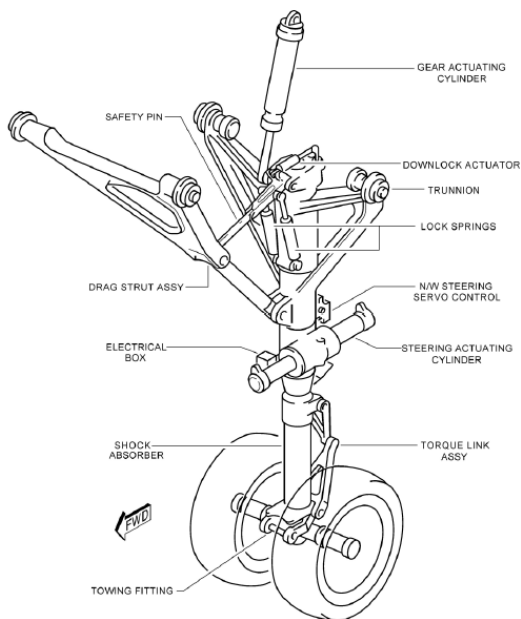
Picture 11.

- Nose landing gear (NLG) was severely damaged with grinded NLG axle (see *Picture 12*). After inspecting nitrogen pressure of nose landing gear and NLG shock absorber, the extension of NLG shock absorber was 20.4cm (normal extension is 44.9cm) (see *Picture 11* - NLG structure diagram).

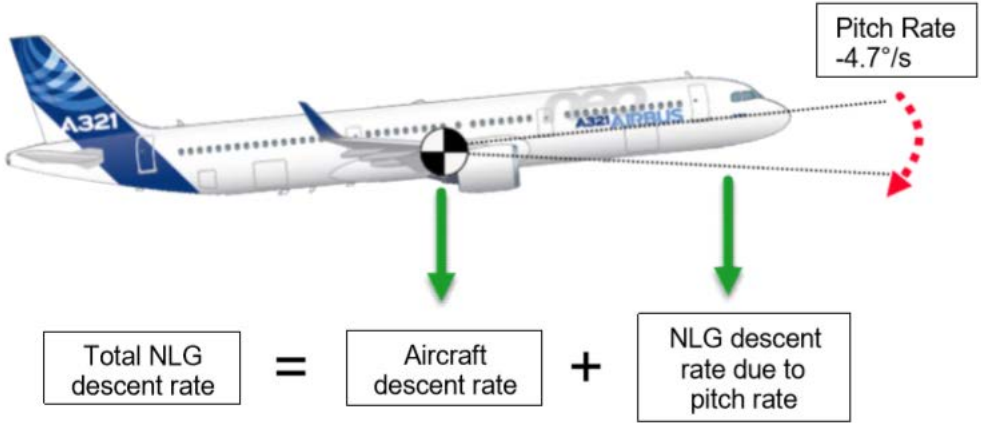
*Picture 21.*

The total NLG Descent Rate is a combination of aircraft descent rate and NLG descent rate due to pitch rate (see *Picture 21*).

At touch down moment, aircraft descent rate and NLG descent rate due to pitch rate had the same magnitude. Therefore, pitch down command effectively doubled the descent rate of NLG, resulting in a higher load on NLG at touch down (see *Picture 22*).

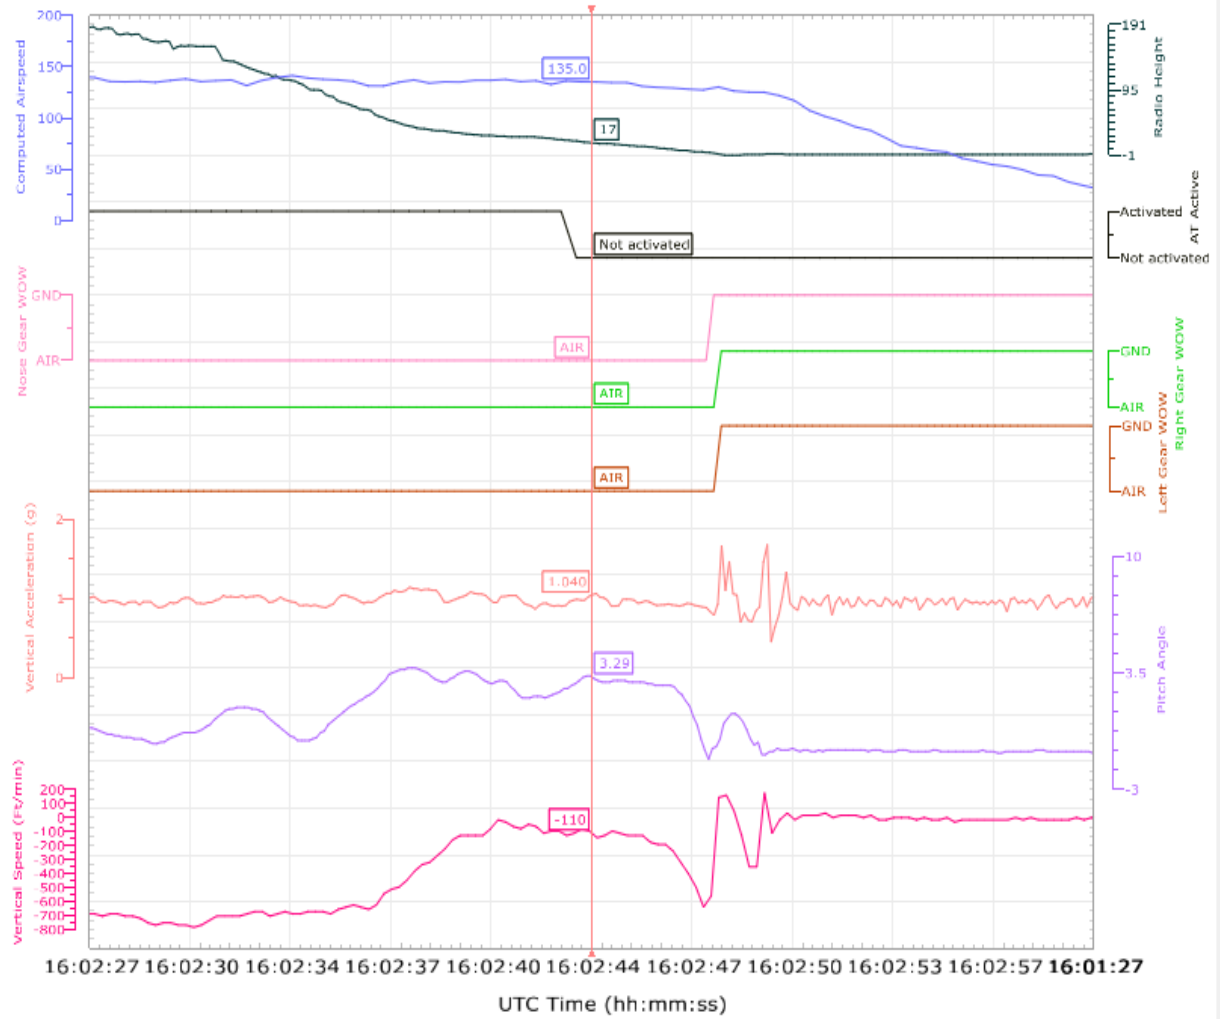
FLIGHT VJ356 29THNOV2018 AT LANDING

At 16:02:34, from 110ft RA, pitch up inputs were continuously applied to the captain sidestick, up to  $10^{\circ}$  (about 2/3 of full back stick) caused aircraft pitch increased from  $0.2^{\circ}$  nose down to  $3.8^{\circ}$  nose up. Descent rate started to decrease from -640fpm, and CAS reduced from 139kts to 131kts (the approach speed target was 134 kts).

Analysis: The continuously applied sidestick input caused the aircraft pitch up to  $3.8^{\circ}$ . Thus descent rate and aircraft descent rate reduced and aircraft speed decreased below its target. Consequently, the engaged autothrust had to increase engine thrust to maintain target speed (see *Picture 18*).
