**FINAL REPORT<sup>1</sup>**

**INVESTIGATION RESULT OF SERIOUS INCIDENT**

**VIETNAM AIRLINES UNCONTAINED ENGINE**

**AIRBUS A321 MSN 5306 (VN-A392)**

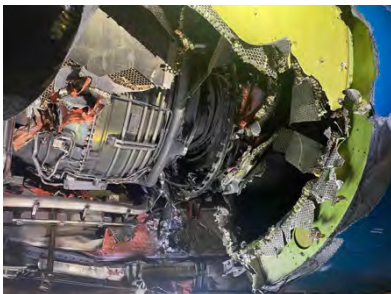
*Picture 01*

- Engine #2 was major damaged:
  - + HPT 1st disc was broken and thrown out (Picture 01 and 02);
  - + Thrust Reverser was torn (Picture 04),
  - + Fan cowlings was thrown out of engine (Picture 05);
  - + The liberated portion of the HPT 1st disk, to include the disk bore and hub cone, was separated circumferentially from the inner portion of the disk which remained connected to the HPC shaft and in the engine;
- Main wheel #3, 4 was blown-out (picture 06), main wheel #2 was worn out of limit (picture 07);
- 01 hole on right hand side of Engine #1 (Picture 03);
- Some evidence of scratches and gouges were observed on the primary structure of the wings and fuselage.

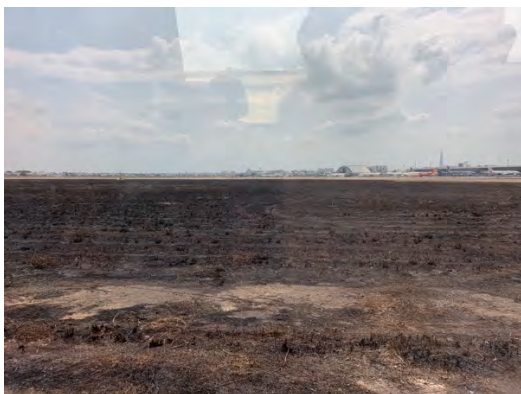
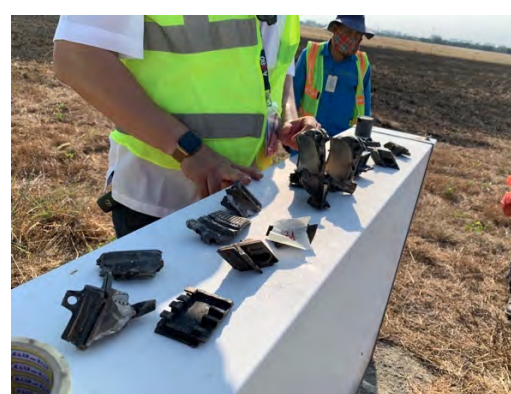
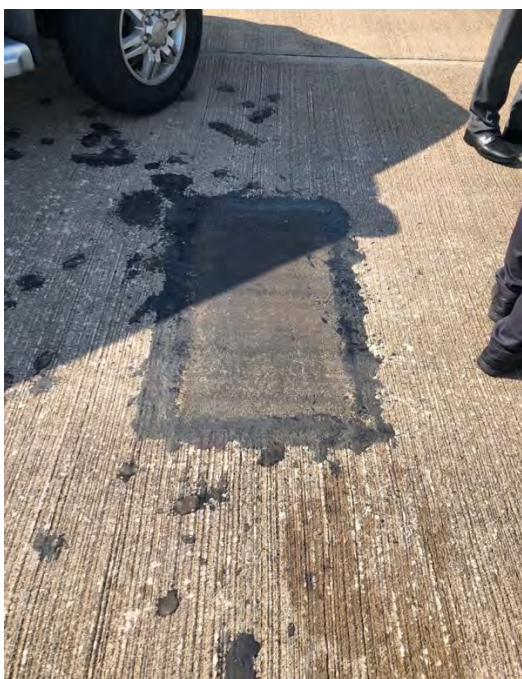
- Some of small fragment hit to the runway 25L/07R causing 07 small holes on the runway and burning grass on the north side of the runway (Picture 08, 09 and 10).
- 01 fragment of HPT 1st disc was thrown into the weather radar station area, breaking the window of the office in this area (Picture 11).

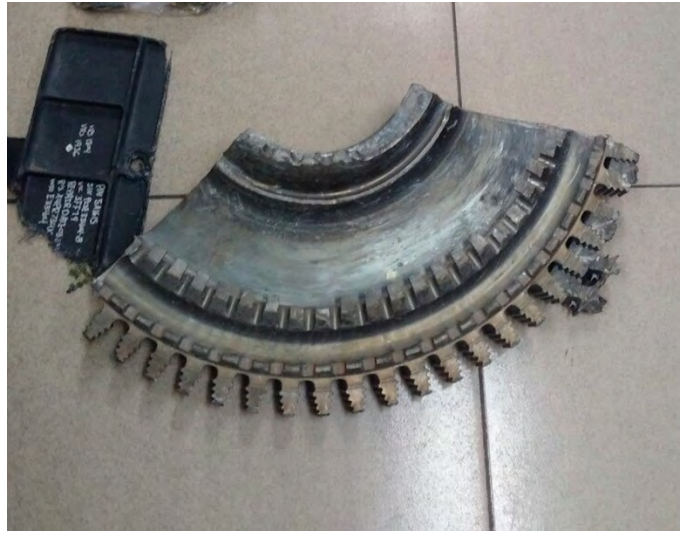
Fragment #2 of the HPT 1st disc (approximate about 1/3 discs) is determined about 80m to the left of the runway from the event location, specifically according

*Picture 16: 1/3 Disc*

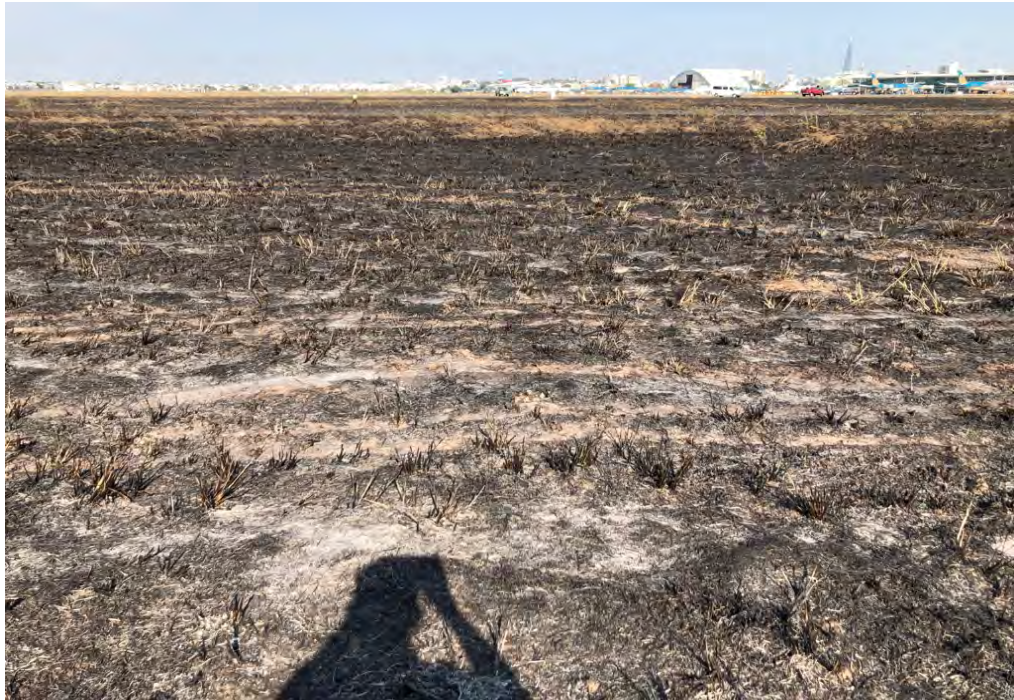
There was not a fire on aircraft, but there was a fire of grass on right side of runway 25L because of debris from engine.

*Picture 18: Right side of runway*

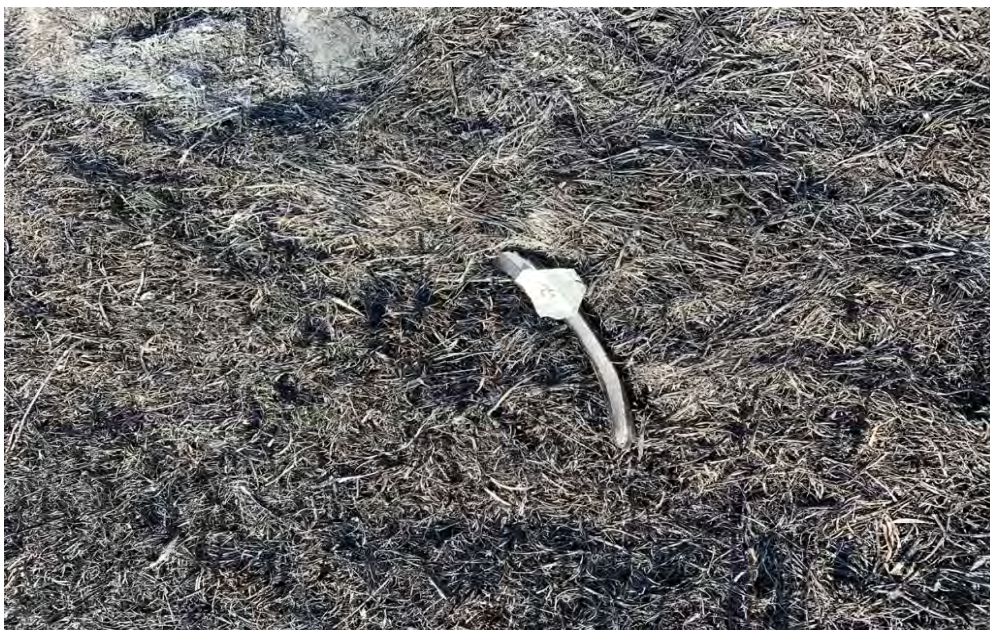
*Picture 19: One of the engine parts on right side of runway*

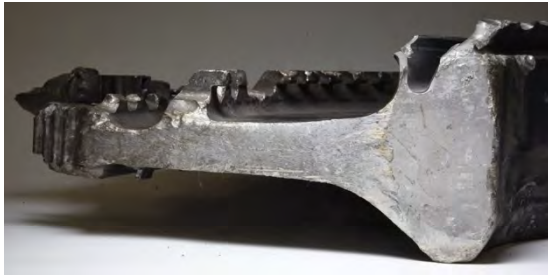
*Picture 22: Fracture A*

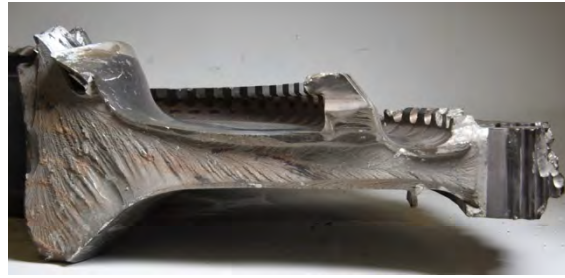
*Picture 23: Fracture B*

Fracture B did not exhibit as planar of an axial-radial fracture path as Fracture A. Review of the Fragment 1 side of Fracture B found rough, directional features and shear lips consistent with overstress/rapid tear. The Fragment 2 side of Fracture B was completely obscured by secondary damage (Figure 12). Fracture B was determined to be secondary to Fracture A.

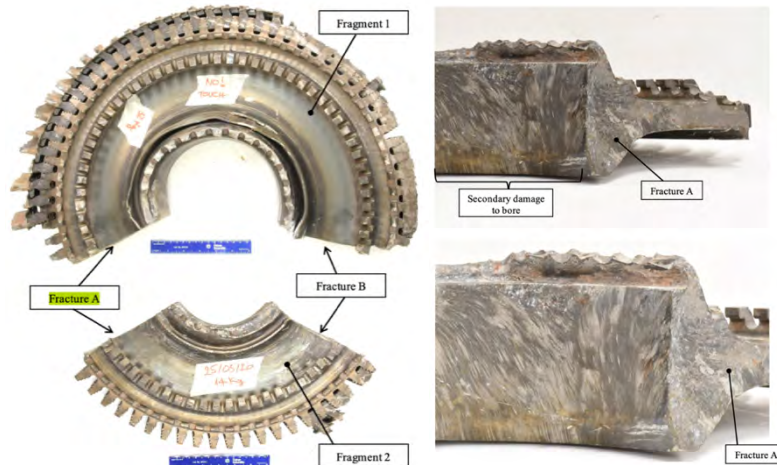
The Fracture A surface on Fragment 1 was sectioned from the remainder of the hub via wire electrical discharge machining (EDM).

*Picture 30: Fracture A*

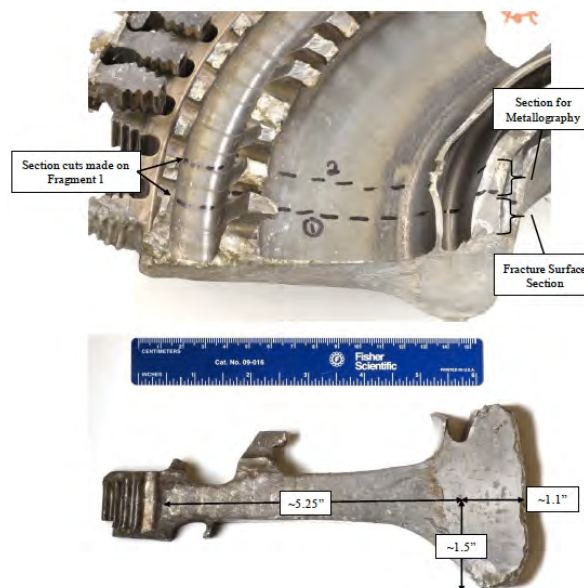
*Picture 31*

The origin was located approximately 1.5” from the aft surface of the bore, 1.1” from the ID surface of the bore, and approximately 5.25” from the blade slot bottom

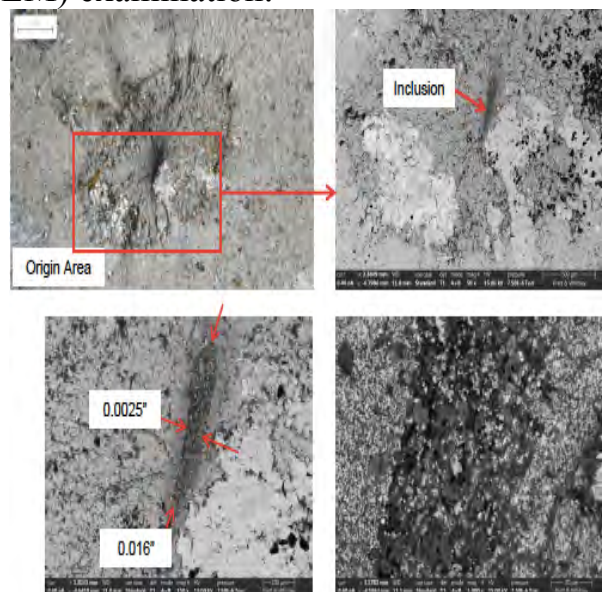
*Picture 33*

+ Fracture surface features within the oval shaped region were intergranular. Immediately surrounding the oval shaped region was a ring of

ductile dimples, and the remainder of the fracture surface outside this area had transgranular features.

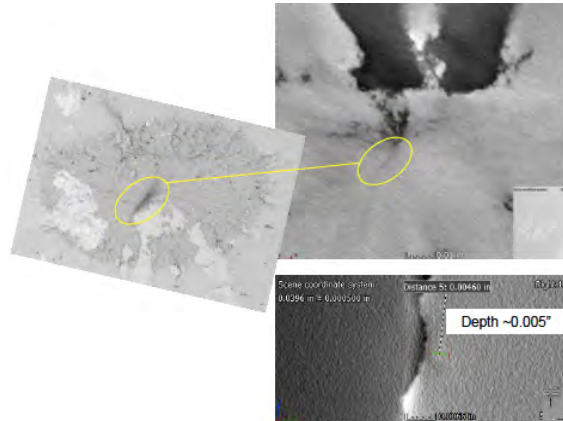
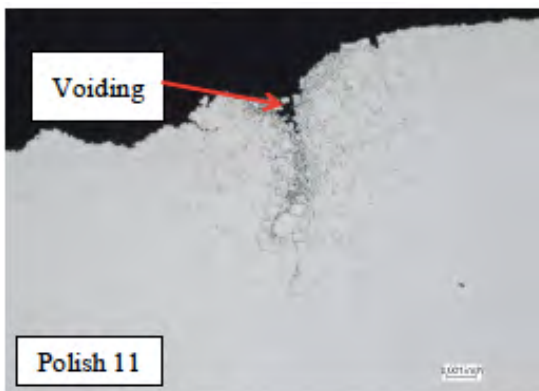
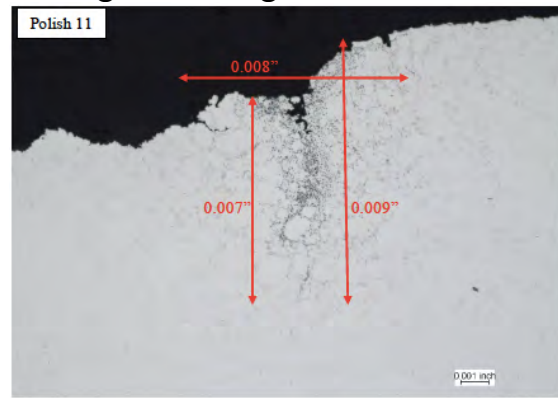
The inclusion was found through the serial polish, at each of these locations, the inclusion was roughly centered within the intergranular region of the fracture.

The inclusion area consisted of a region of distributed particles with Al-O and Al-Mg-O type chemistries. At one polish, a particle with the P-Ti-Ni-Co chemistry consistent with those in the main inclusion area on the fracture surface was observed.

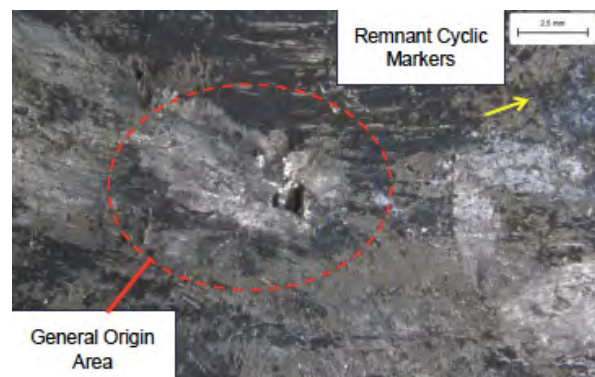
*Picture 38*

+ Binocular microscope examination of the fracture surface identified significant smearing and mechanical damage.

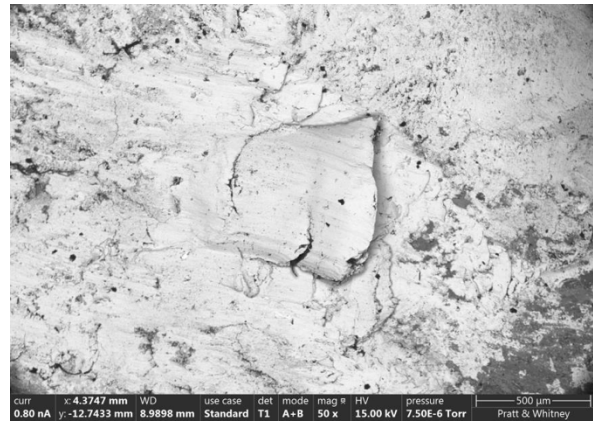
*Picture 39*

+ SEM evaluation of the fracture surface confirmed secondary damage and smeared features. There were no original fracture features remaining within the vicinity of the origin area.

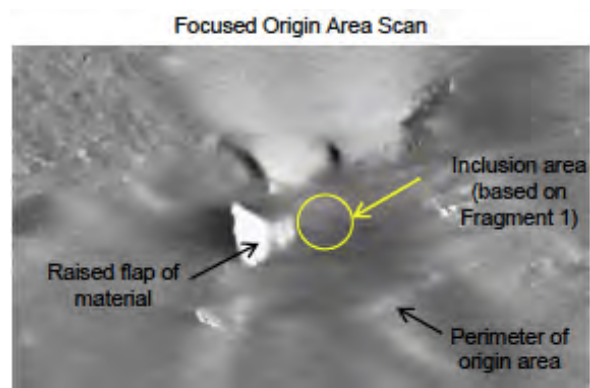
*Picture 40*

+ Micro-CT scans from the Fragment 2 origin area. No evidence of the inclusion was identified.

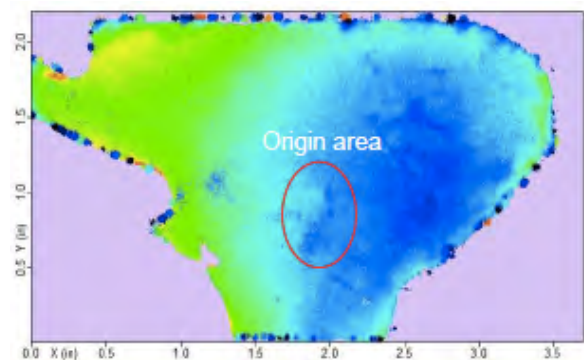
*Picture 41*

+ Results of the ultrasonic (UT) scans on the 0.1" thick section of Fragment 2. No indications associated with the known inclusion location were observed.

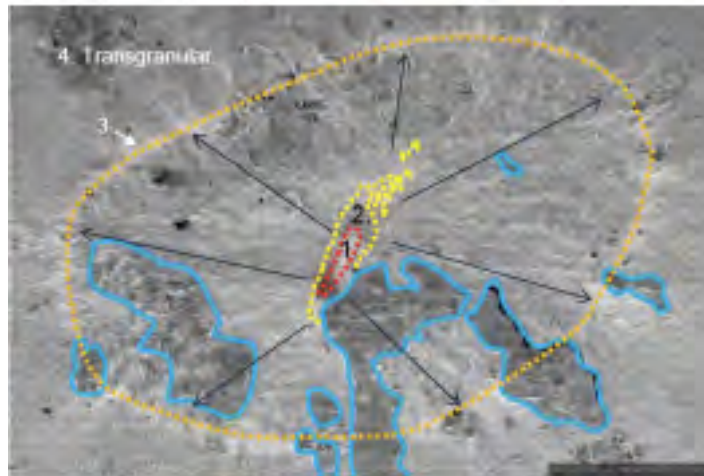
*Picture 43*

1. The manufacturer found inclusion mixed into the core of the metal ingot during the processing of the HPT 1st stage disc billet with dimensions of 0.016 inches x 0.0025 inches (0.4064 x 0.0635). mm), however, it could not be positively determined how the inclusion was mixed in during the manufacturing process of HPT 1st stage disc.

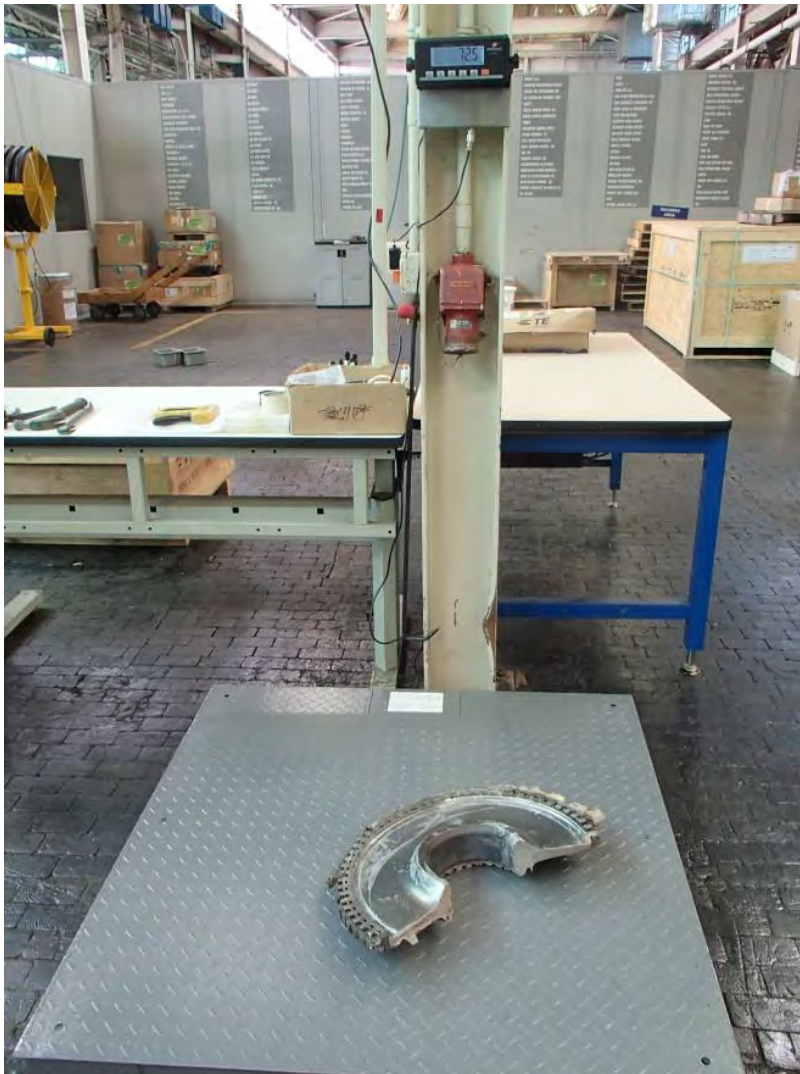
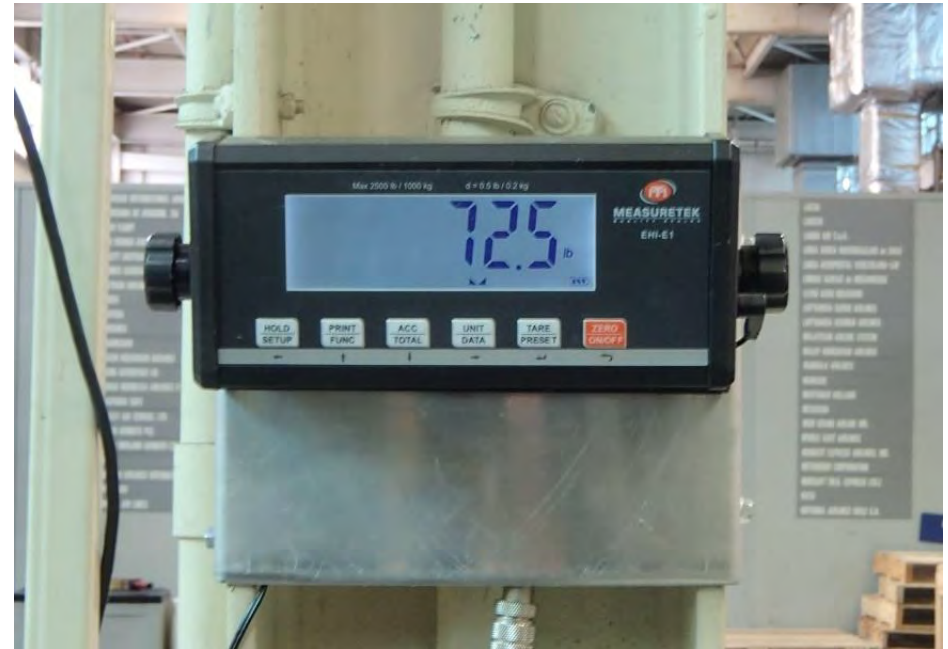
Visual review of Fragment 1 found that both the forward and aft sides of the hub exhibited smearing and other secondary, impact-related damage; damage to the bore was also observed, particularly in the vicinity of Fracture A. The inner diameter (ID) of the fragment appeared to have sprung open slightly. Thirty-eight (38) blade roots were retained in the blade slots; most airfoils had fractured off at or below the platform (Figures 2-3). Some of the blade roots were loose and could be removed by hand. The fragment and remnant blades weighed a total of 72.5 lbs (Figure 4). Review of the lugs identified the part markings as shown in Figure 5.

Figure 4: The weight of Fragment 1 and the remaining blades as-received measured 72.5 lb.

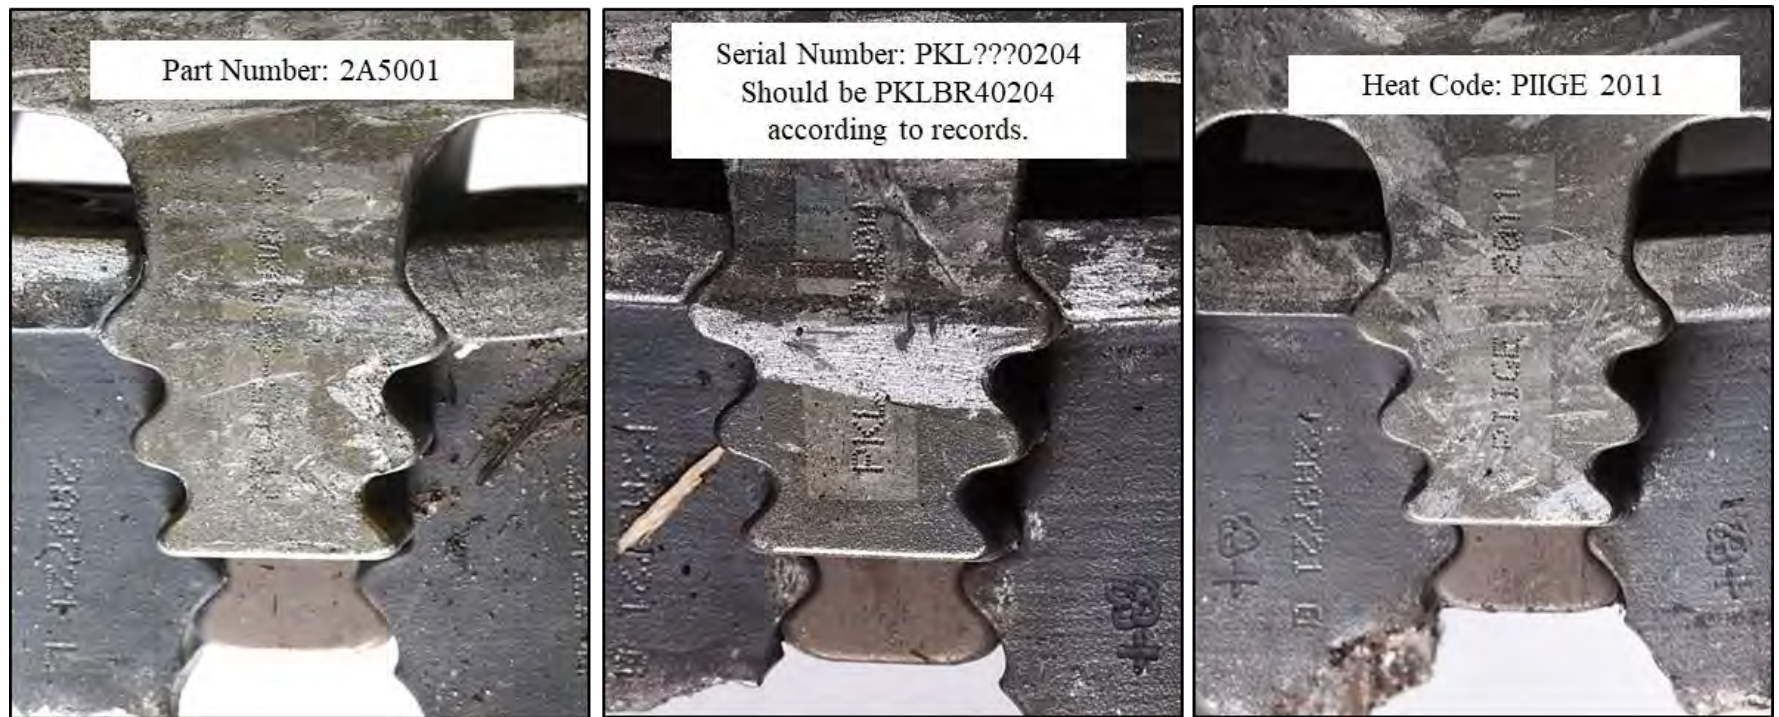
Figure 5: Hub part markings on Fragment 1.

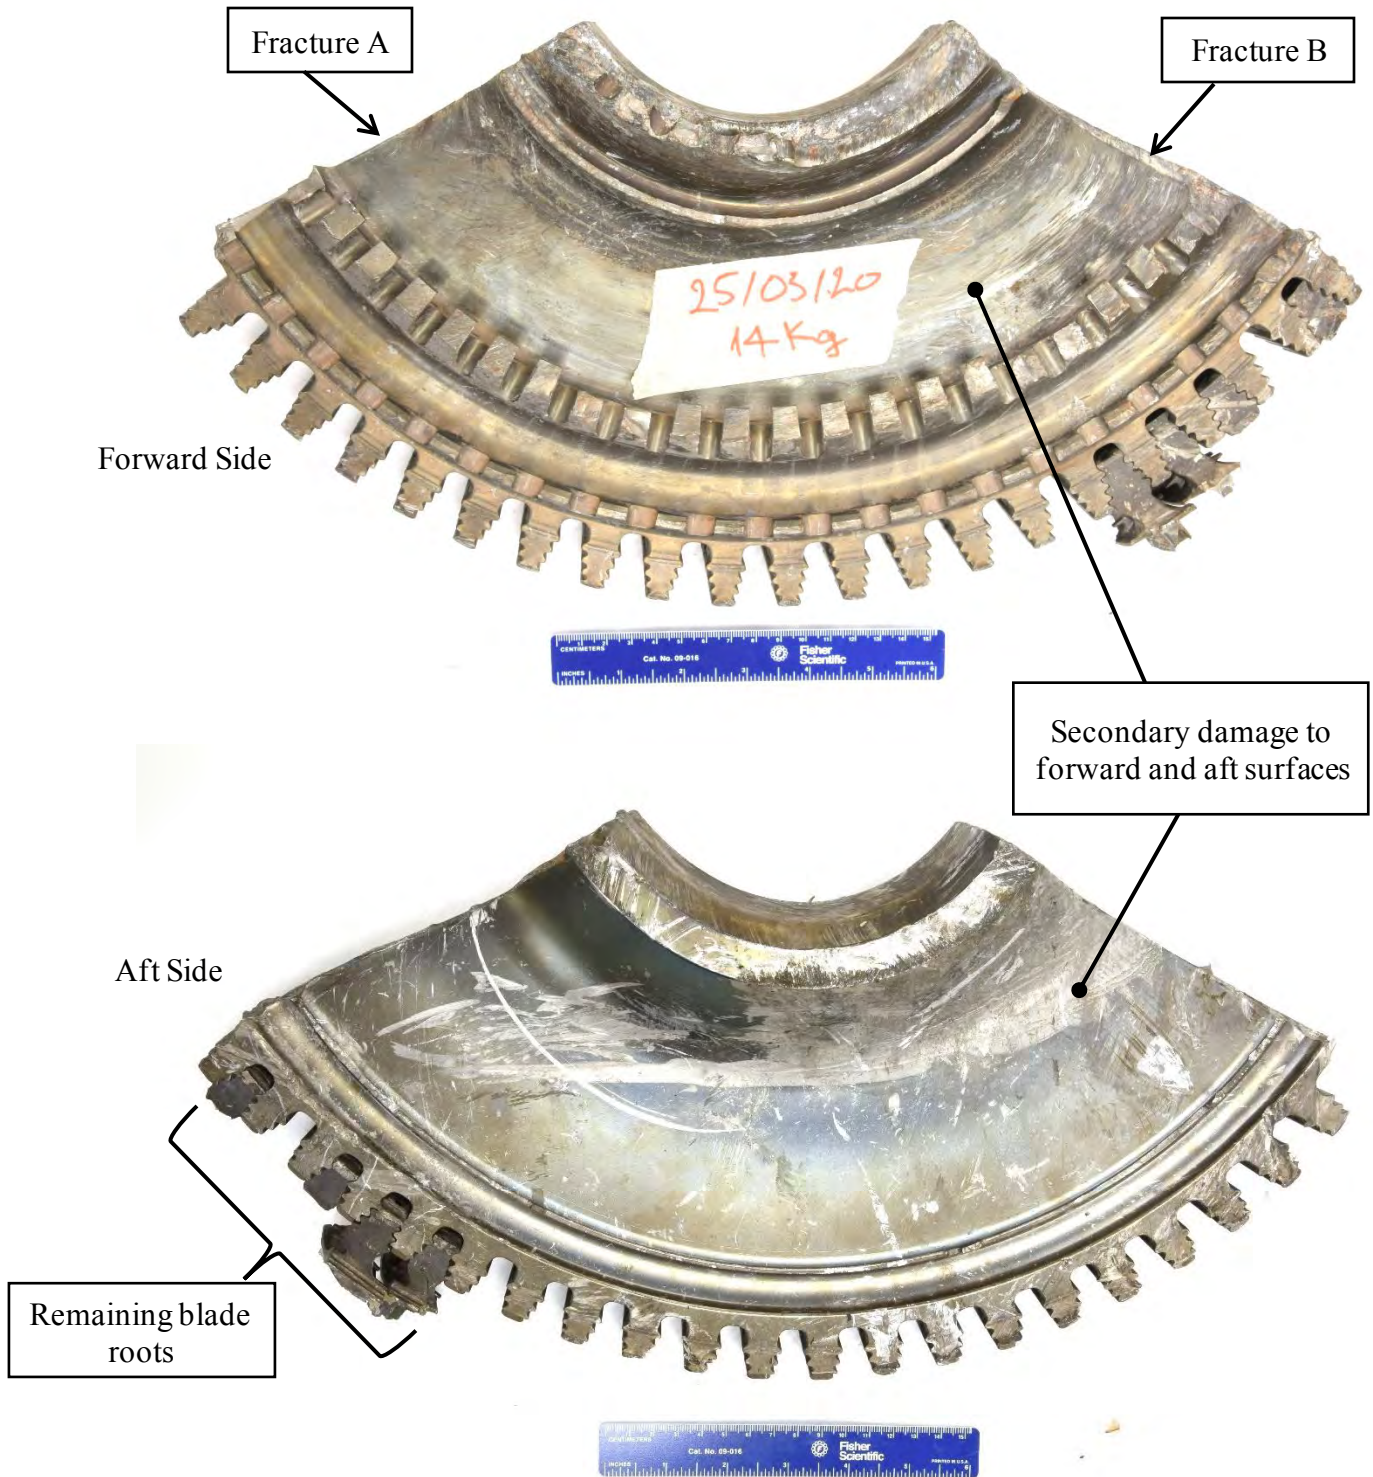
Visual review of Fragment 2 found that the piece exhibited a significant amount of damage on both the forward and aft sides of the part, as well as on the ID of the bore. Only four blade roots were retained on Fragment 2. The fragment and remnant blades weighed a total of 31.5 lbs (Figures 6-8).

Figure 6: Forward (top) and aft (bottom) sides of Fragment 2.

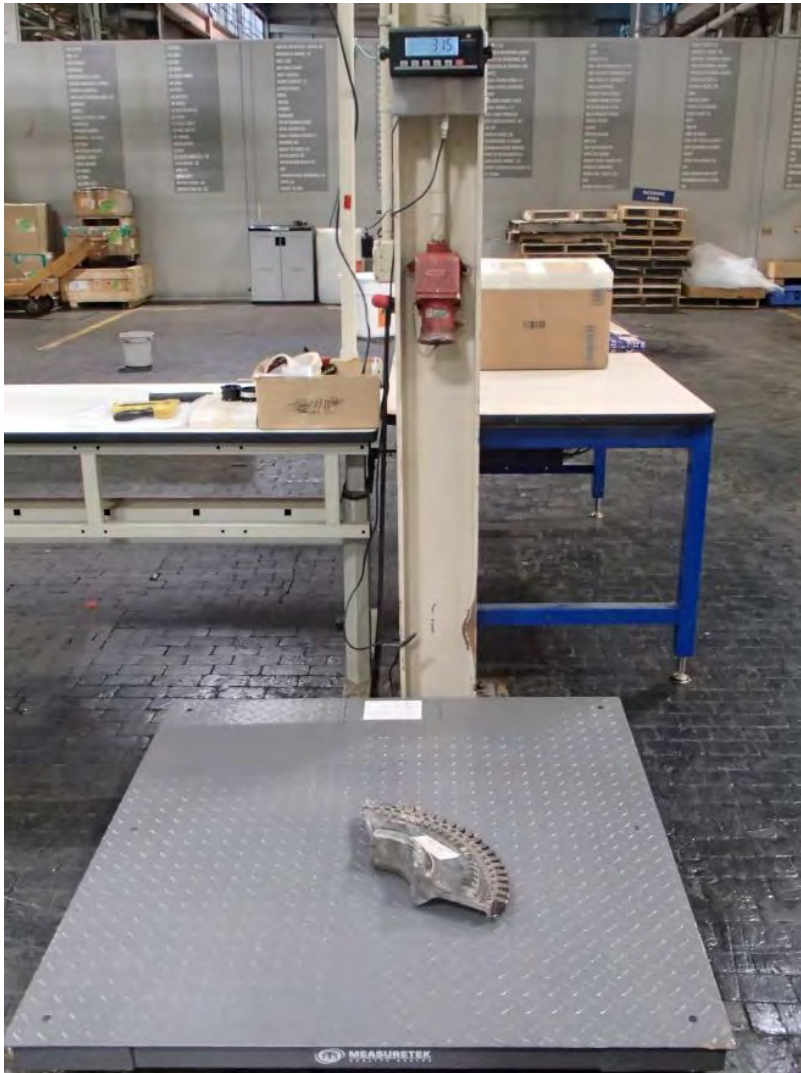
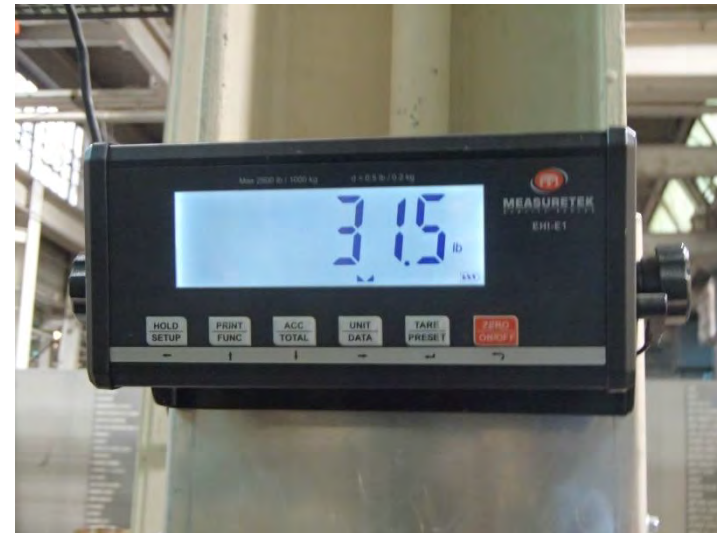
Figure 8: The weight of Fragment 2 and the remaining blades as-received measured 31.5 lb.

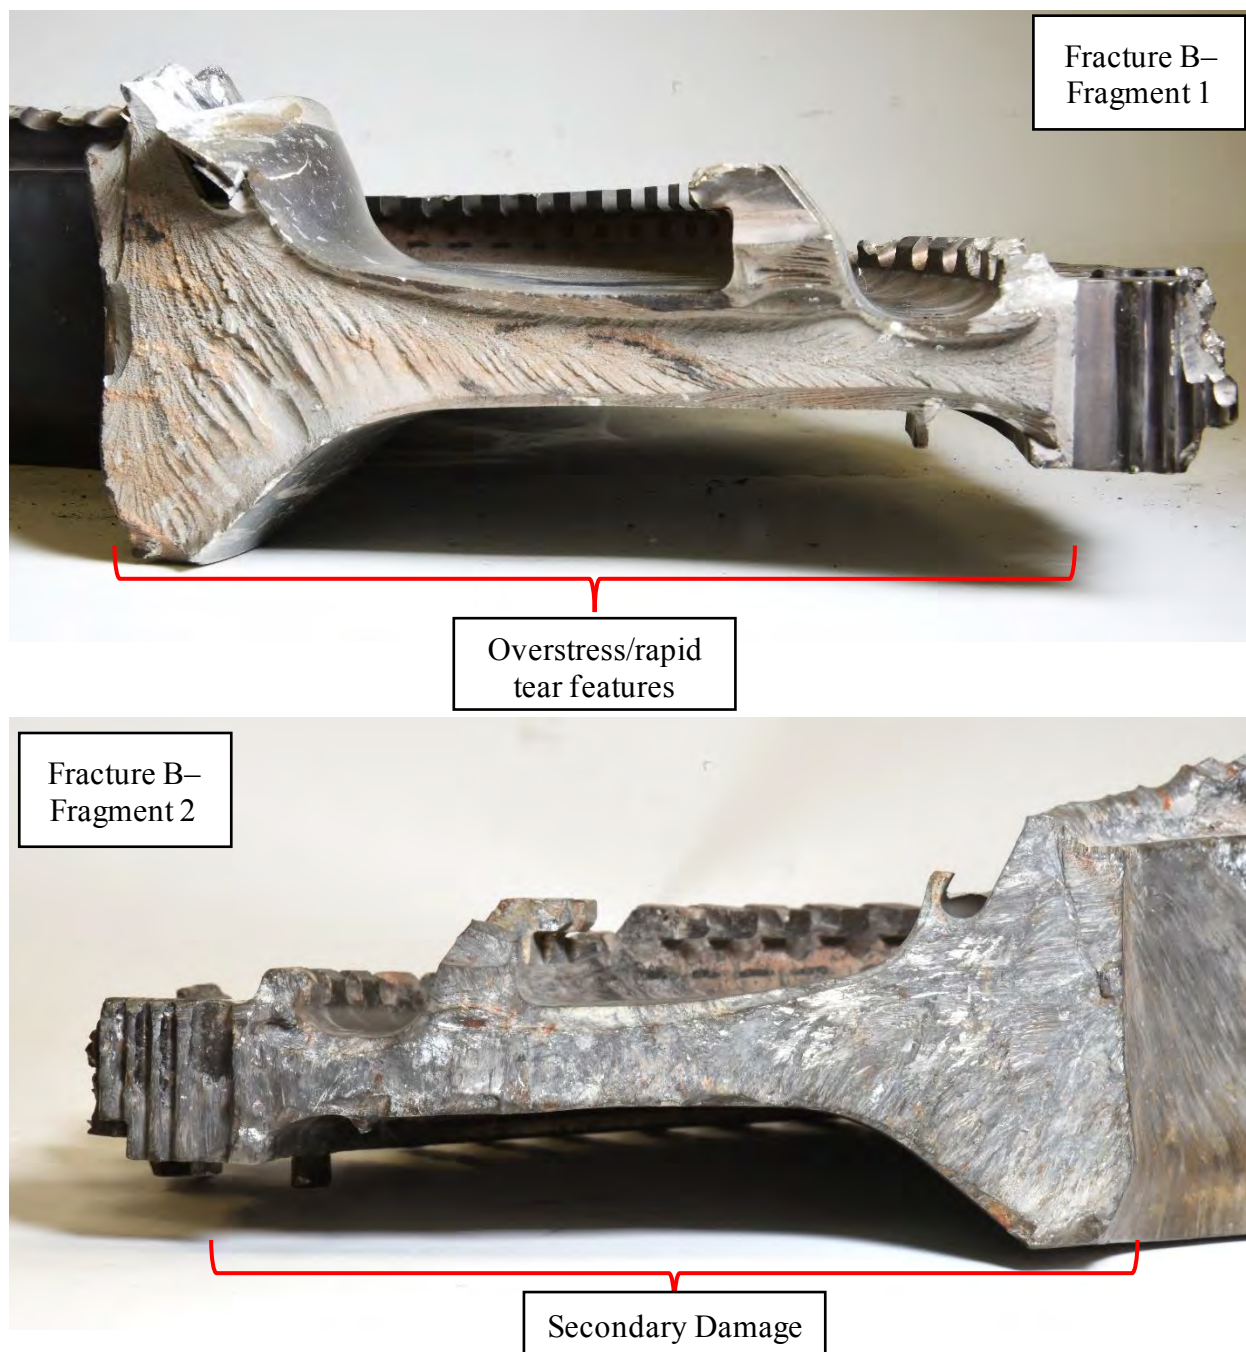
Figure 12: Mating sides of Fracture B on Fragment 1 (top) and Fragment 2 (bottom).

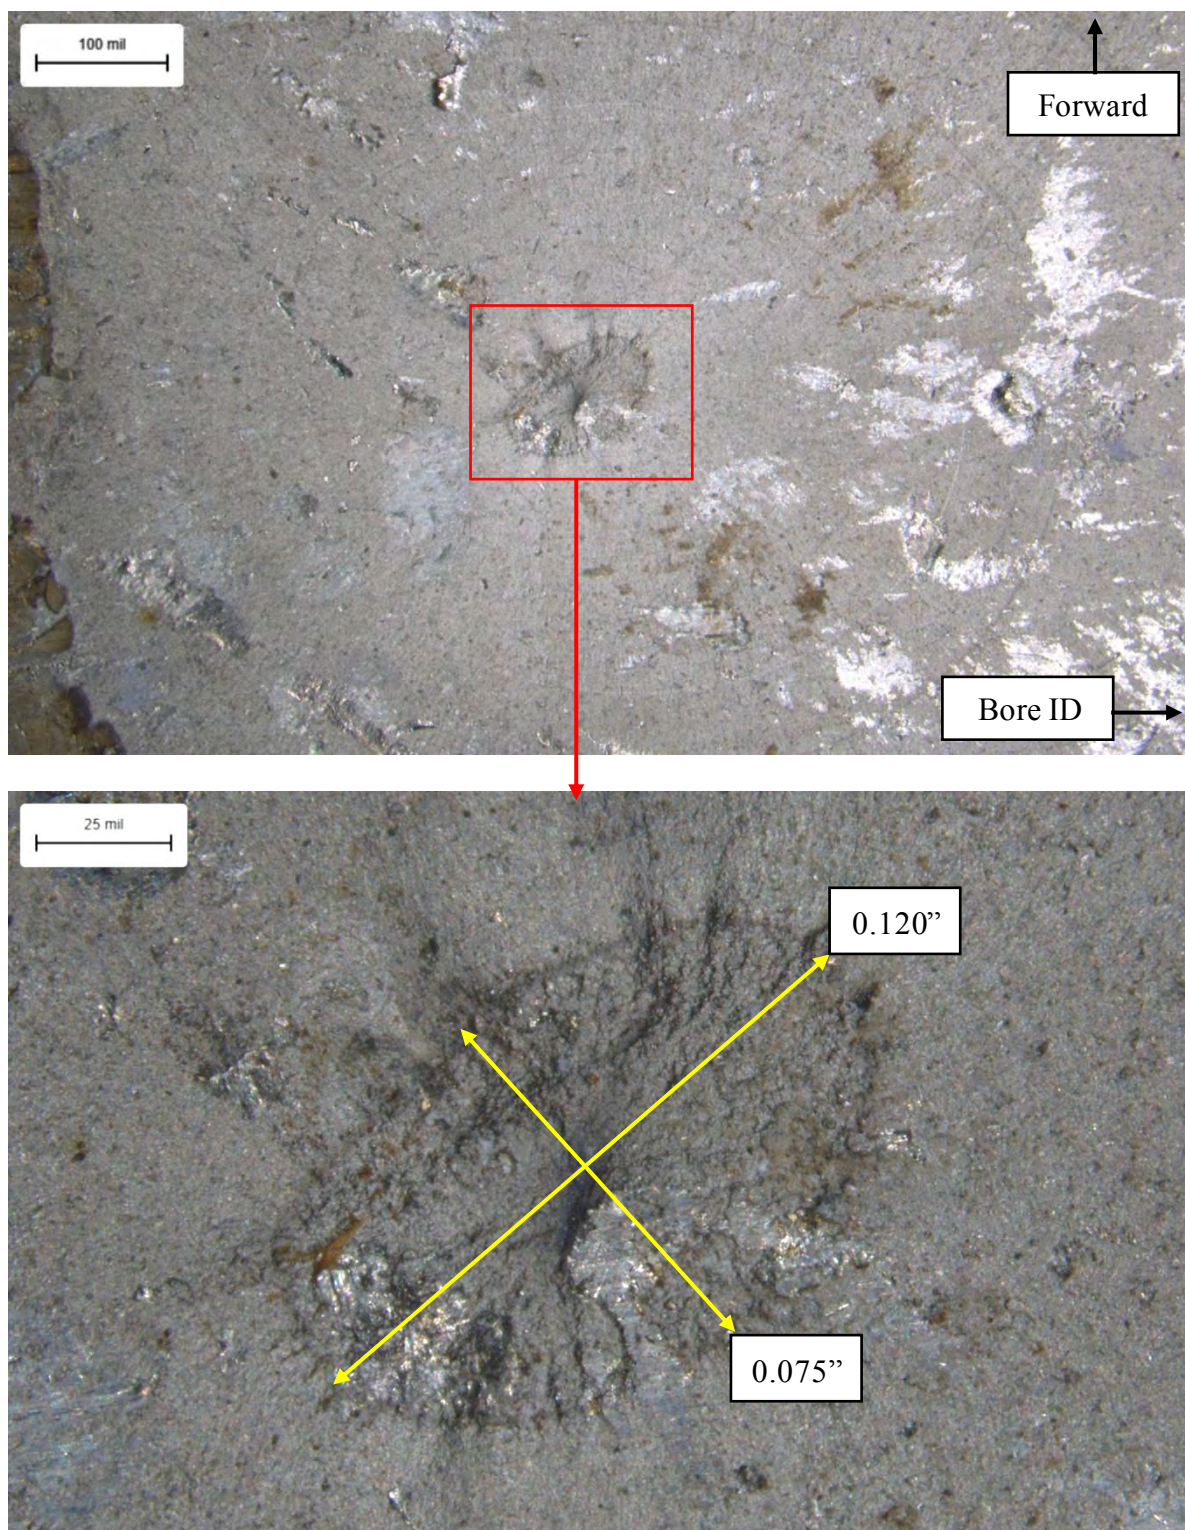
Further visual and binocular review of the fracture surface identified cyclic markers throughout the crack progression surrounding the oval shaped origin area. The oval shaped origin region appeared rougher textured compared to the surrounding area. This region measured approximately 0.120” x 0.075” (Figures 14 – 15).

Figure 15: Higher magnification images showing the origin area on Fragment 1.

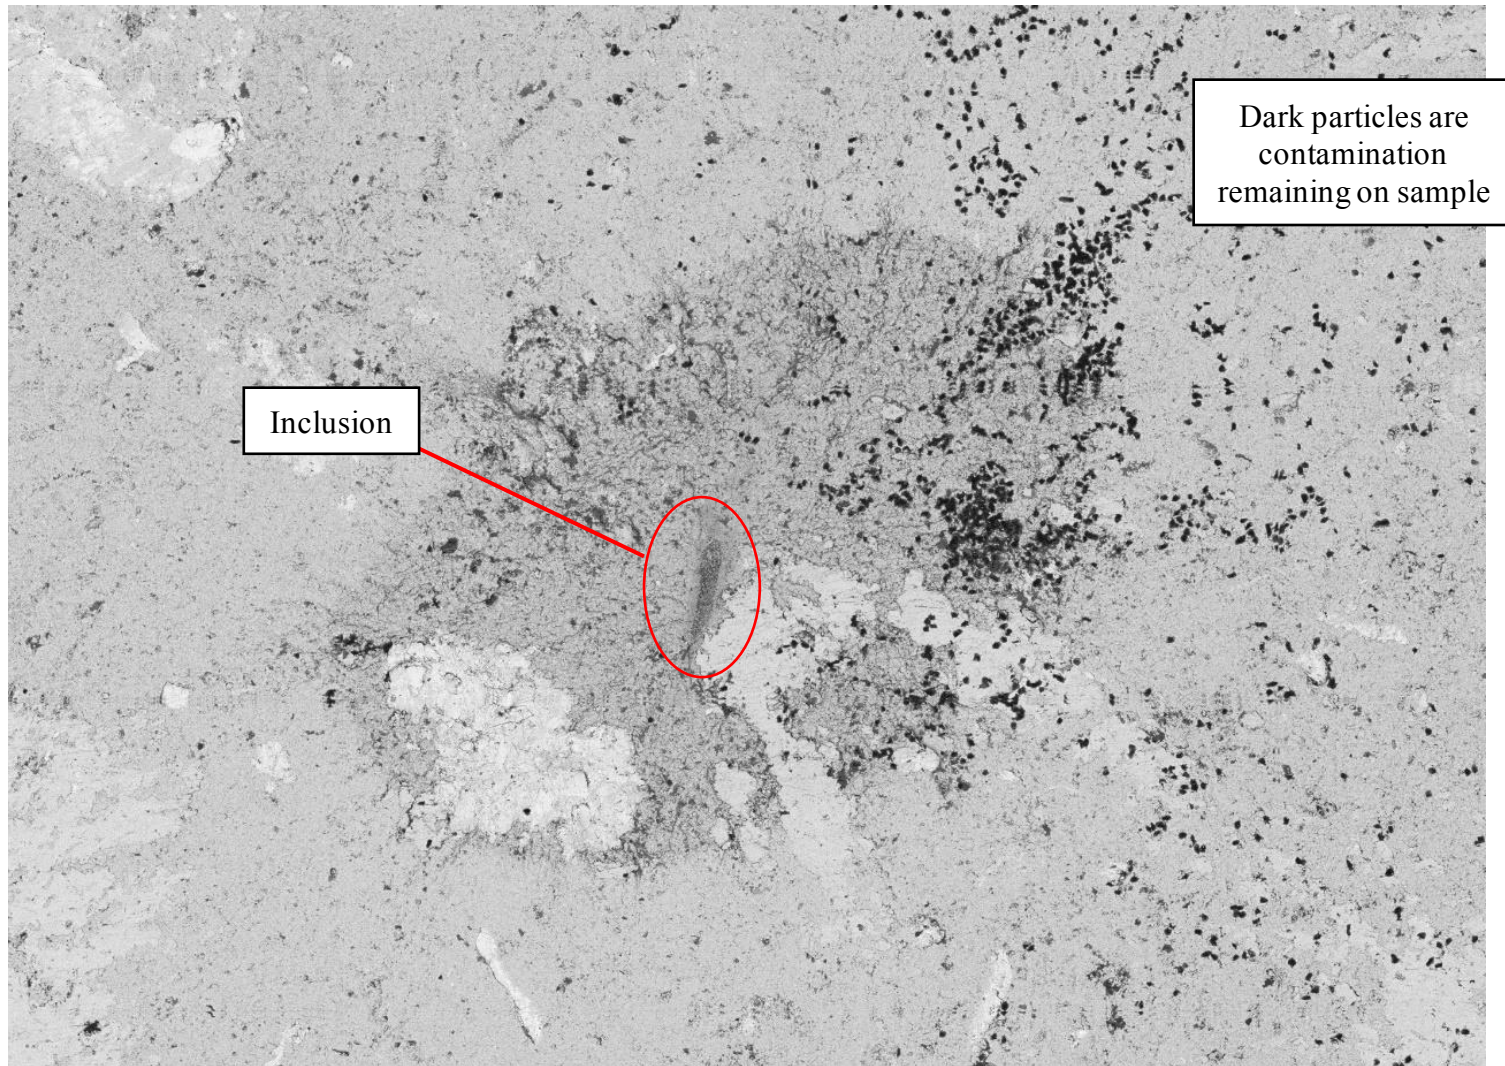
The Fragment 1 fracture surface was rinsed with water and isopropanol to clean it for scanning electron microscope (SEM) examination. SEM examination of the oval-shaped origin area identified an inclusion roughly centered in this region. Via back scatter electron imaging, the inclusion appeared as a region of darker gray/black particles (Figures 16 – 17). Initial energy dispersive spectroscopy (EDS) analysis of the inclusion region identified an increased concentration of oxygen, magnesium, aluminum, phosphorous, and titanium (O, Mg, Al, P, and Ti). Additional elements were also identified however it could not be determined if they were due to the inclusion or other event-related contamination sources (Figures 18-19). Outside of this inclusion, crack features within the oval shaped area appeared intergranular. This intergranular region 0.120” x 0.075” in size was surrounded by a band of ductile dimples ~0.001 to 0.005” wide. Transgranular features were observed progressing in all directions from the ductile dimple band (Figure 20).

Figure 16: Initial SEM examination following a water and isopropanol rinse identified an inclusion roughly centered in the oval-shaped origin area.

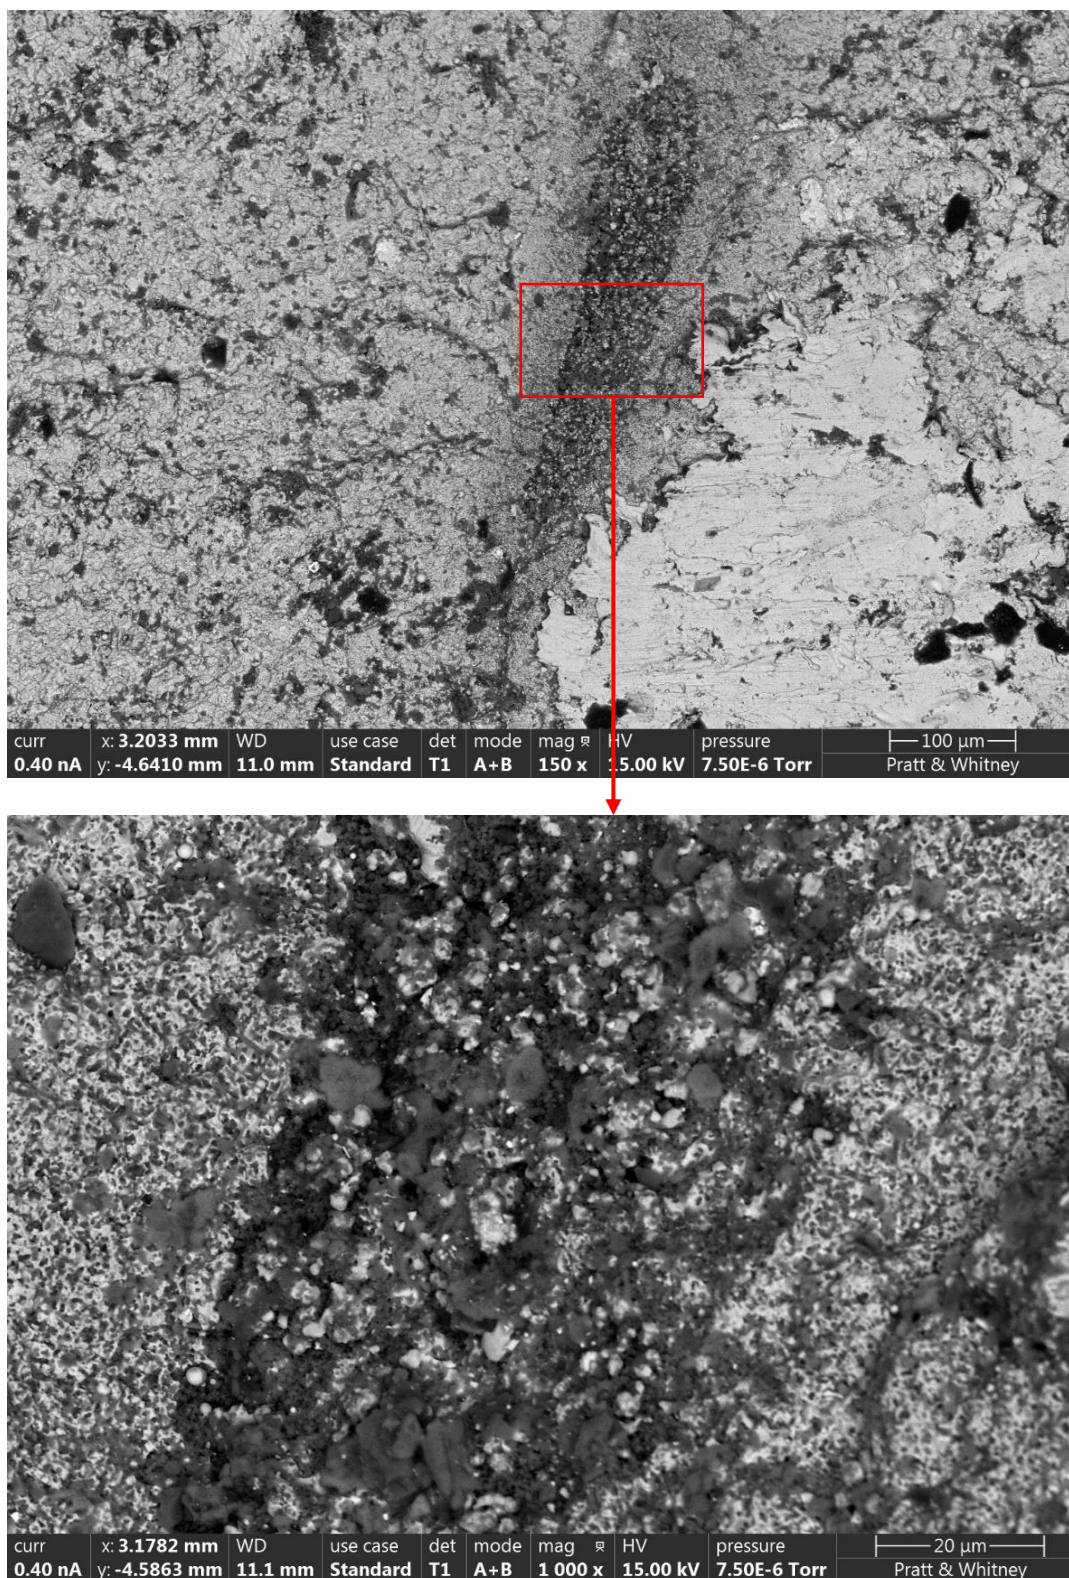
Figure 17: SEM images showing the region of darker gray/black particles within the inclusion as viewed via back scatter electron imaging.

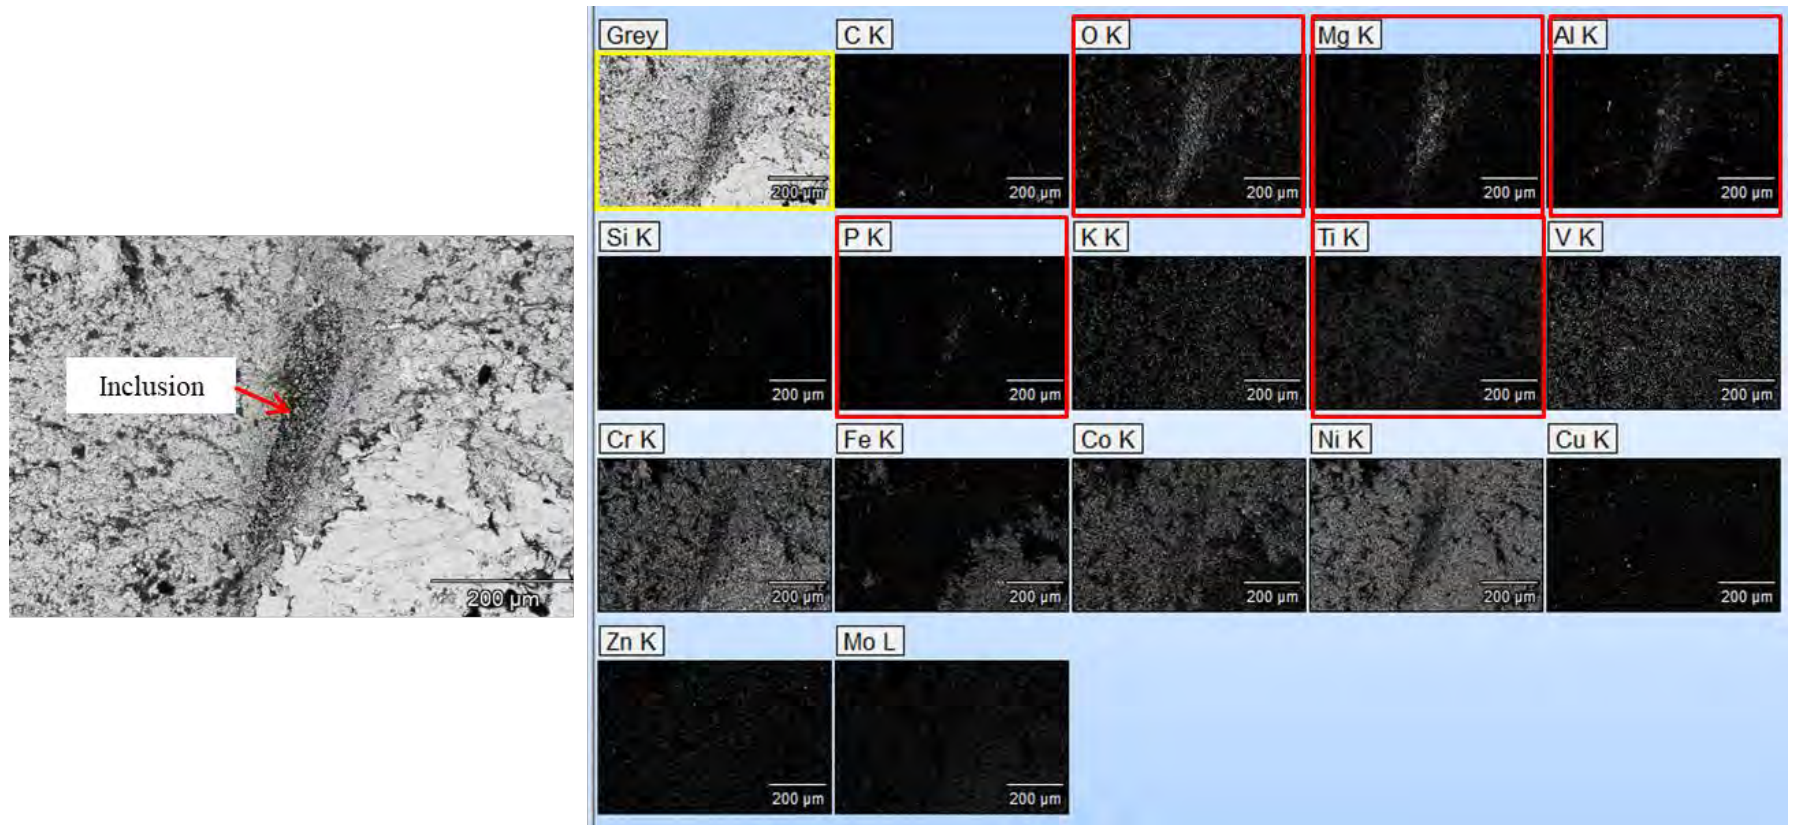
Figure 18: Initial SEM/EDS examination of the inclusion area identified locally higher concentrations of O, Mg, Al, P, and Ti (red outlines, above). Lighter color in maps on right indicates a higher concentration of the given element.
