**FINAL REPORT<sup>1</sup>**

**INVESTIGATION RESULT OF SERIOUS INCIDENT**

**VIETNAM AIRLINES UNCONTAINED ENGINE**

**AIRBUS A321 MSN 5306 (VN-A392)**

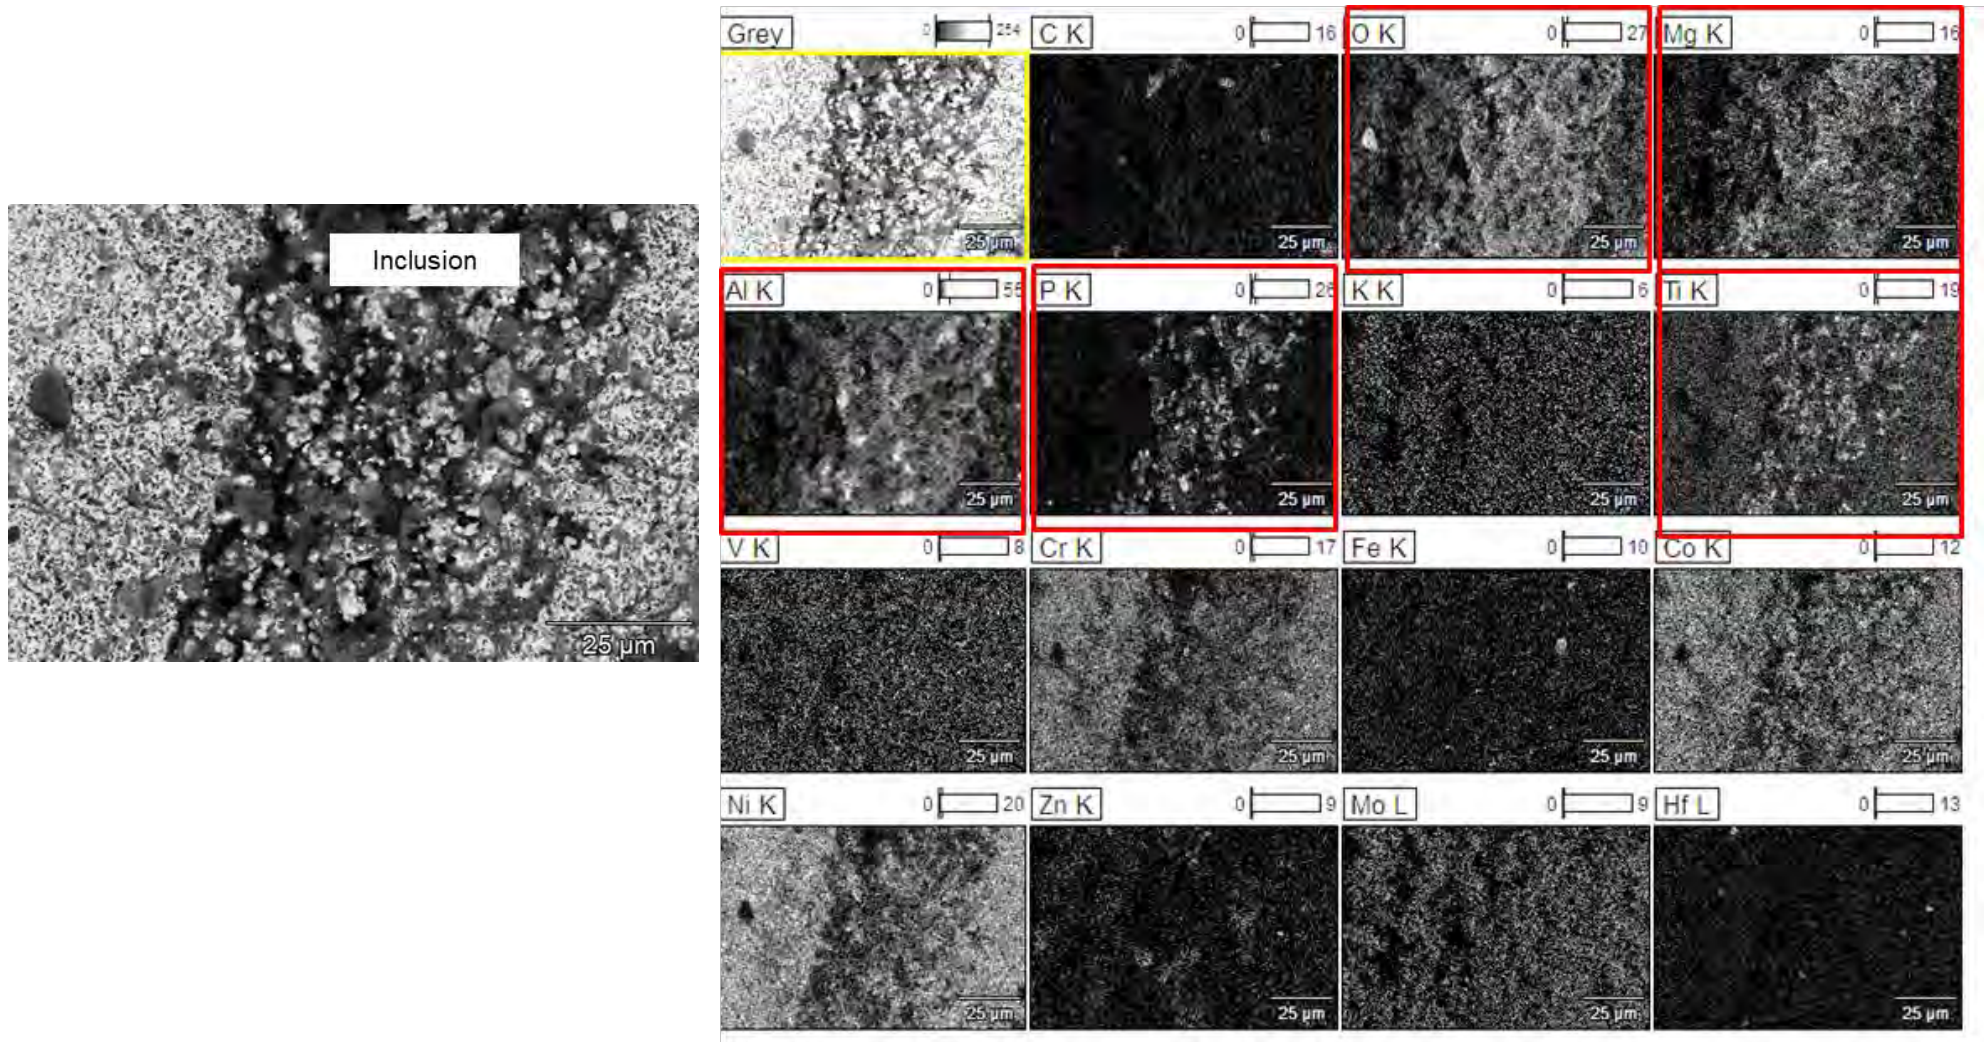
Figure 19: Higher magnification SEM/EDS maps showing locally higher concentrations of O, Mg, Al, P, and Ti (red outlines, above). Lighter color in maps on right indicates a higher concentration of the given element.

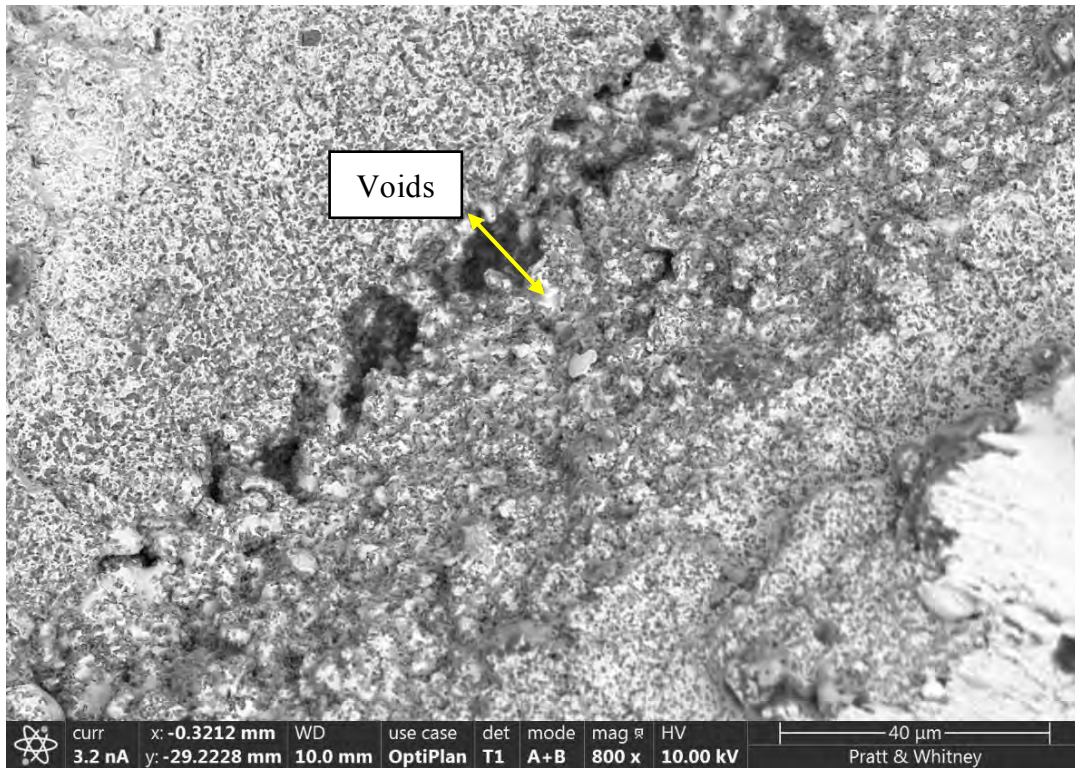
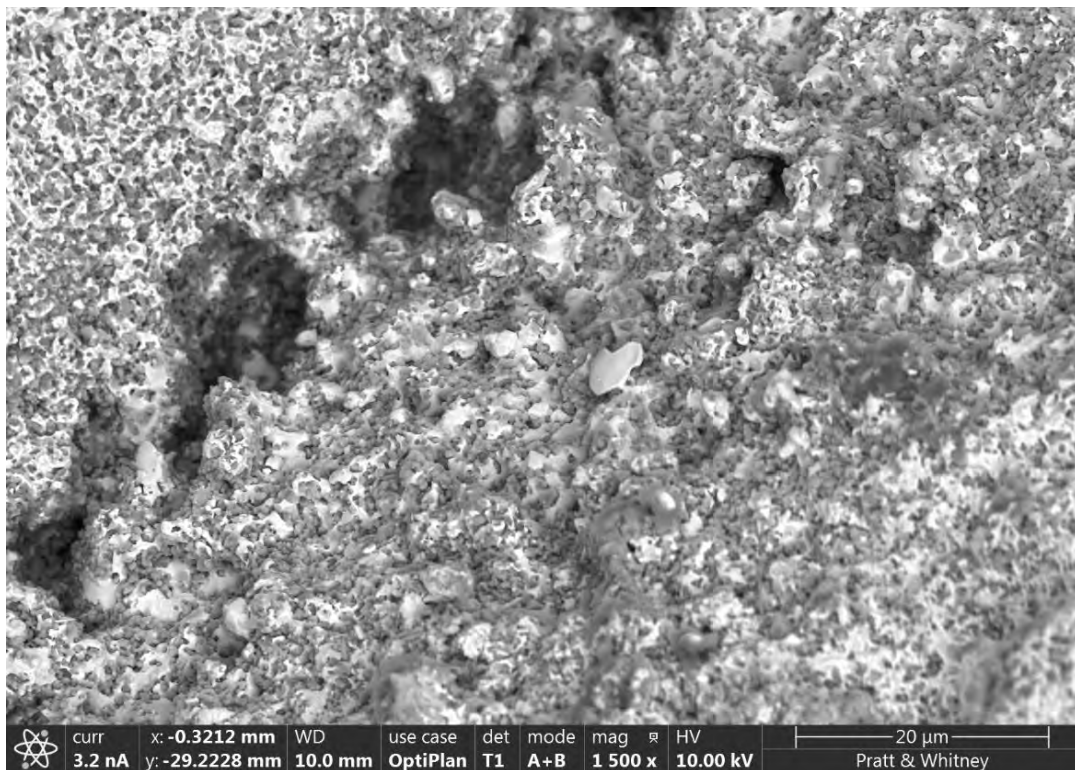
The main inclusion area consisted of a concentrated area of voids and foreign particles. This area measured 0.016” x 0.0025” on the fracture surface (Figures 22-23).

Figure 23: SEM images showing appearance of the main (inner) inclusion area. The inner inclusion area consisted of voids and foreign particles (dark particles, above).

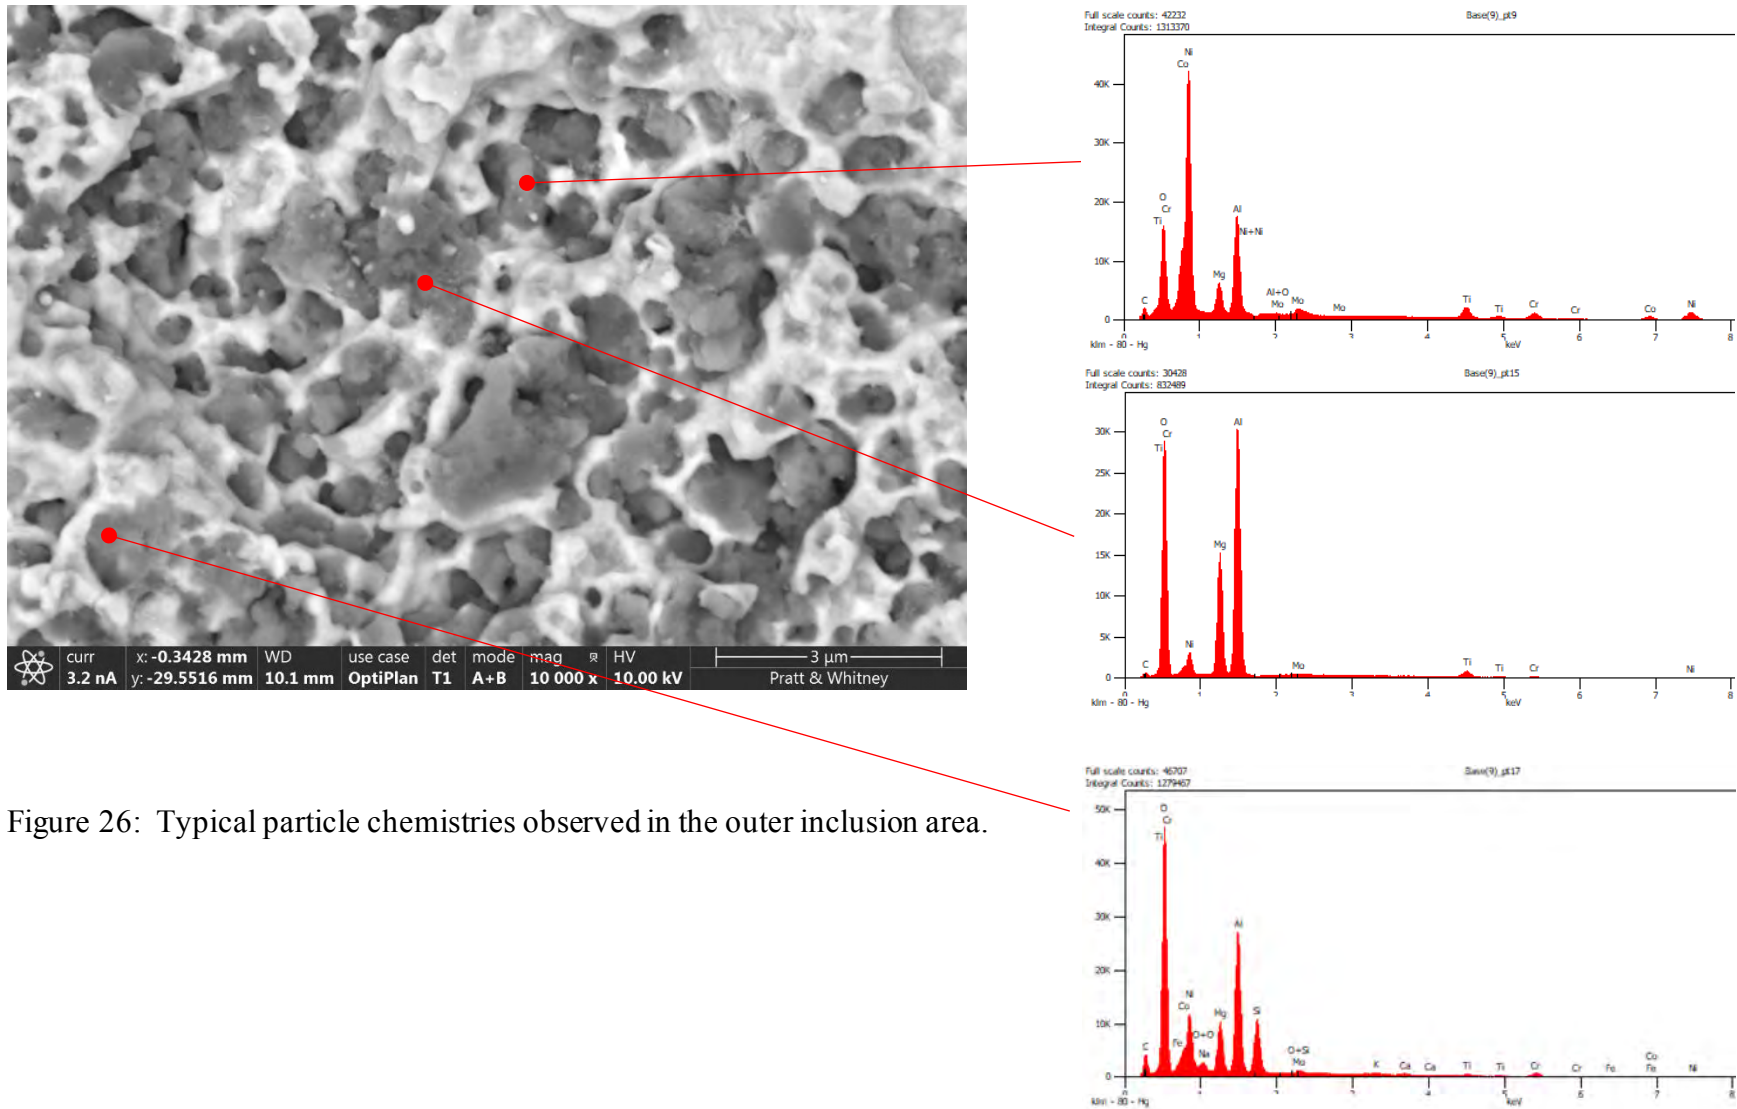
SEM/EDS analysis of the particles identified the two common chemistries also observed in the main inclusion area – Al-Mg-O and Al-O with much less Mg. The P-Ti-Ni-Co type particle was not observed in the outer inclusion area (Figure 26).

Figure 26: Typical particle chemistries observed in the outer inclusion area.

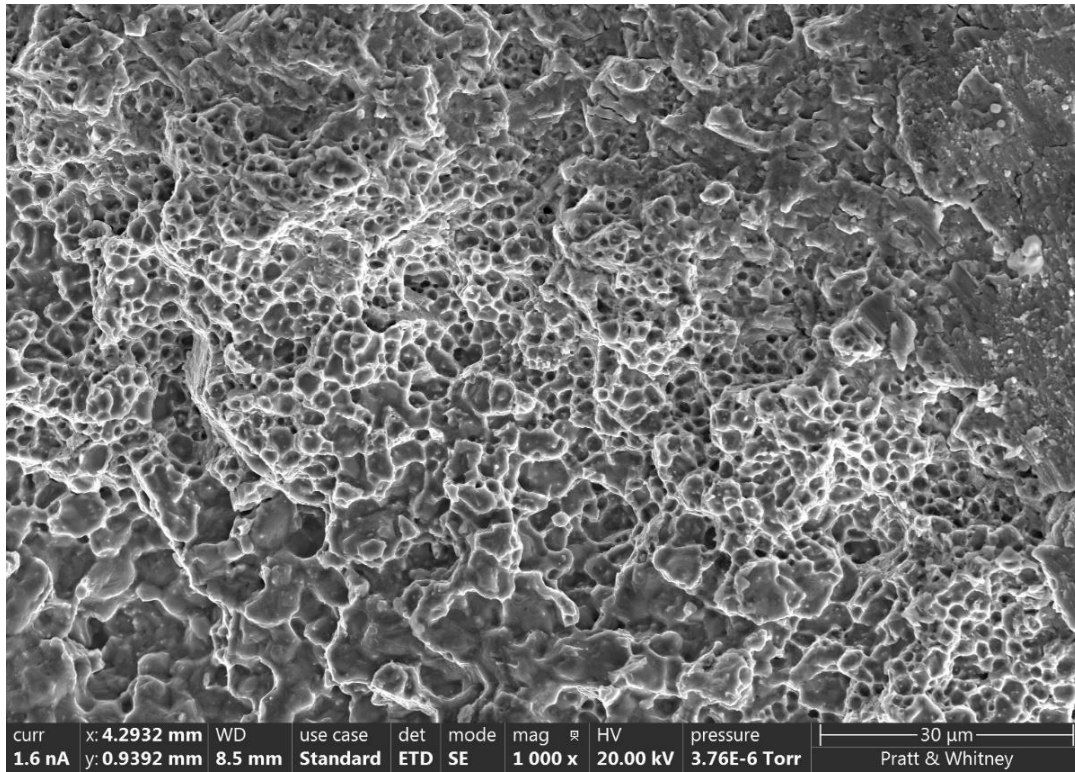
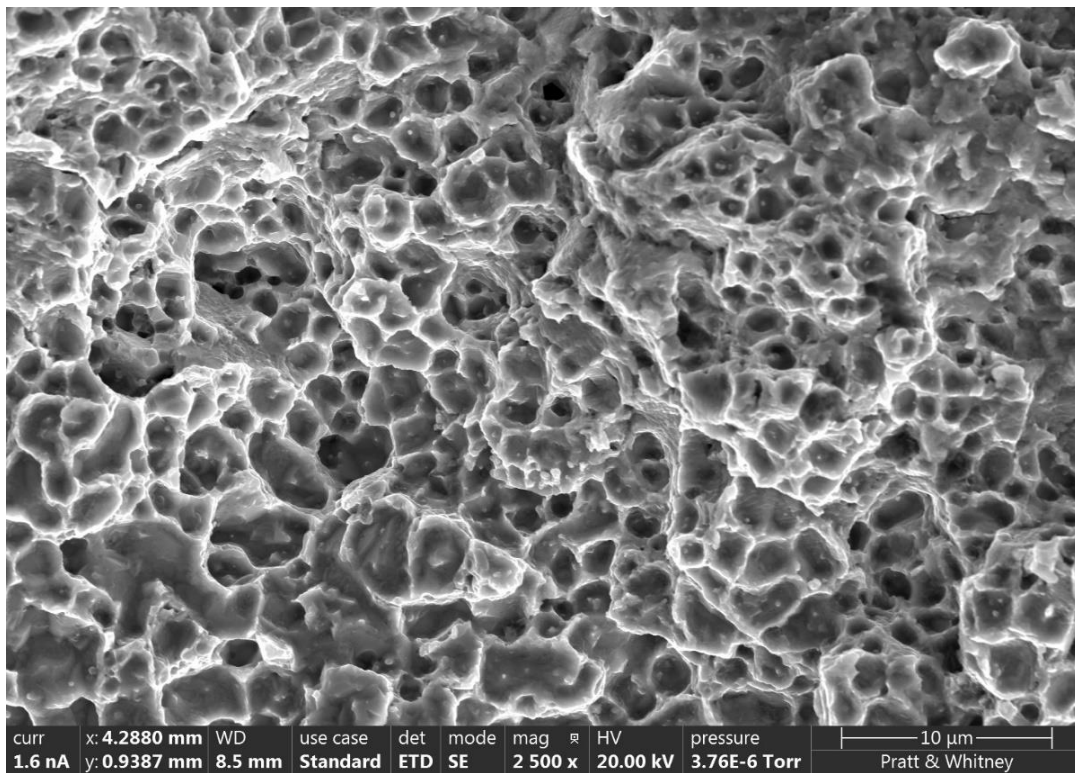
At the extremity of the intergranular region, a discrete band of ductile dimple features was observed. This band varied in width from approximately 0.001” – 0.005”. Within this region, the ductile dimple features were the predominant mode of fracture. The band was observed around the entirety of the intergranular region (Figure 28).

Figure 28: SEM images of fracture surface within the ductile dimple band.

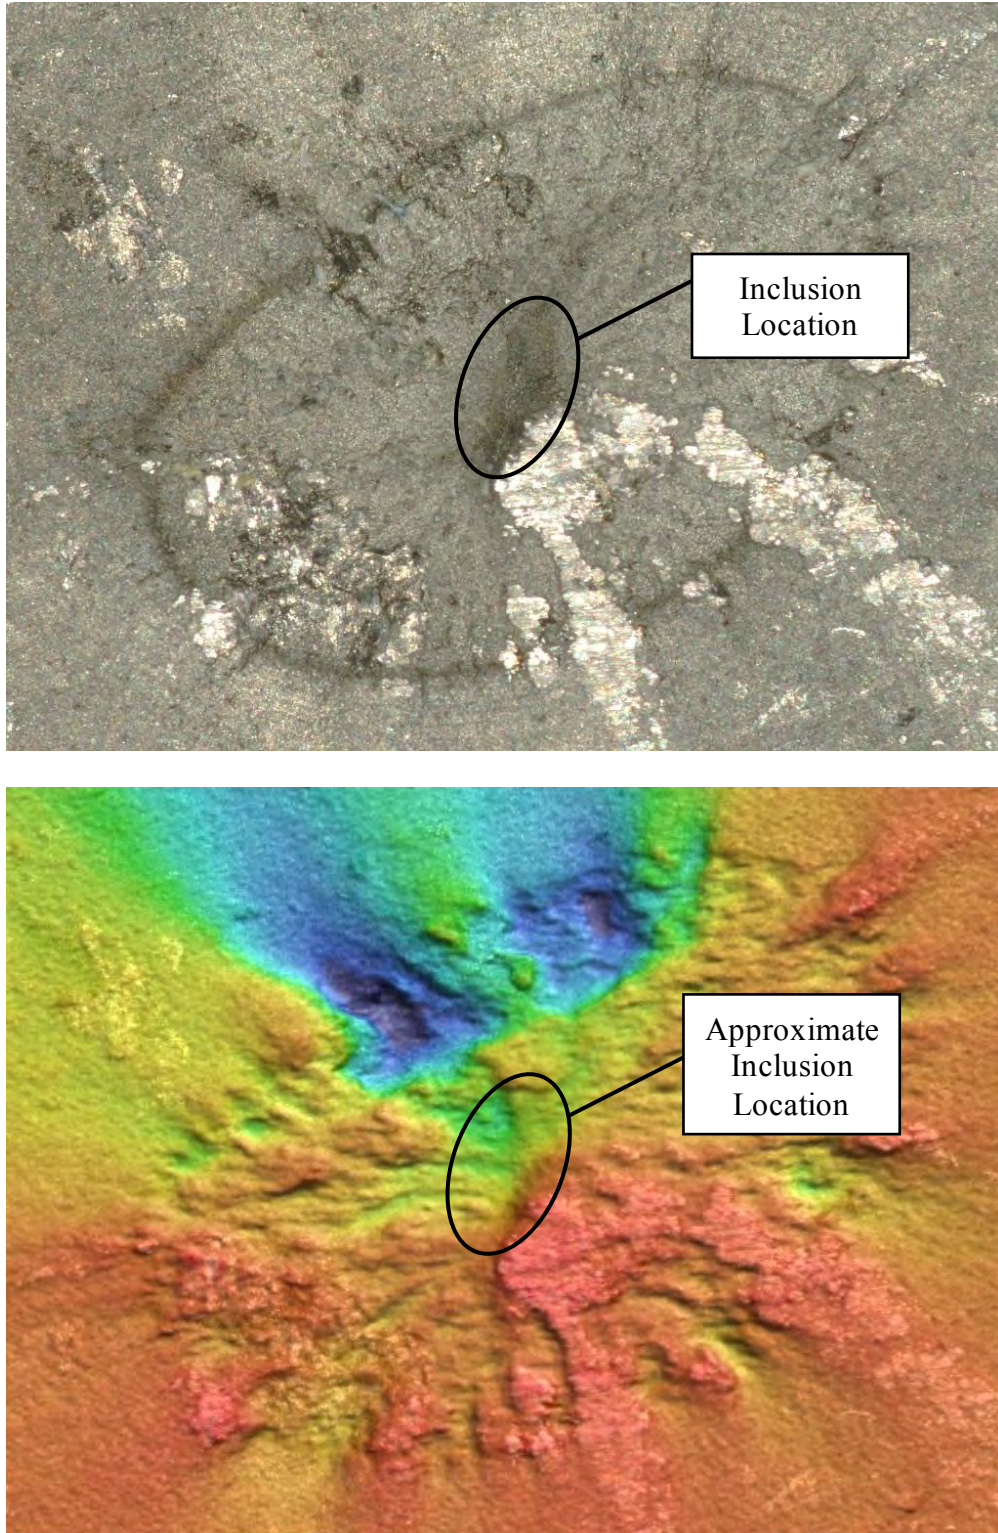
Focused white light scanning of the Fragment 1 origin area was completed to characterize the topography of this region (Figure 32).

Figure 32: Higher magnification view of origin (top) and topography map superimposed on image (bottom). The red areas in the map were high and the blue areas were low.

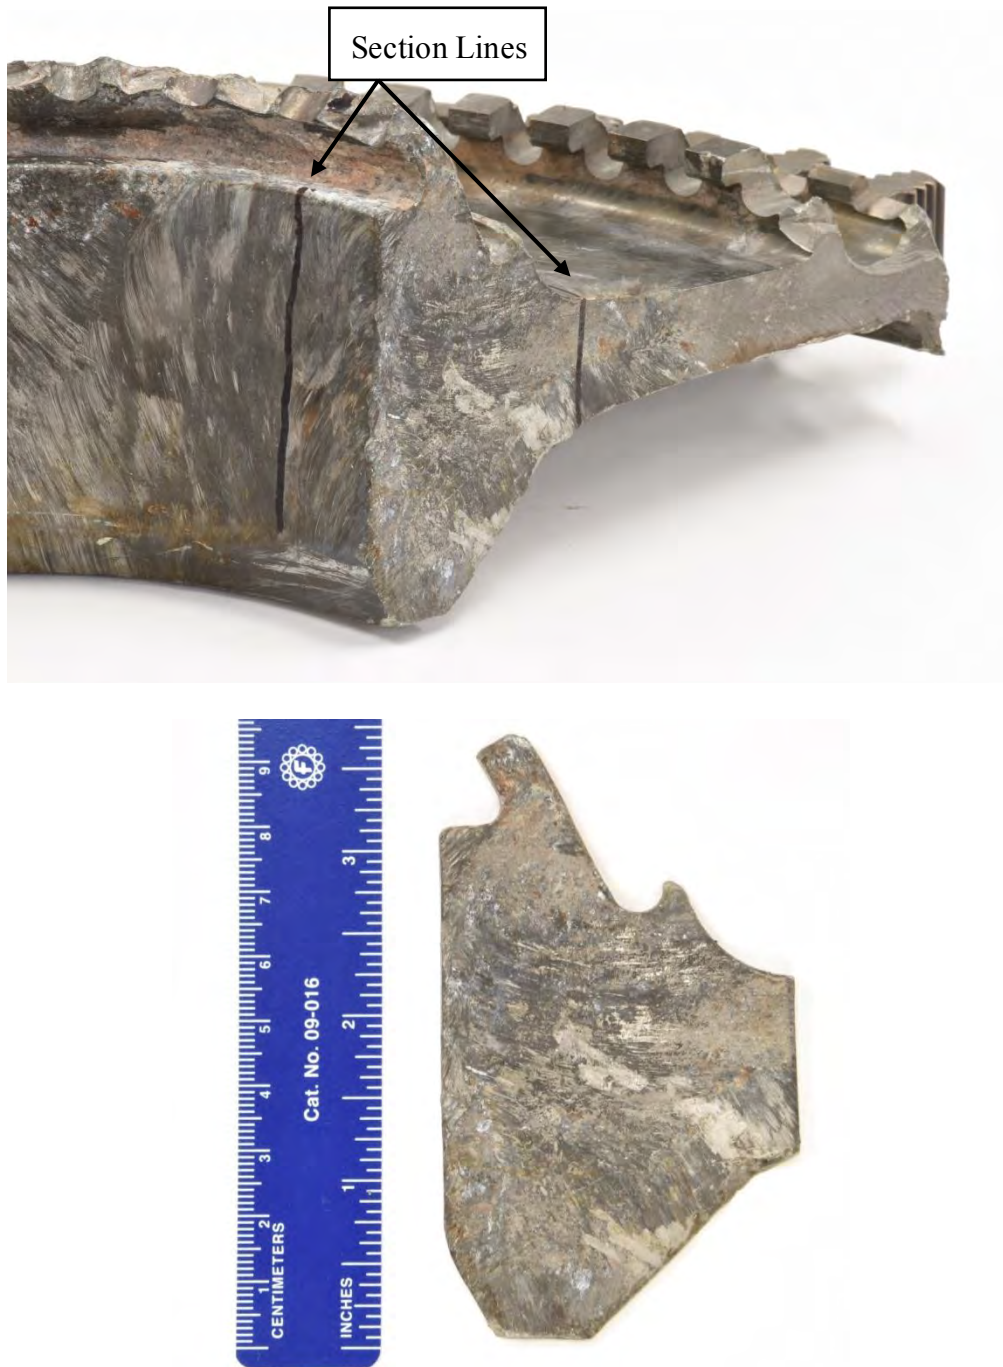
Figure 33: The Fracture A surface on Fragment 2 was sectioned from the remainder of the hub via wire EDM (top). The section was then cut down to a 0.1” thick slice (bottom).

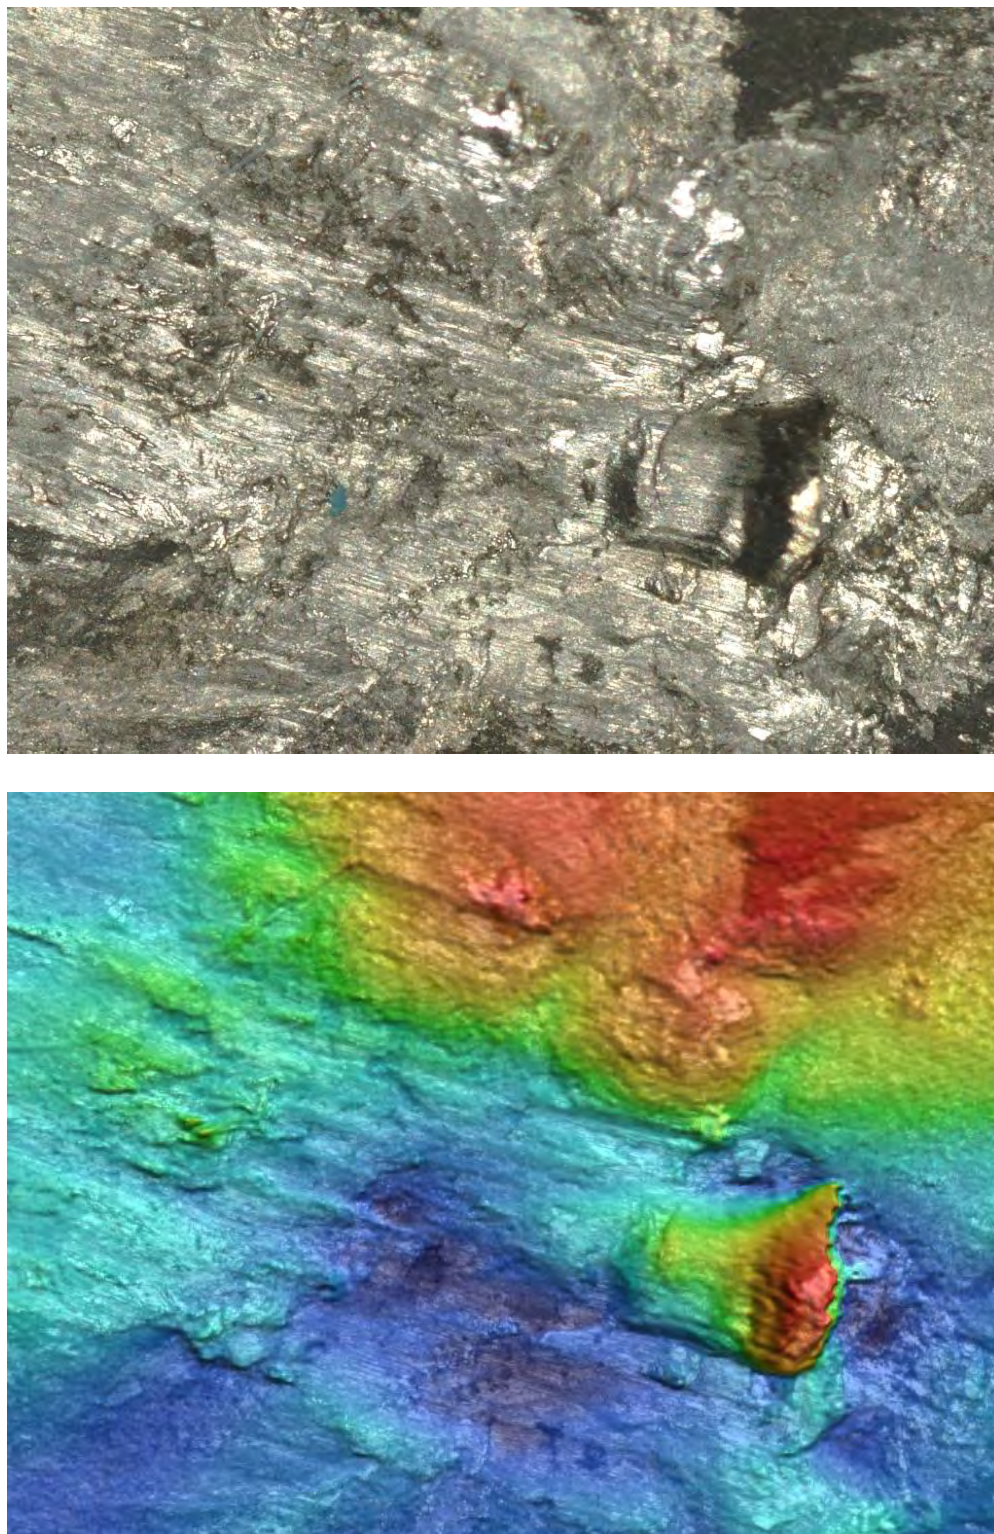
Similar to Fragment 1, focused white light scanning of the origin area was completed to characterize the topography of the fracture surface (Figure 35). While the scan was heavily biased due to the damage on the fracture surface, remnant high and low features could be observed. A comparison of the Fragment 1 and Fragment 2 topography maps allowed for identification of the approximate inclusion location on the Fragment 2 fracture surface. The inclusion location was adjacent to the adhered, smeared flap of material (Figure 36).

Figure 35: Higher magnification view of the origin area on Fragment 2 (top) and topography map superimposed on image (bottom). The red areas in the map were high and the blue areas were low.

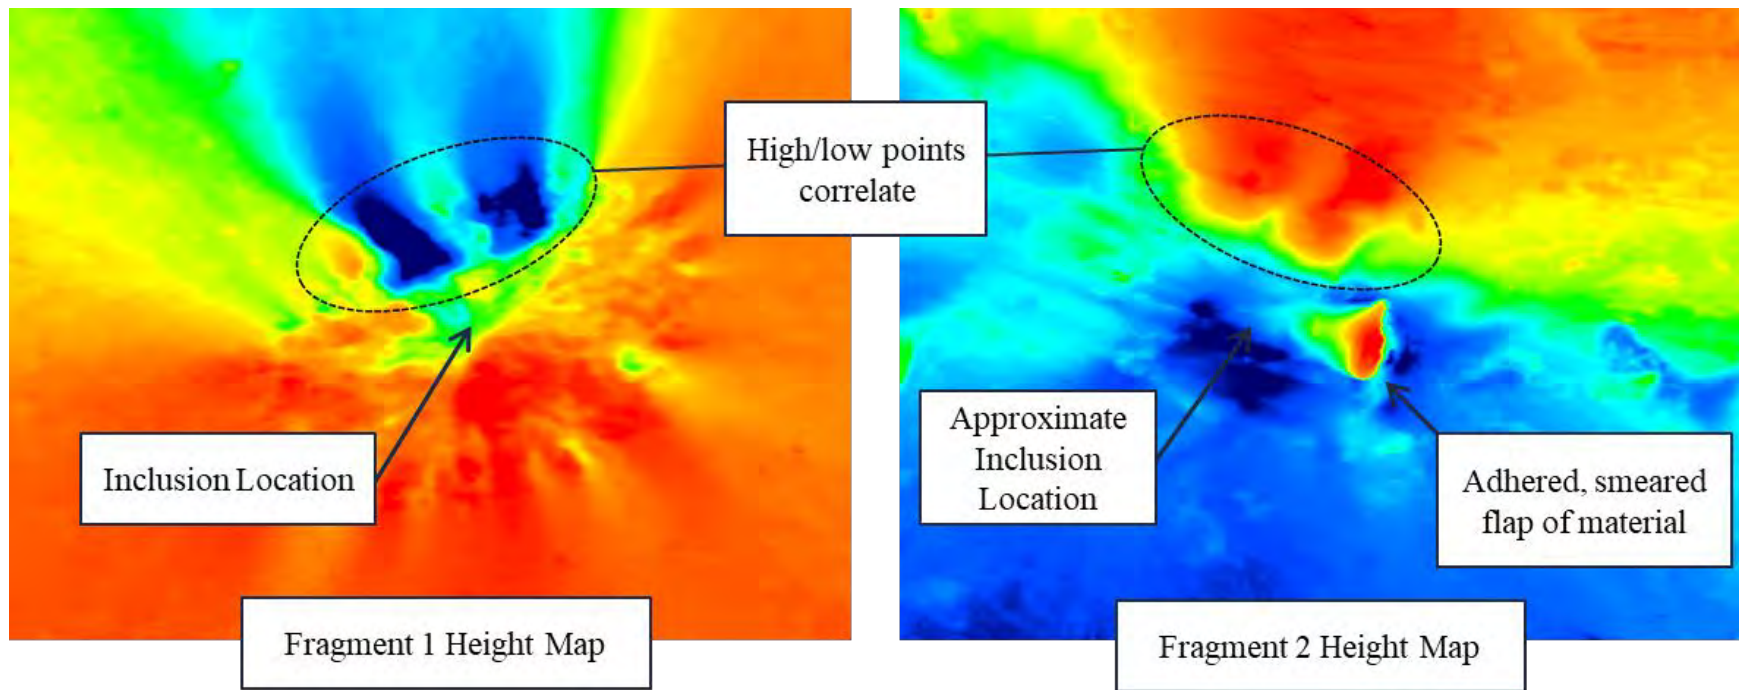
Figure 36: Comparison of Fragment 1 and Fragment 2 topography maps to determine approximate inclusion location. Red areas represent high points; blue areas represent low points.

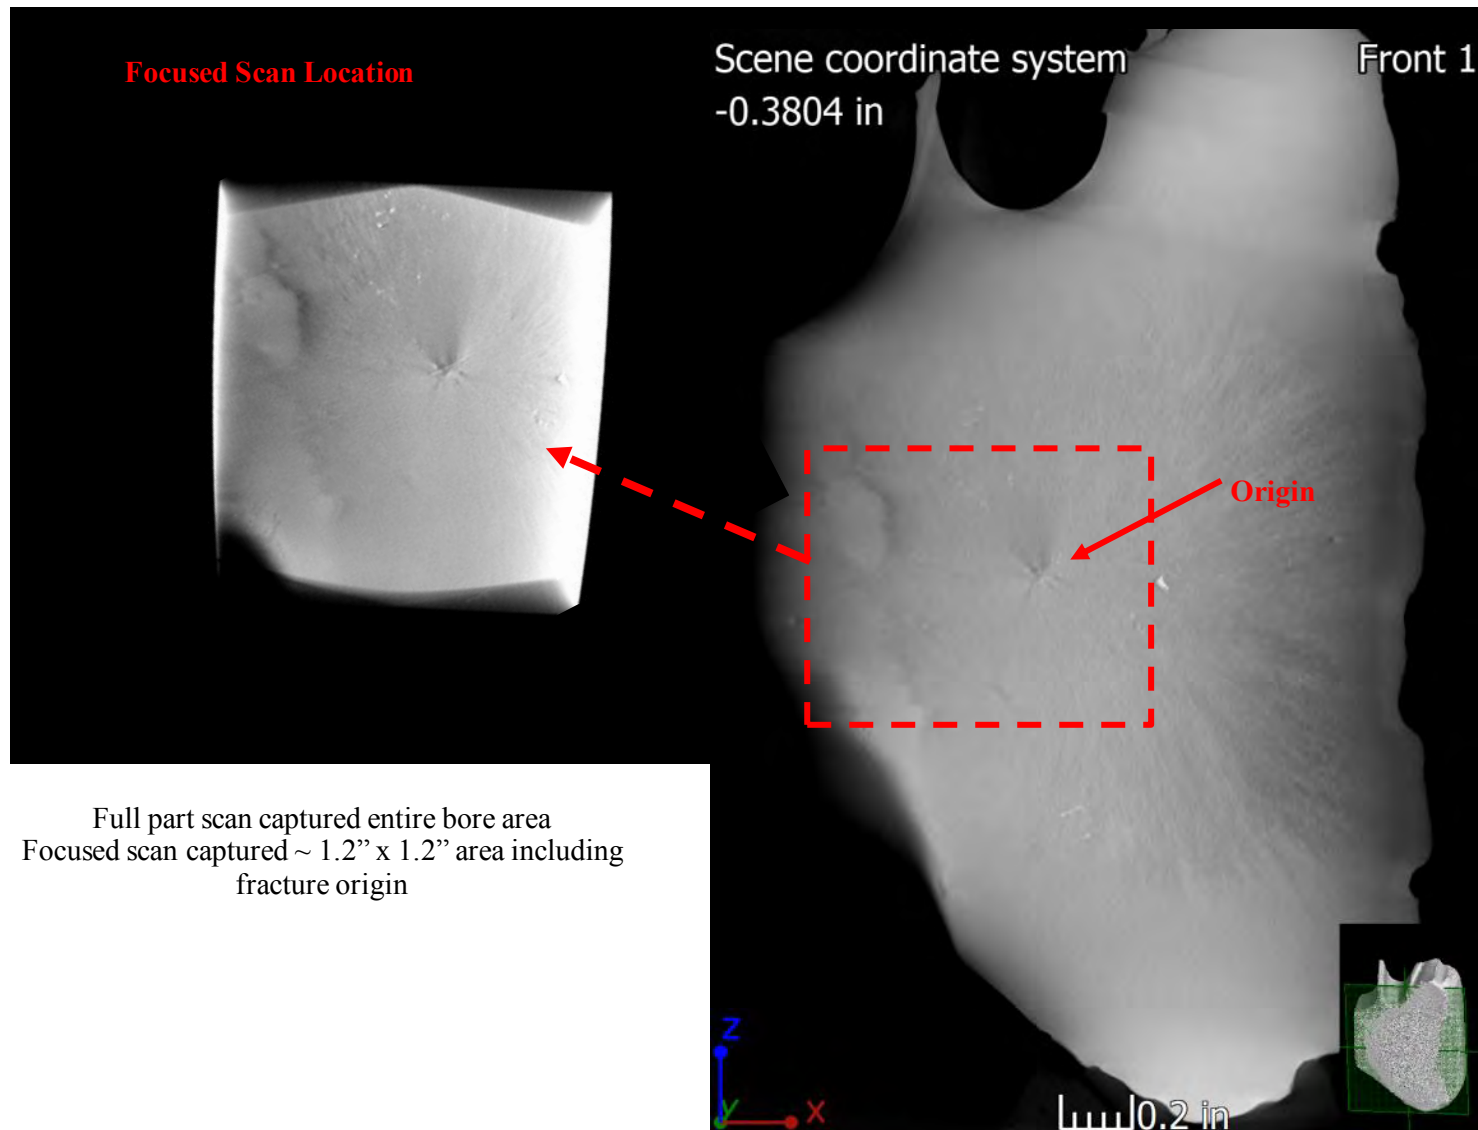
Figure 38: Initial micro CT scan images of the full bore section and a focused scan showing the origin area. Due to the large sample size, contrast was limited within the scan and it mostly captured the surface topography of the sample.

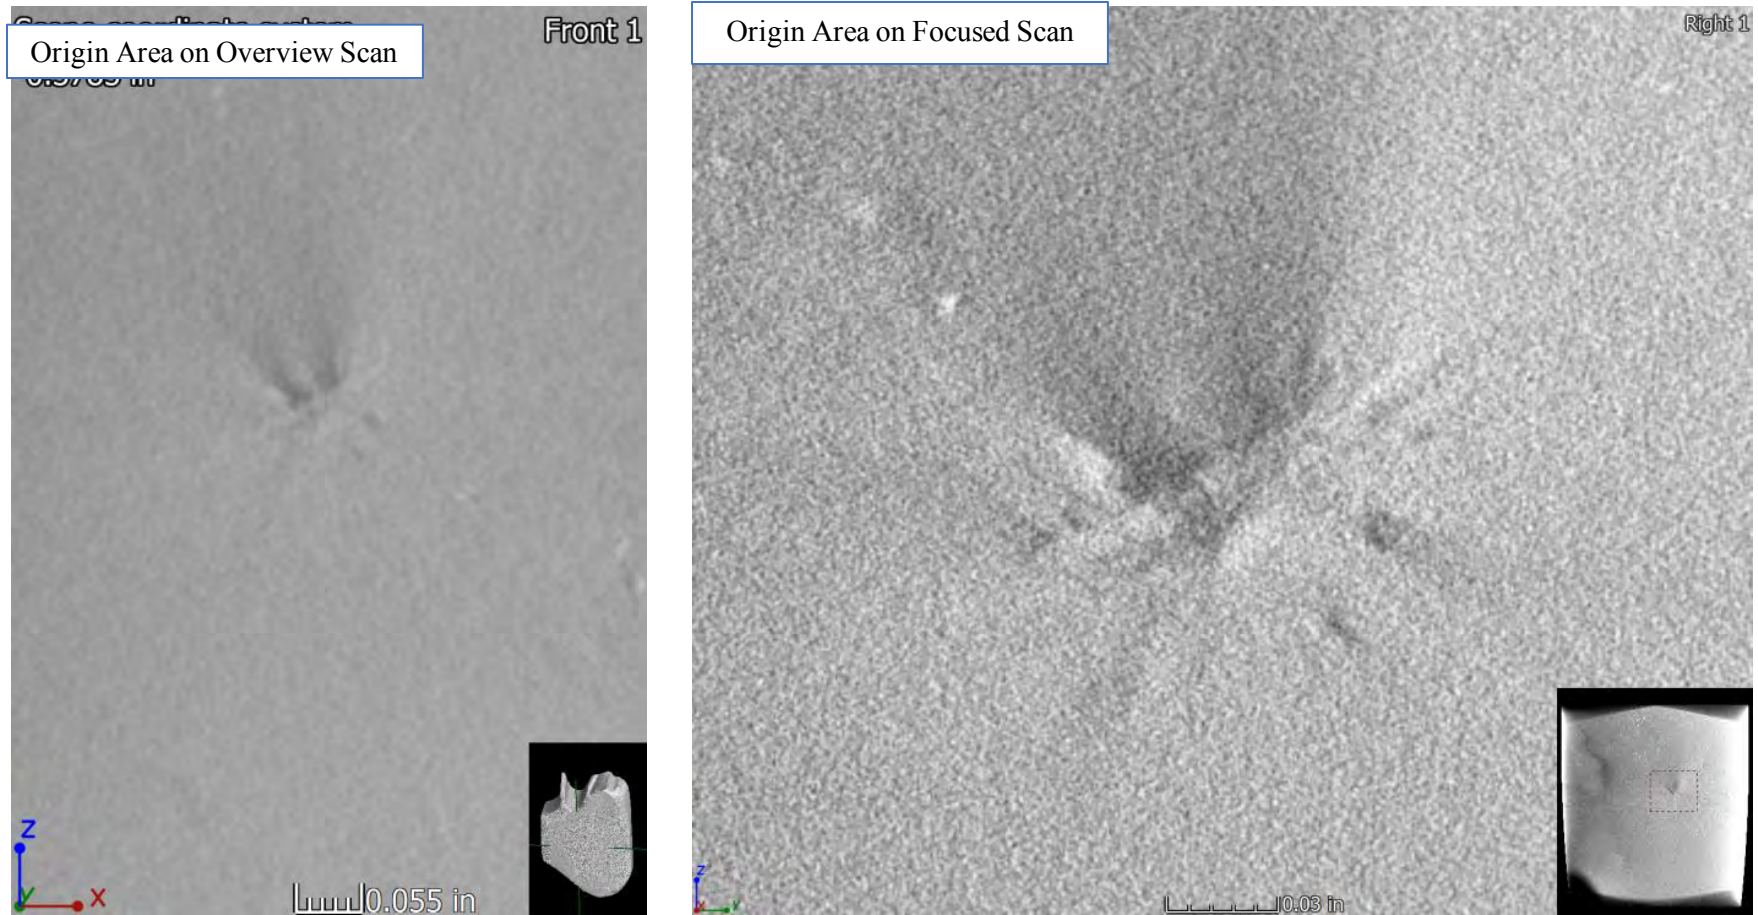
Figure 39: Views of the origin area on the overview micro CT scan (left) and the focused scan (right). The focused scan captured more detail within the origin area, however, was too noisy to identify and characterize the inclusion area.

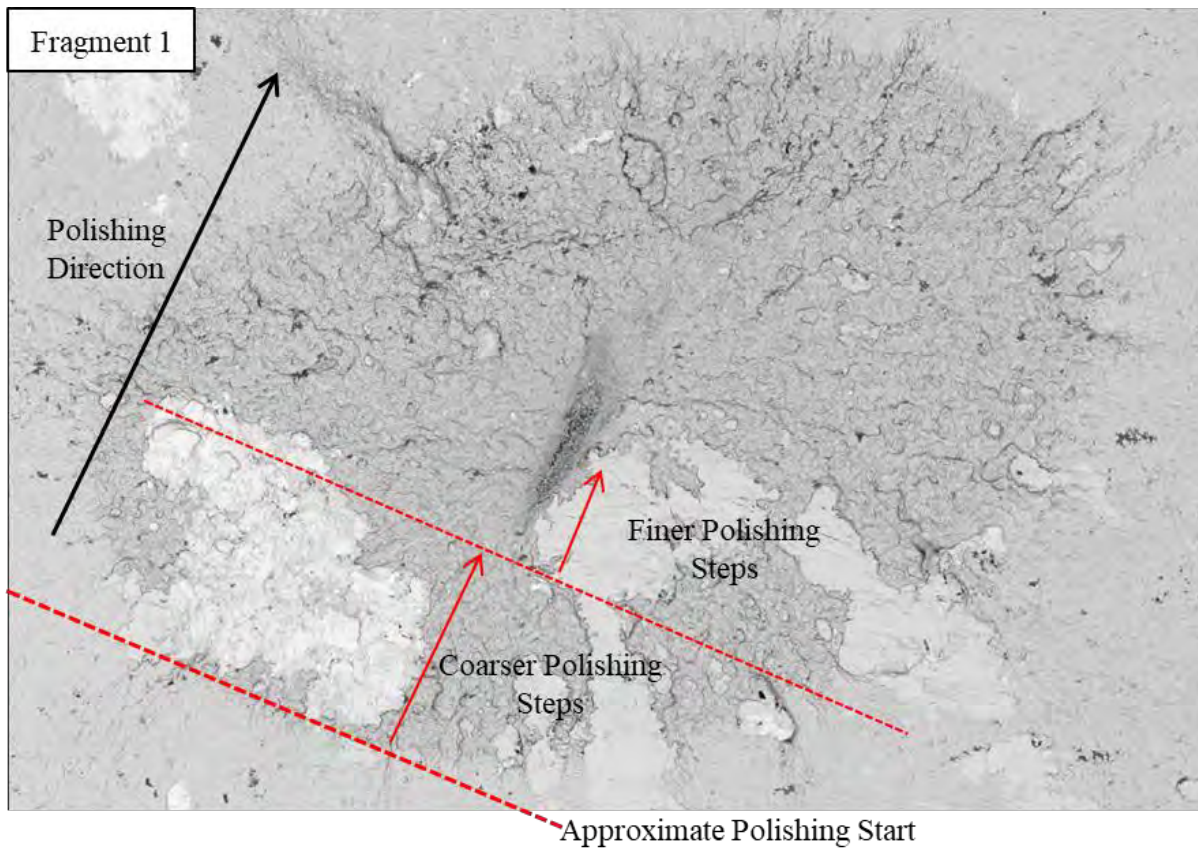
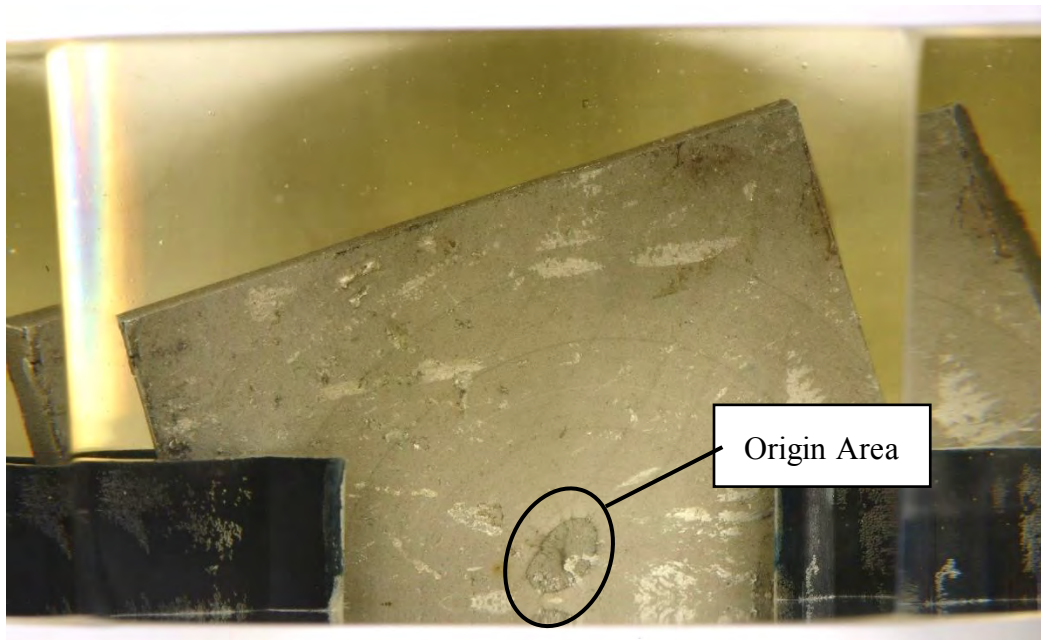
Figure 45: SEM image showing direction and orientation of serial polish sections through the Fragment 1 origin area (top) and image of metallographic section prepared in a clear epoxy mount(bottom).

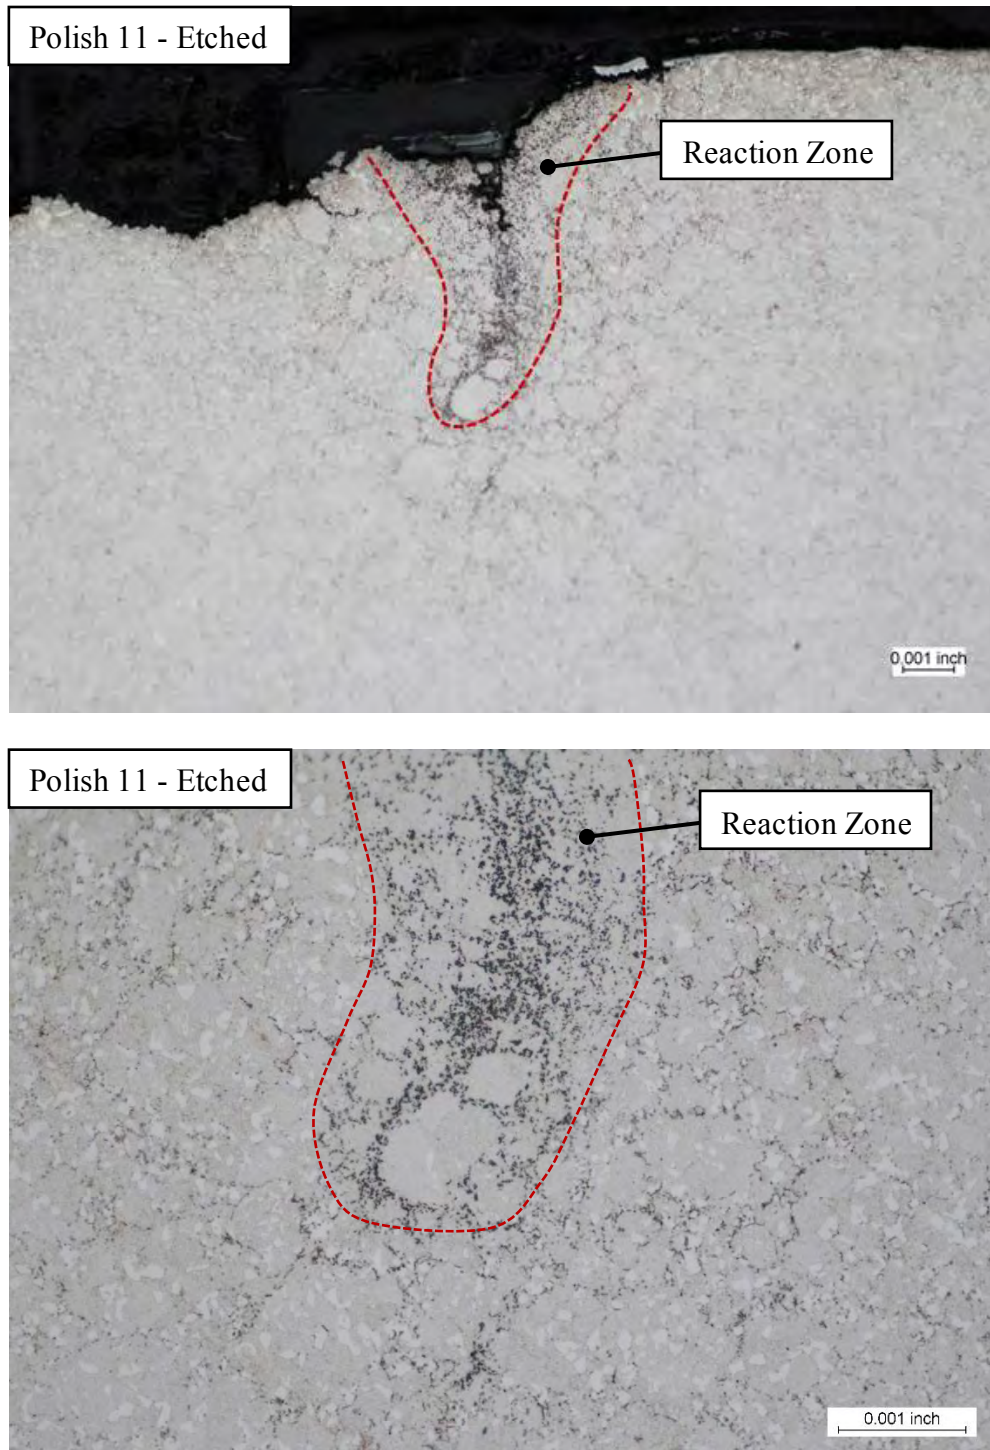
Figure 49: Photomicrographs of Polish 11 etched with a mixed acid etch to reveal the gamma prime phase. The reaction zone was denoted by the area that was denuded of primary gamma prime phase.

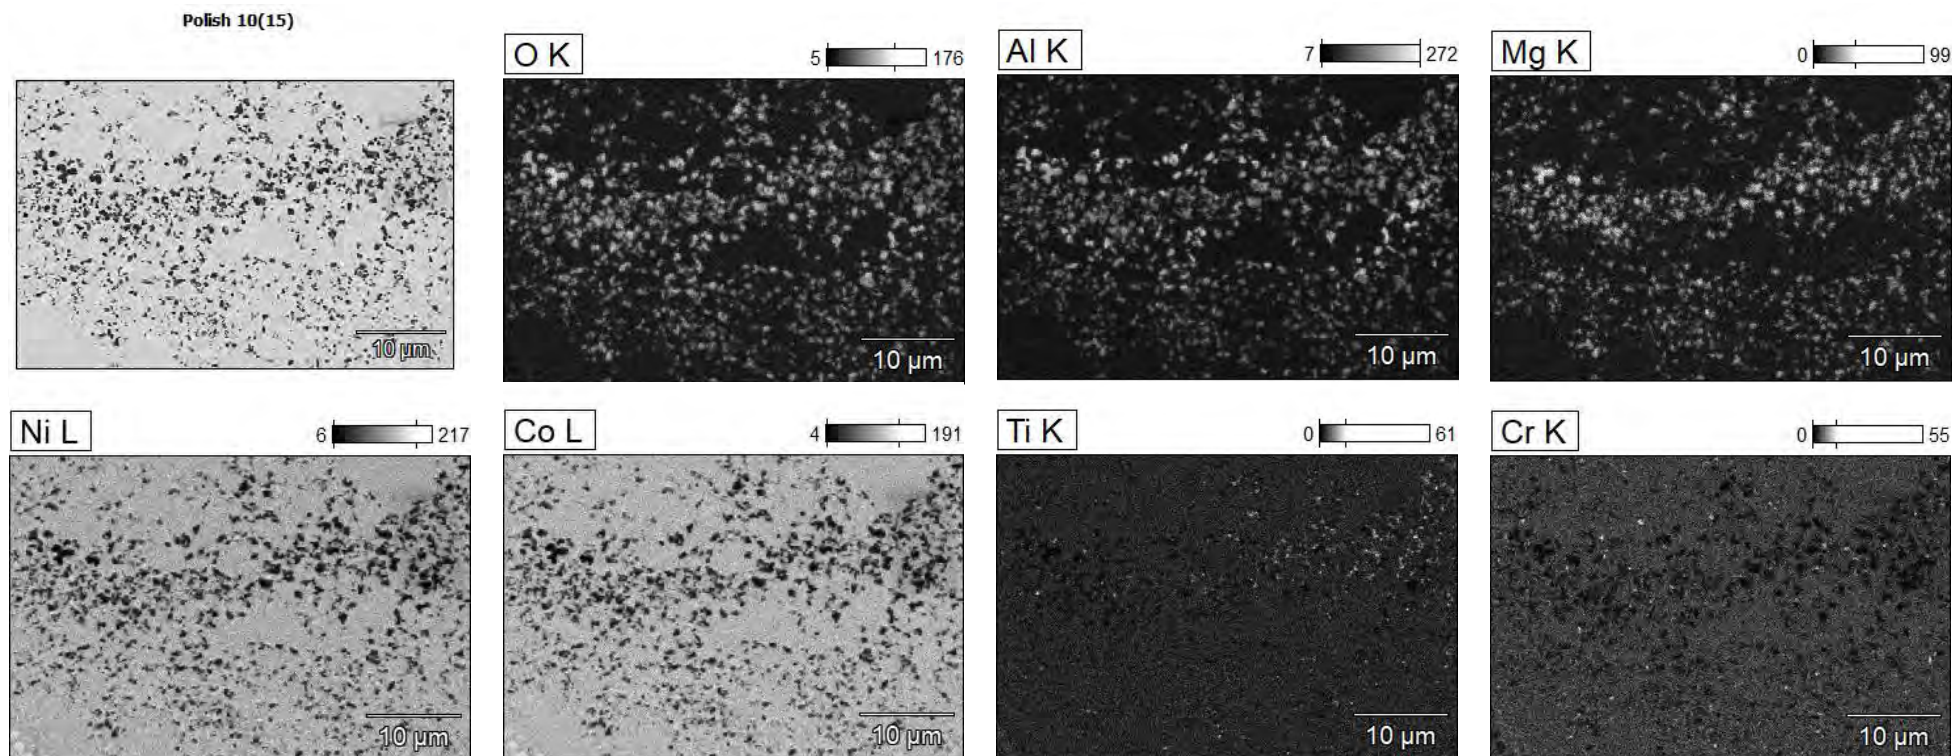
Figure 50: X-ray maps (EDS) taken at Polish 10 showing elements observed. Brighter color in maps indicates a higher concentration of the given element.
