**FINAL REPORT<sup>1</sup>**

**INVESTIGATION RESULT OF SERIOUS INCIDENT**

**VIETNAM AIRLINES UNCONTAINED ENGINE**

**AIRBUS A321 MSN 5306 (VN-A392)**

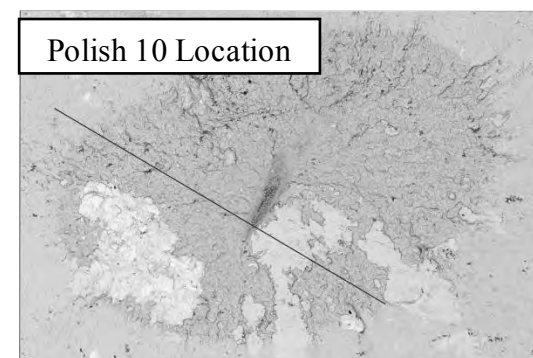
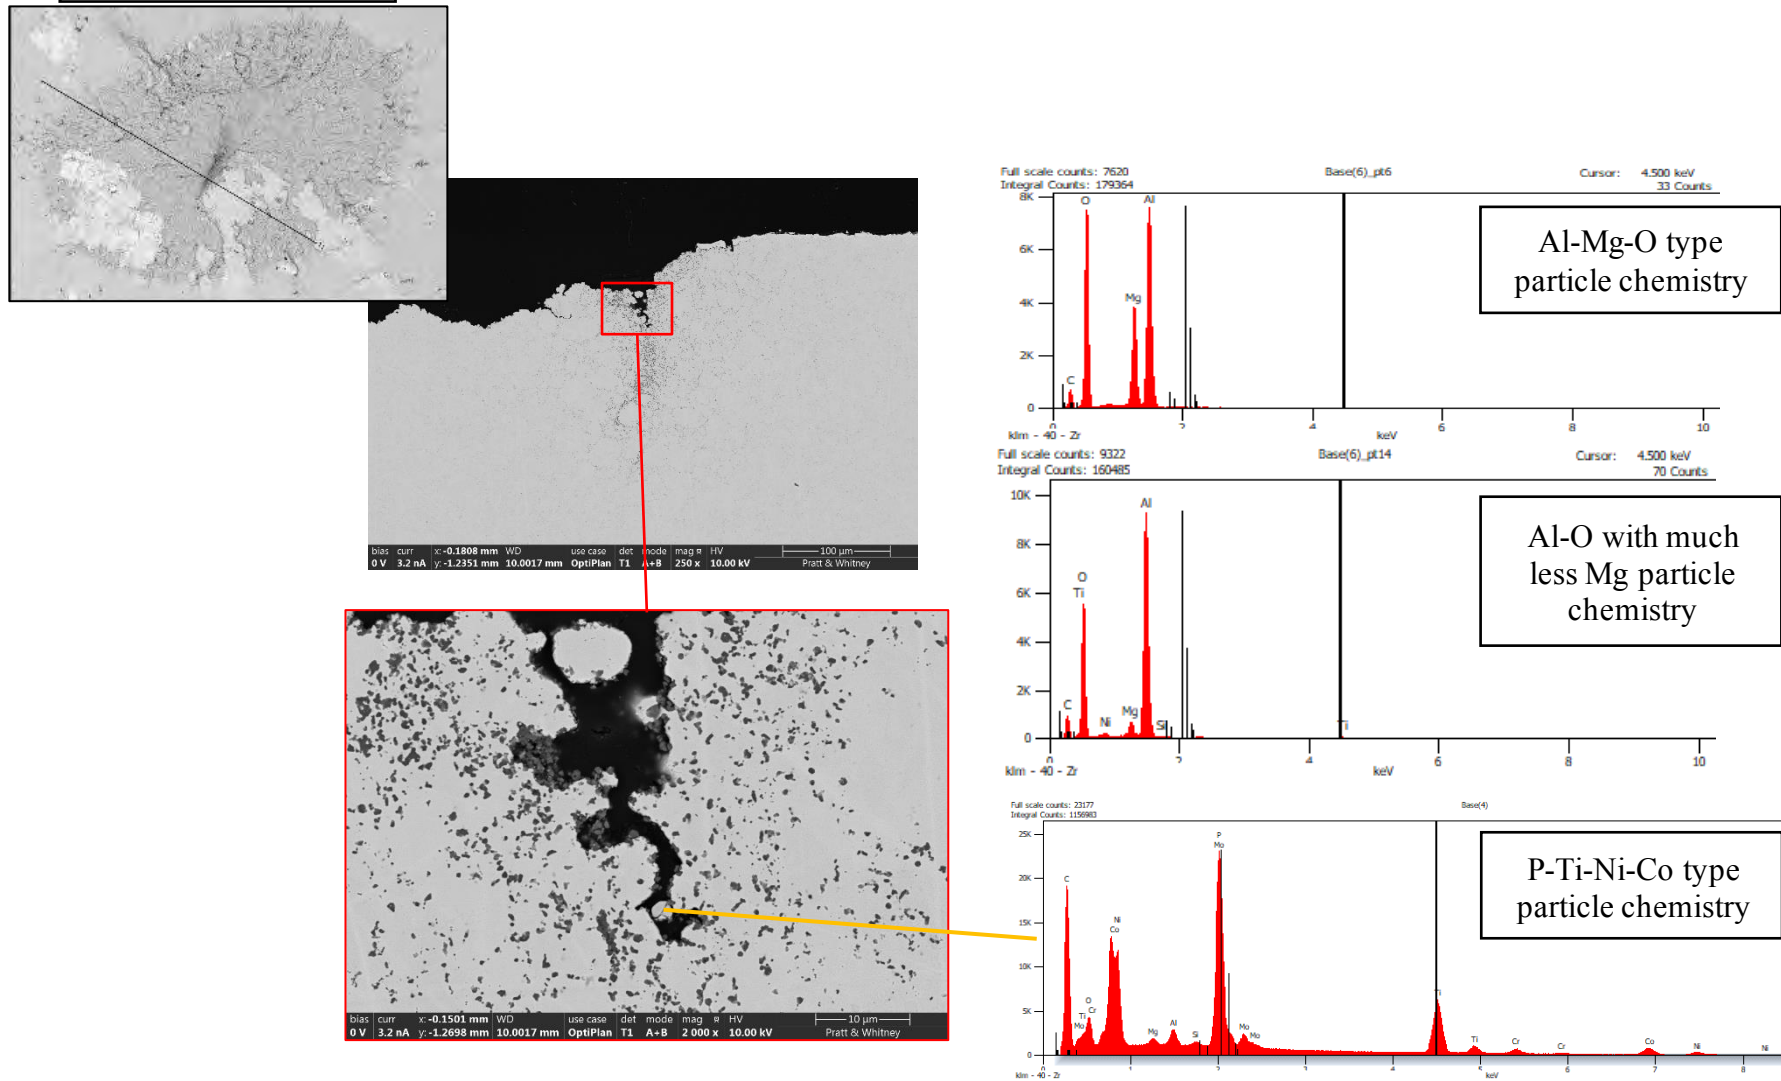
## Polish 11 Location

Figure 51: EDS spectra taken on particles observed at the Polish 11 location (location notated at upper left). The Al-Mg-O, Al-O, and P-Ti-Ni-Co type particles were all identified.

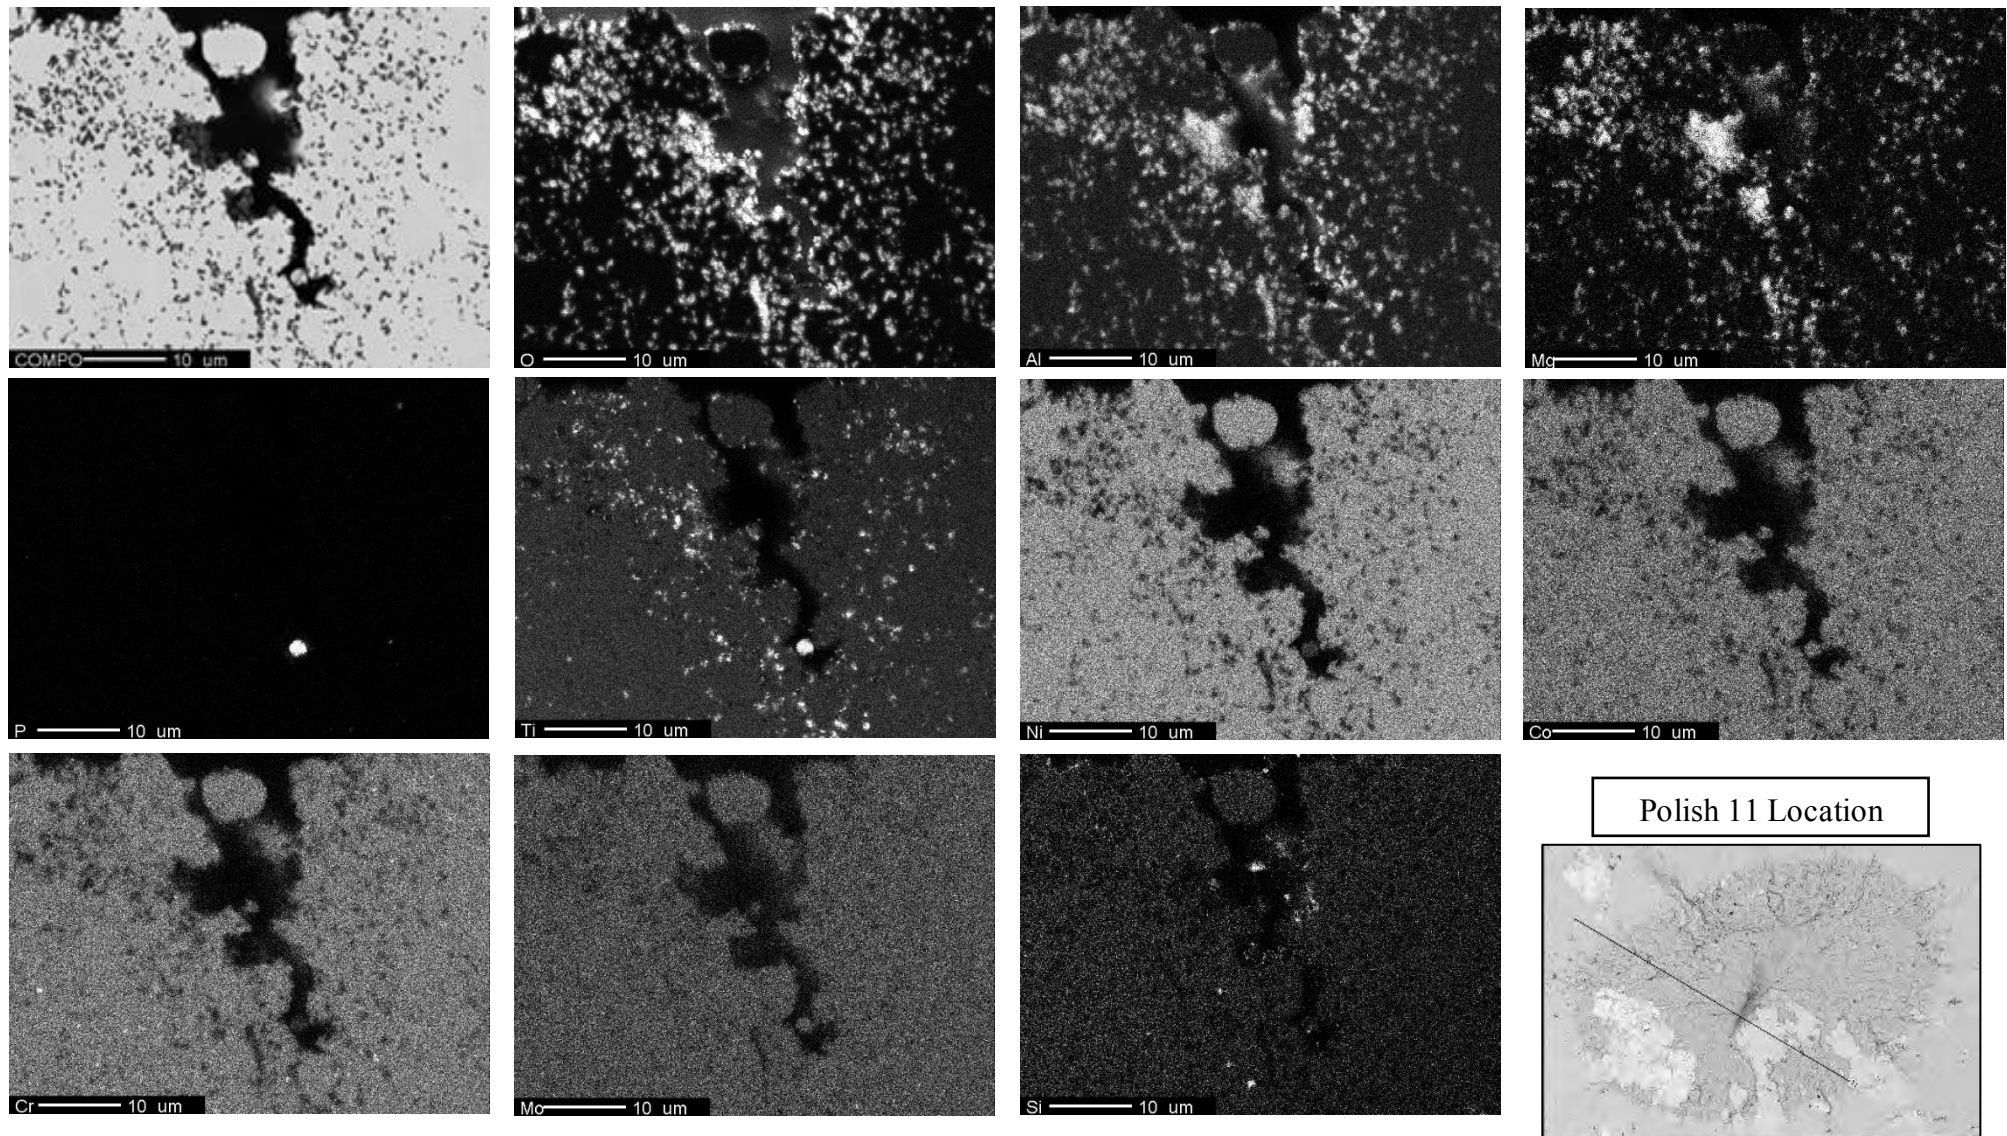
Figure 52: X-ray maps (EDS and WDS) taken at Polish 11 showing elements observed. Brighter color in maps indicates a higher concentration of the given element.

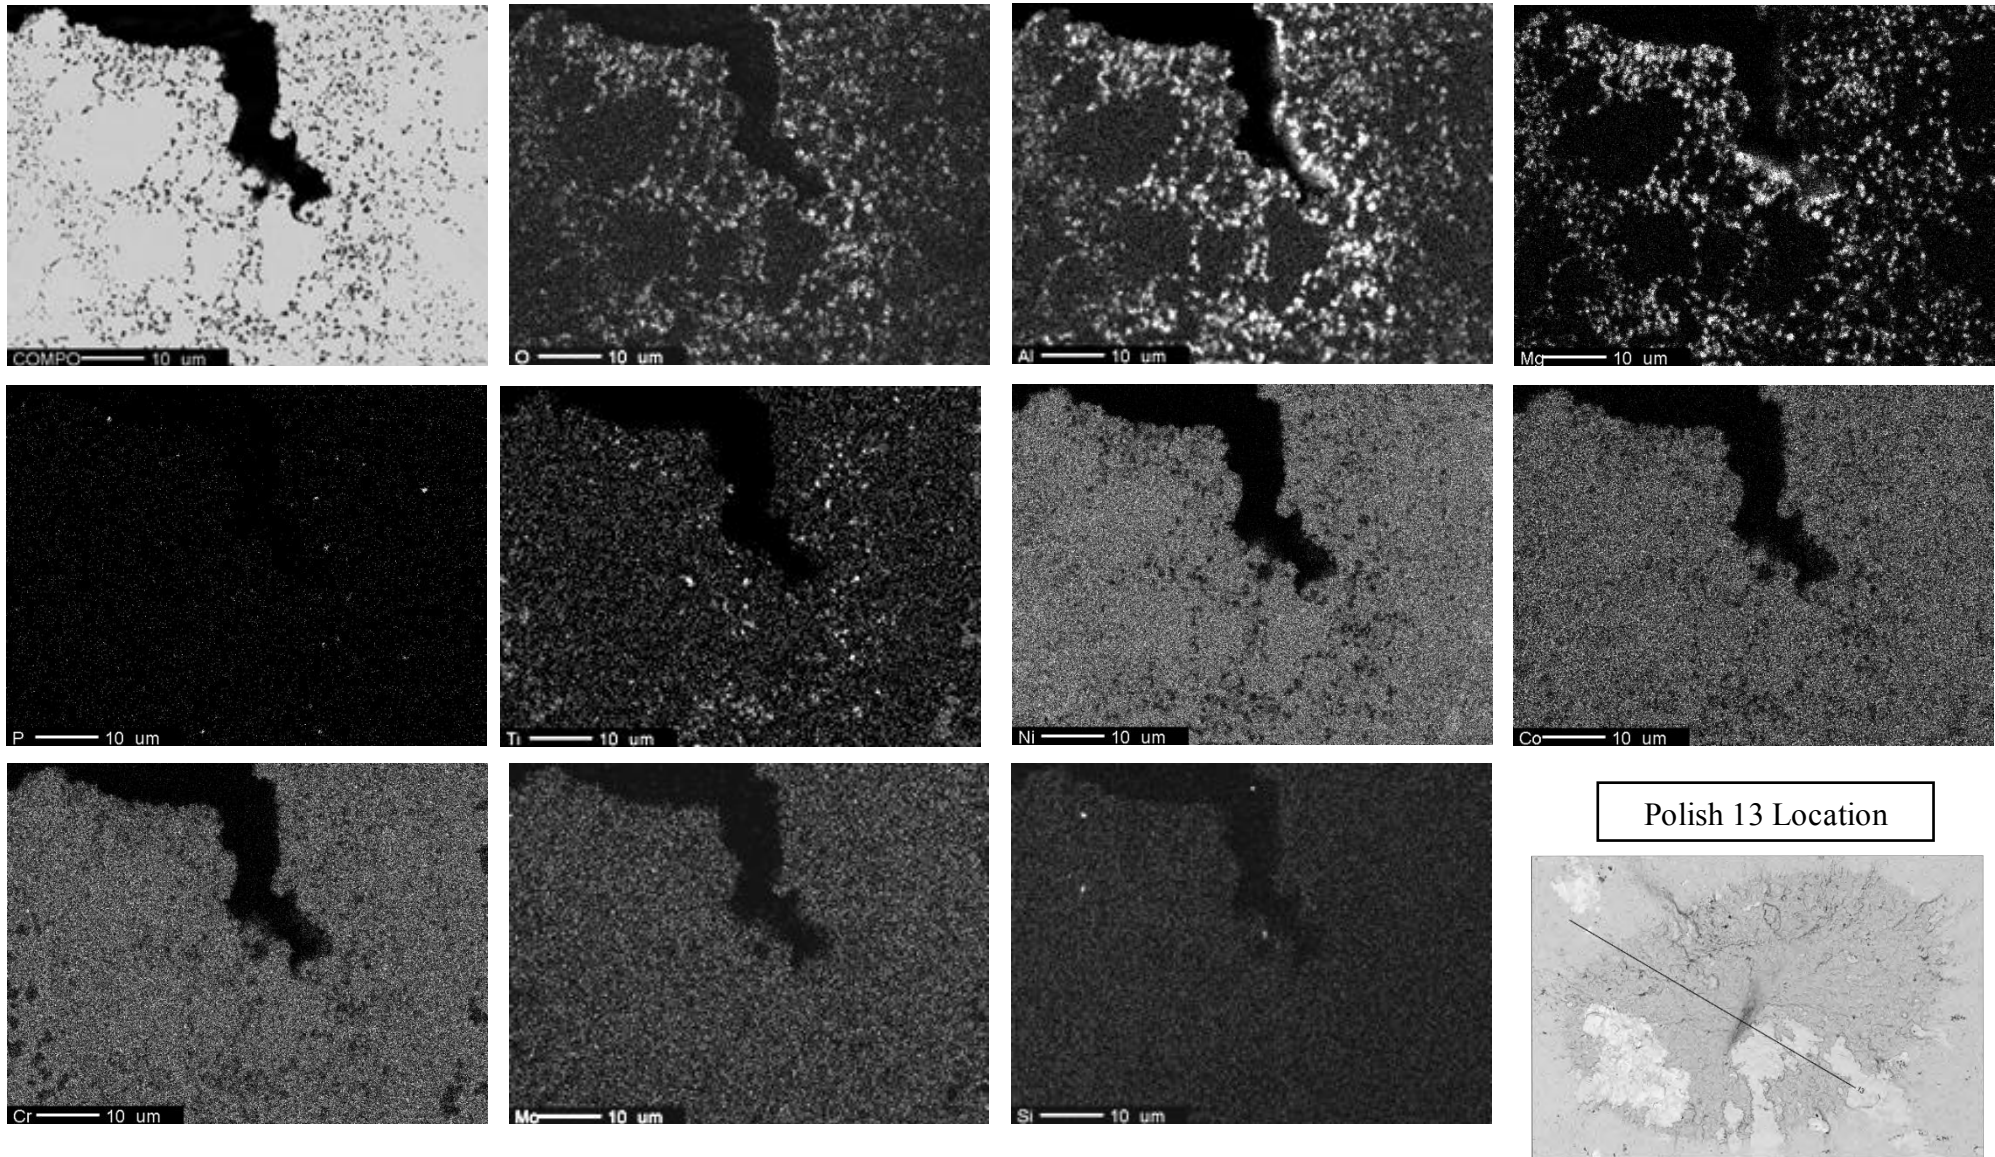
Figure 53: X-ray maps (EDS and WDS) taken at Polish 13 showing elements observed. Brighter color in maps indicates a higher concentration of the given element.

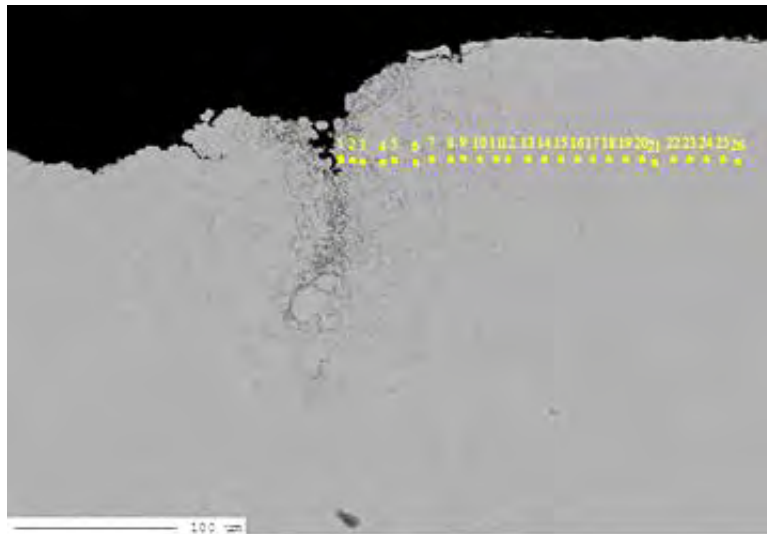
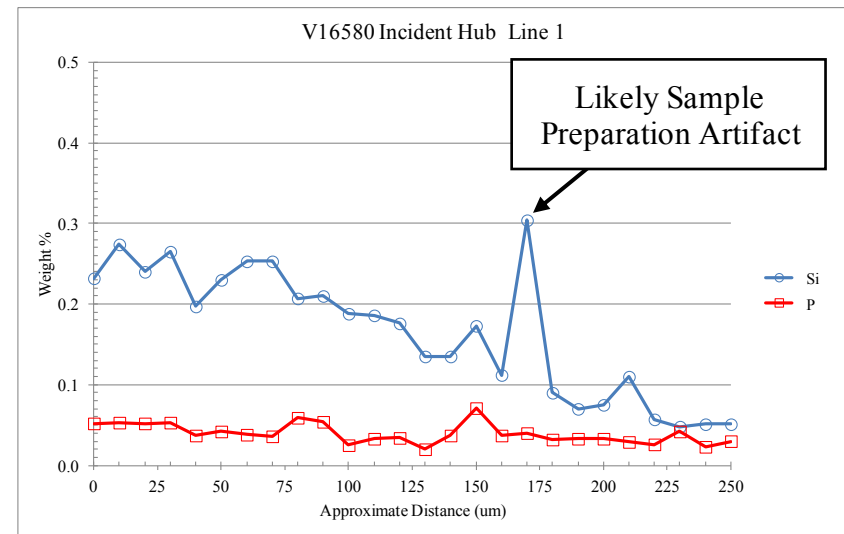
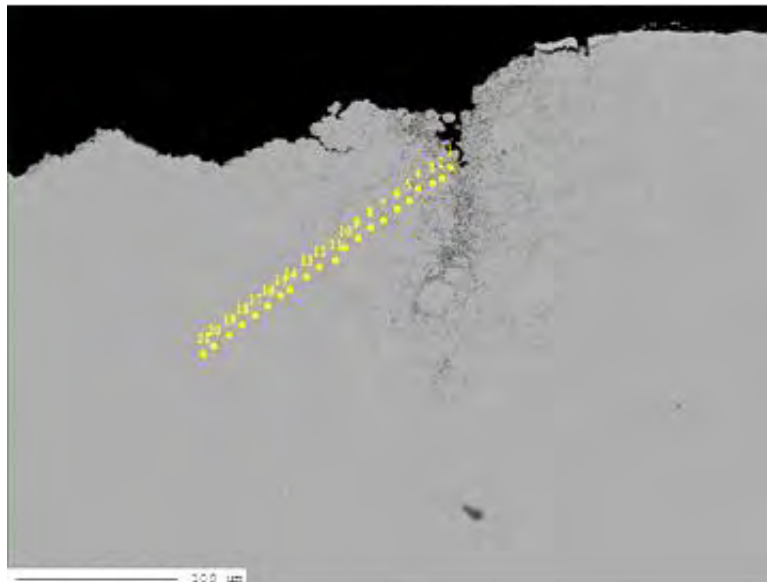
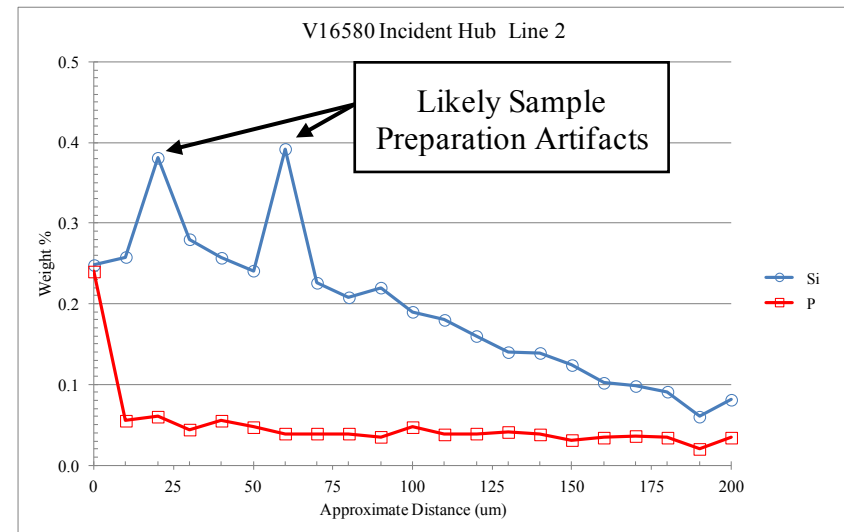
Figure 54: Electron microprobe line scans taken on Polish 11 moving away from the inclusion. Weight percent values of Si and P for each trace shown on right. It should be noted that while this data can be used to understand general trends, the absolute value of the weight percent measurement is uncertain due to a lack of calibration of the electron microprobe at the levels observed.

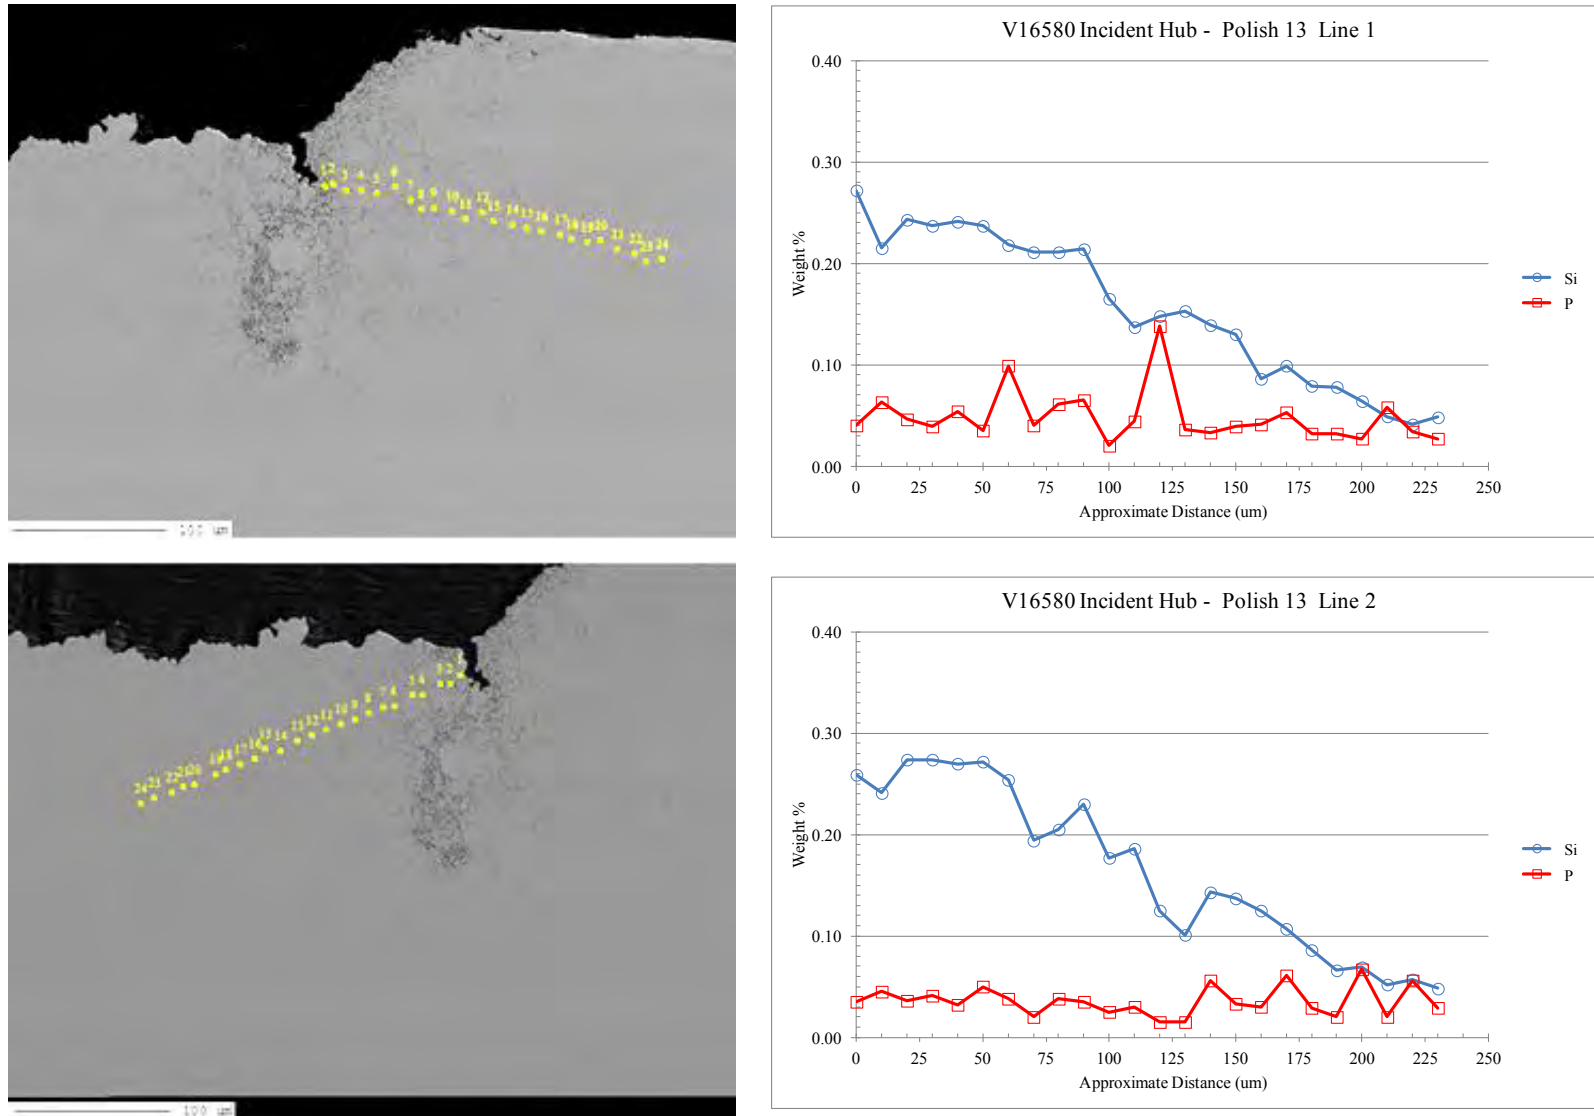
Figure 55: Electron microprobe line scans taken on Polish 13 moving away from the inclusion. Weight percent values of Si and P for each trace shown on right. It should be noted that while this data can be used to understand general trends, the absolute value of the weight percent measurement is uncertain due to a lack of calibration of the electron microprobe at the levels observed.

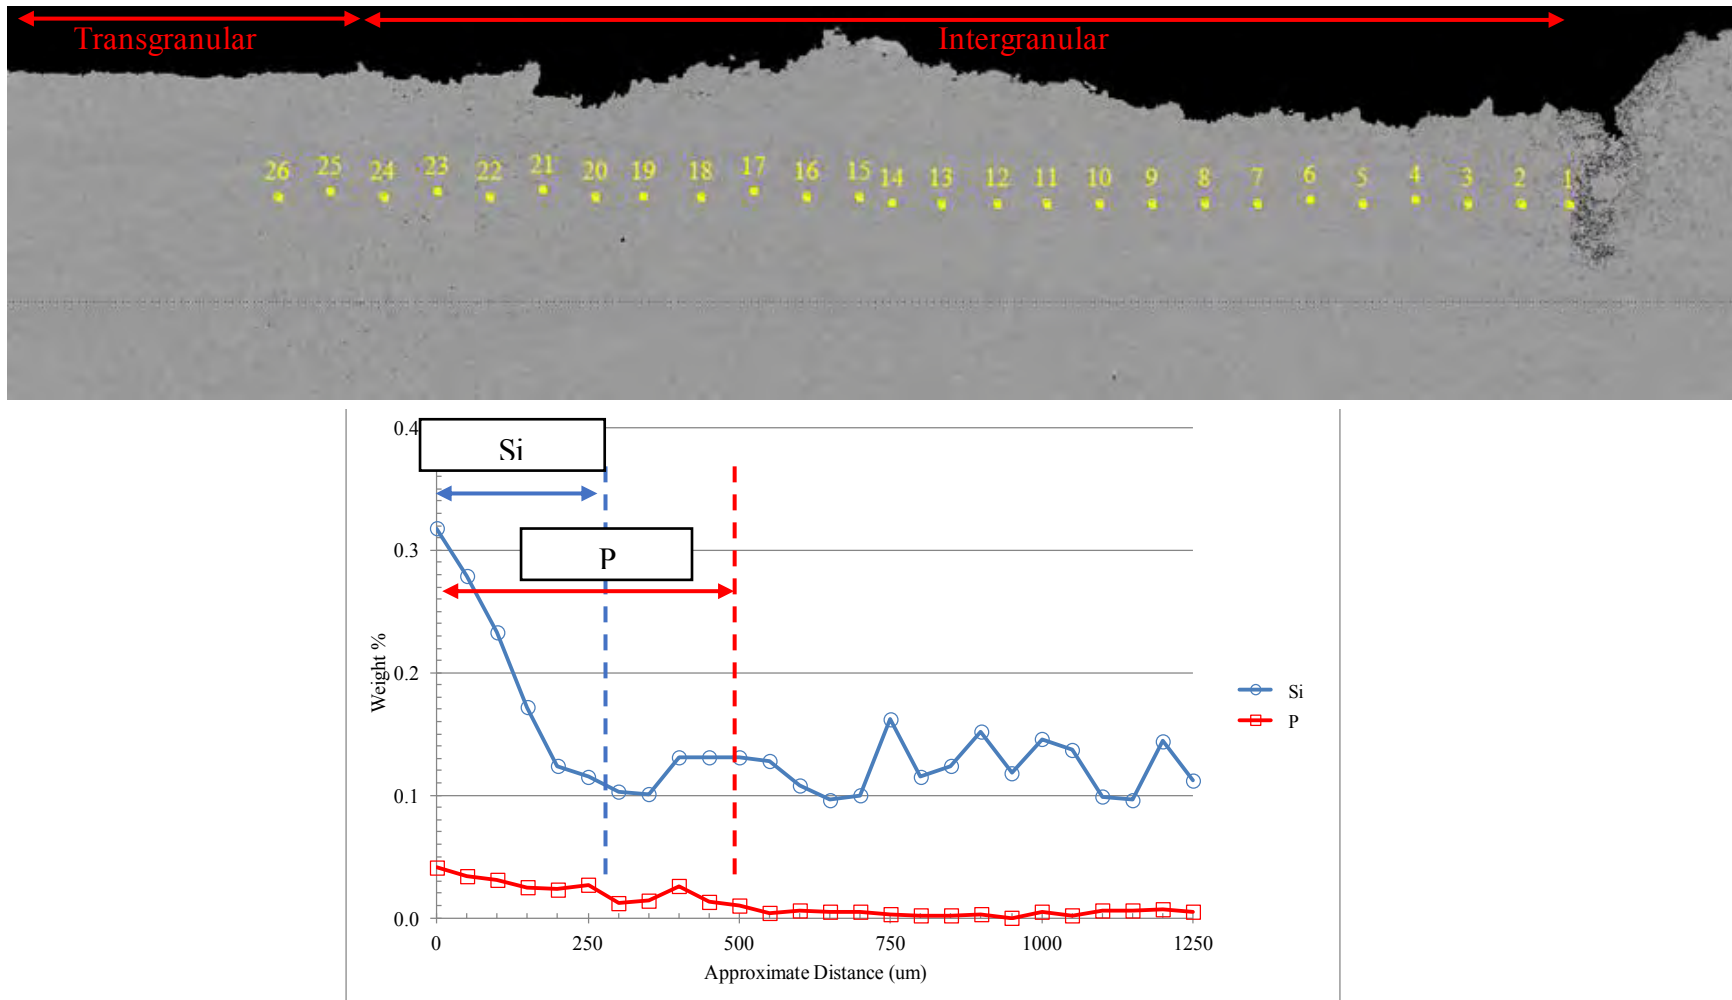
Figure 56: Electron microprobe line scans taken on Polish 13 moving away from the inclusion through the intergranular area and into the transgranular area. Weight percent values of Si and P for each trace shown at bottom. It should be noted that while this data can be used to understand general trends, the absolute value of the weight percent measurement is uncertain due to a lack of calibration of the electron microprobe at the levels observed.

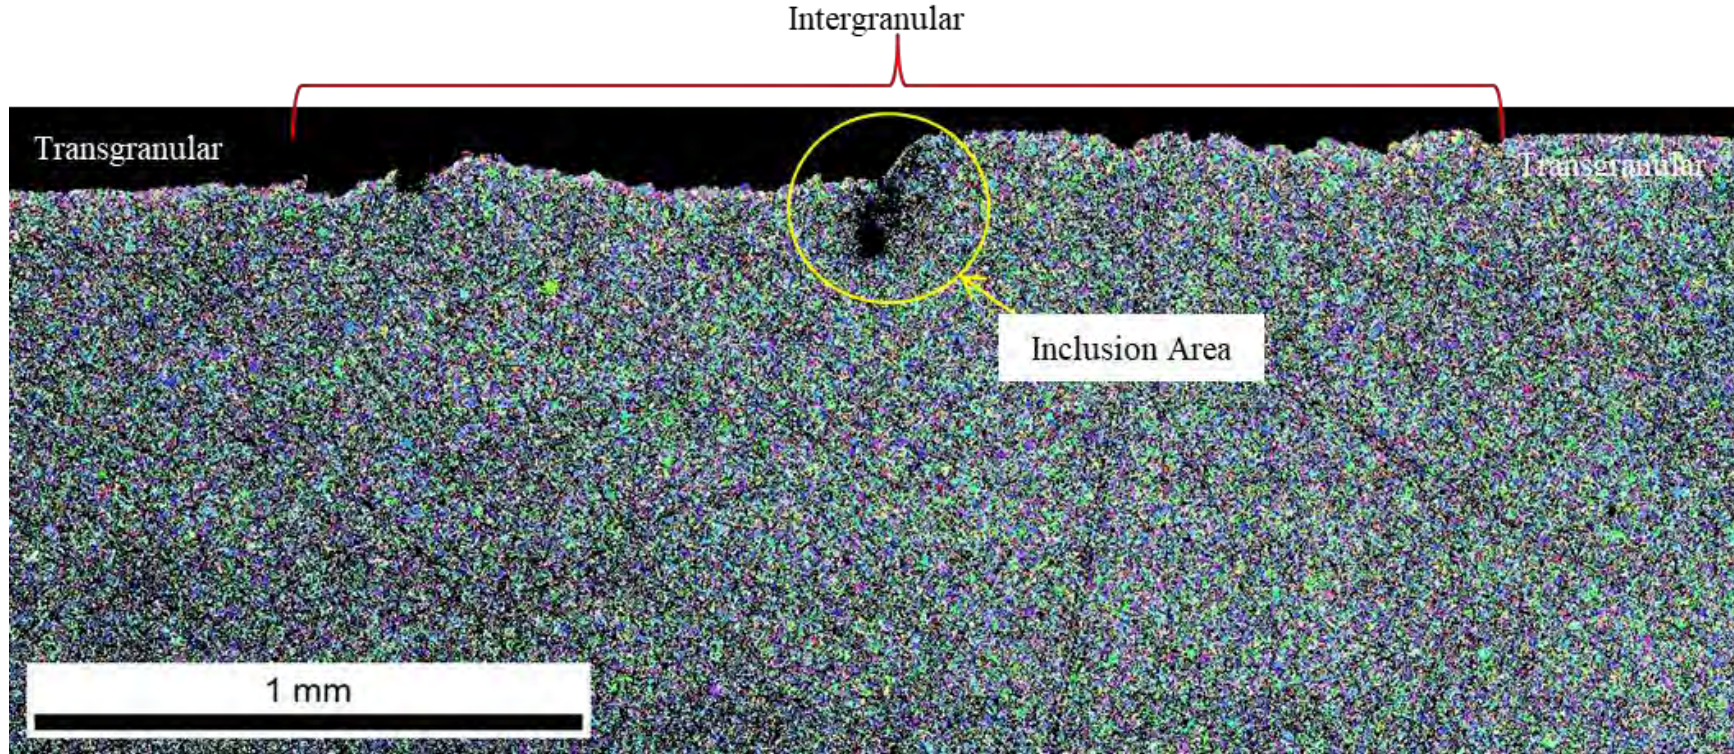
Figure 57: Inverse pole figure (IPF) produced by EBSD showing no discernable difference between the intergranular and transgranular areas.

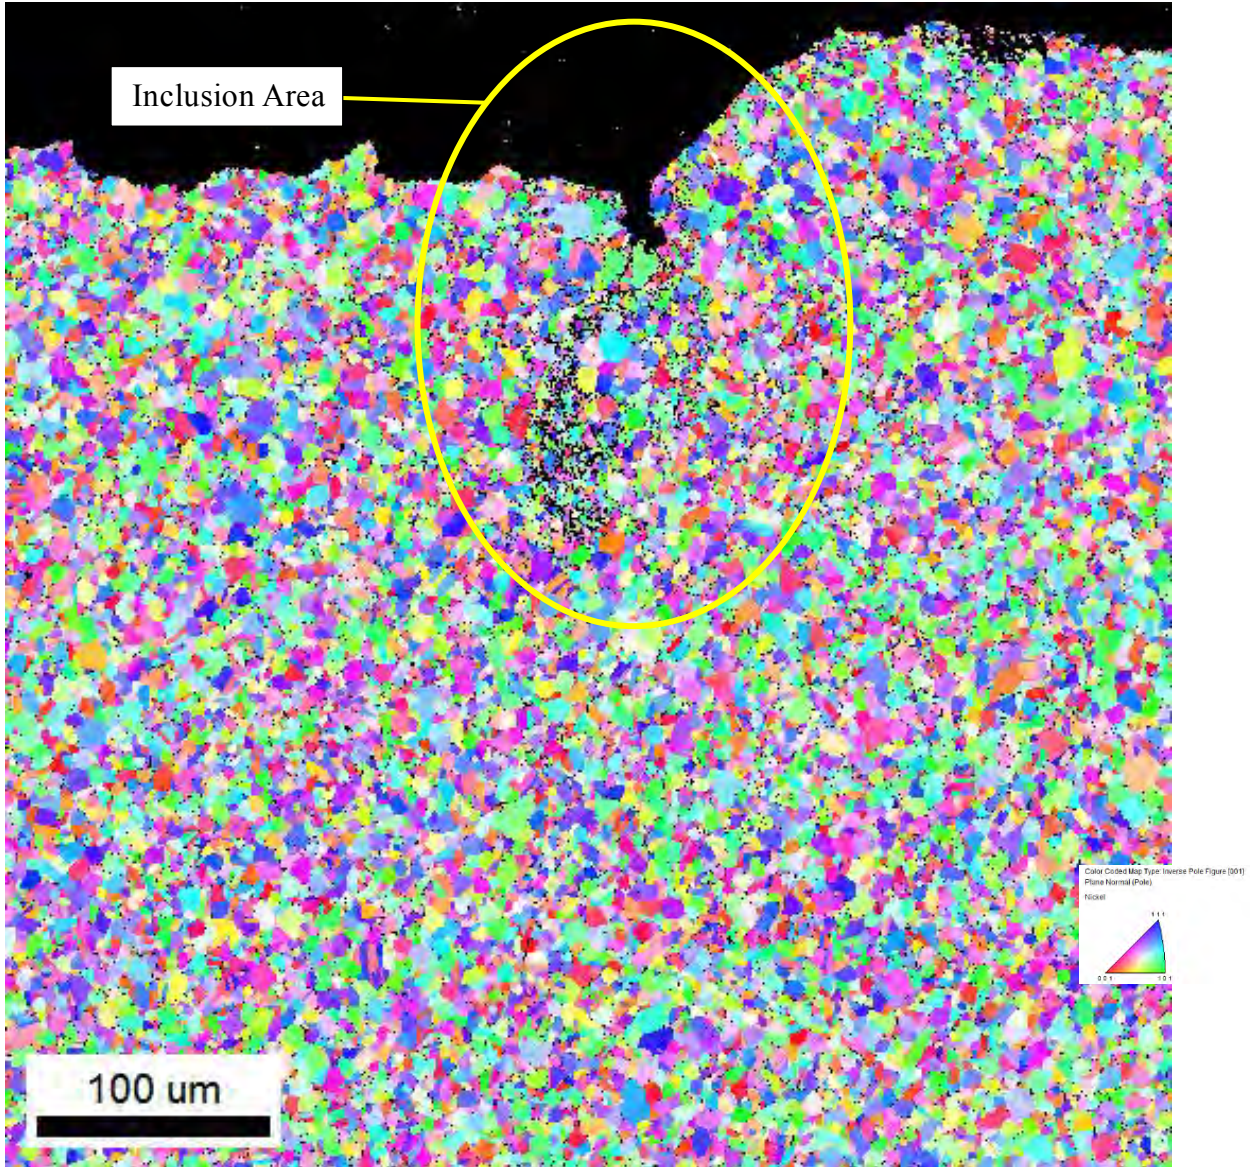
Figure 58: Inverse pole figure (IPF) produced by EBSD showing no discernable difference between the inclusion area and the surrounding intergranular area.

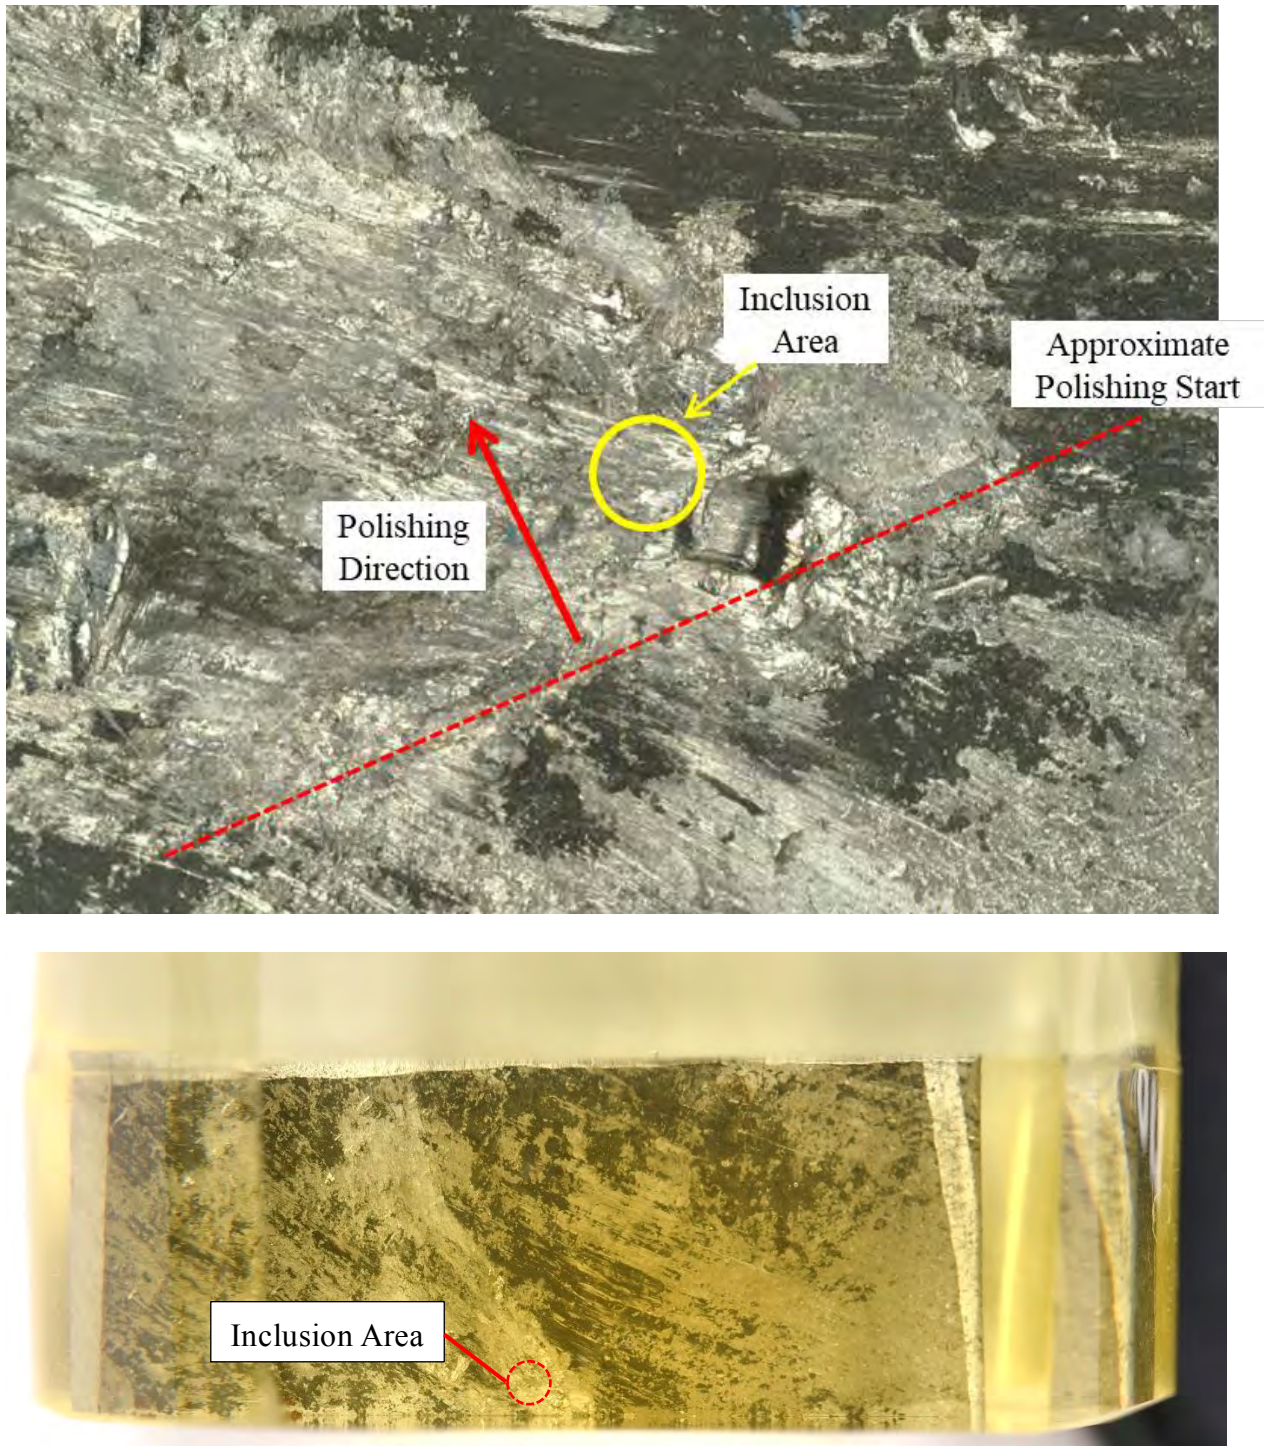
A metallographic section was prepared through Fragment 2 in order to understand the size, shape, and morphology of the inclusion via serial polishing. The Fragment 2 section was mounted in clear epoxy so that the progress of the polish plane across the fracture surface could be visually observed. The location of the inclusion area had been roughly identified using the comparison of the topography of Fragment 1 (Figure 59). At each plane of polish, the section was examined as-polished and via two different etchants to characterize the microstructure.

Figure 59: Binocular microscope image showing direction and orientation of serial polish sections through the Fragment 2 origin area (top) and image of metallographic section prepared in a clear epoxy mount(bottom).

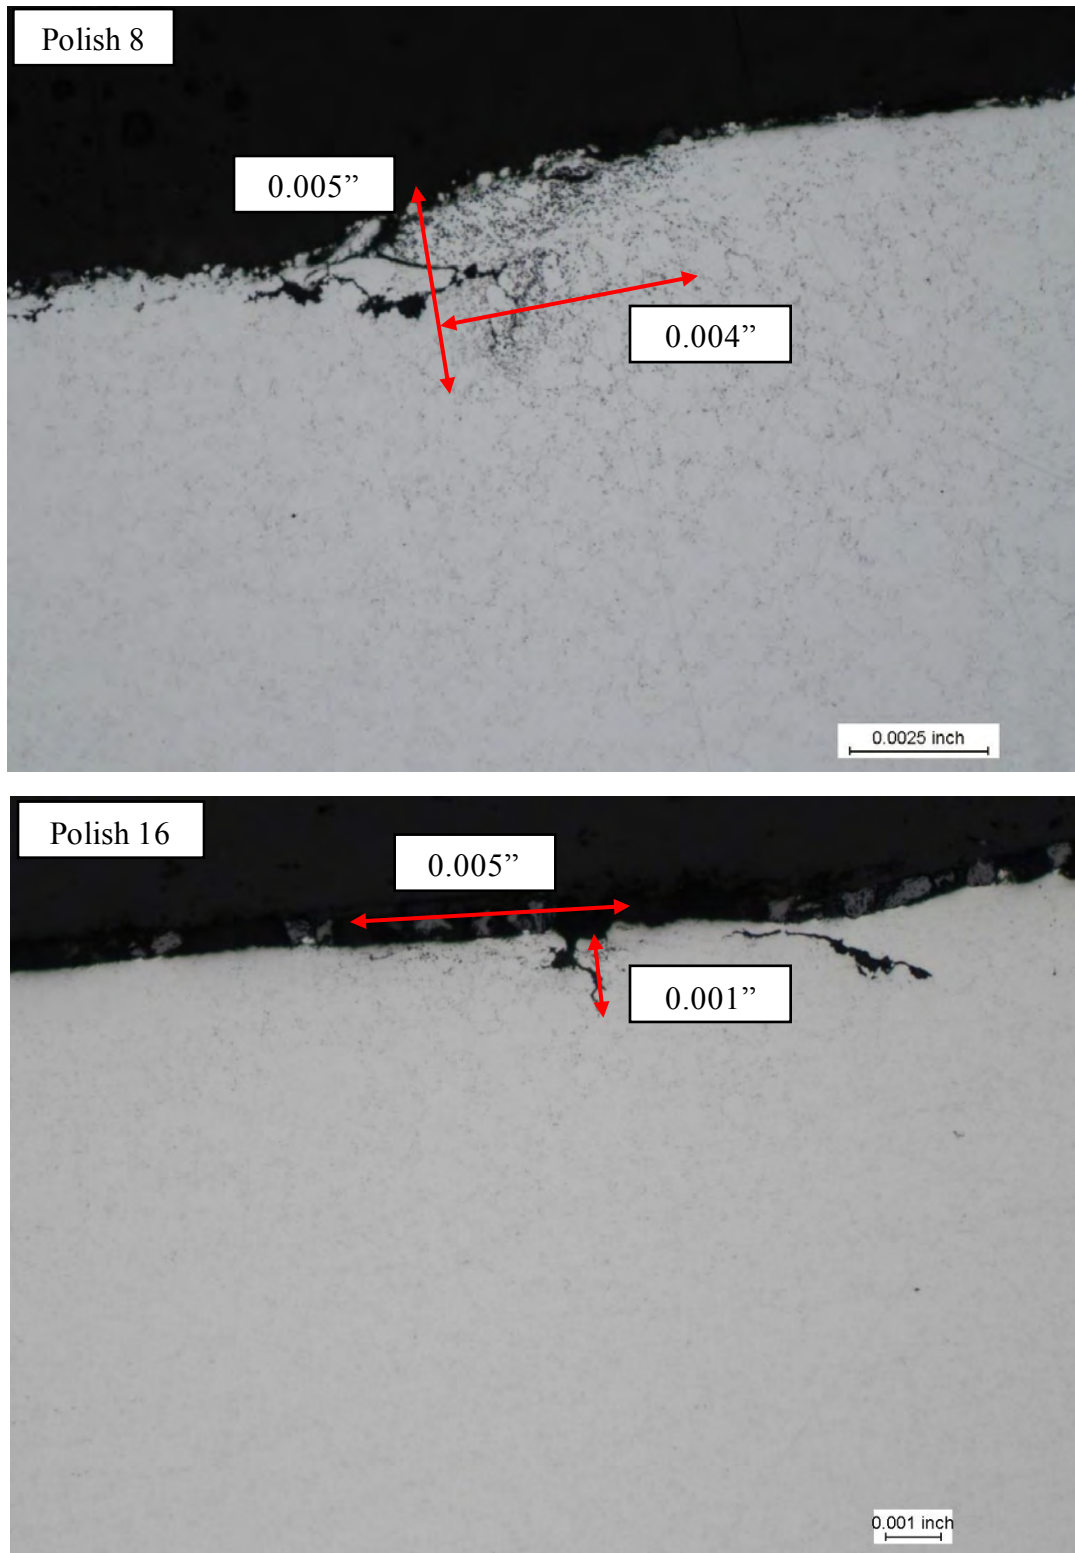
Review of each of the polish planes in the as-polished condition identified the inclusion area as a region of distributed particles. The particles appeared dark gray to black when compared to the surrounding base metal. Many of the particles appeared to be concentrated on the prior particle boundaries in the material. This appearance was consistent with what was observed on the fracture surface as part of the outer inclusion area and on the Fragment 1 serial polish. The most dense region of this area was measured as the particle cloud dimension; minimum size observed at Polish 16 measured 0.001" x 0.005"; maximum size measured at Polish 8 was 0.005" x 0.004" (Figure 61). Additionally, cracking was observed at multiple polishes on this section. However, due to

Figure 61: As-polished photomicrographs at Polishes 8 (top) and 18(bottom).

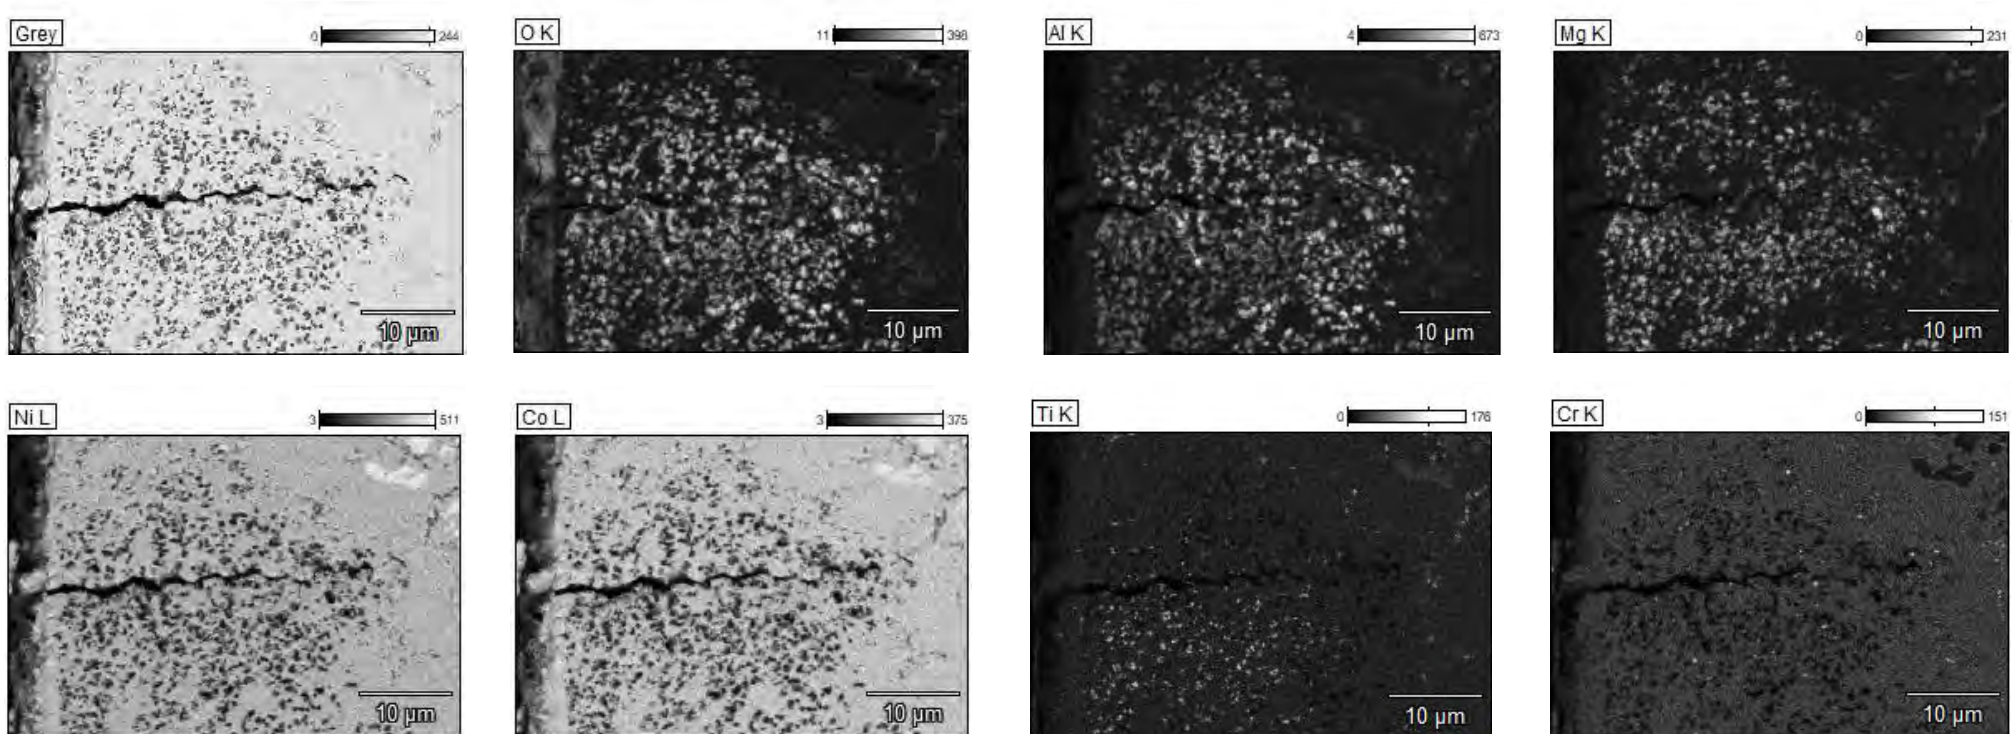
SEM/EDS analysis of the metallographic section at each of Polishes 5 and 7 was completed. EDS maps of the particle cloud showed the distribution of elements within the region. The particle cloud itself consisted of the Al-O and Al-Mg-O type chemistries (Figure 62). This was consistent on both polishes.

Figure 62: X-ray maps (EDS) taken at Polish 5 showing elements observed. Brighter color in maps indicates a higher concentration of the given element.

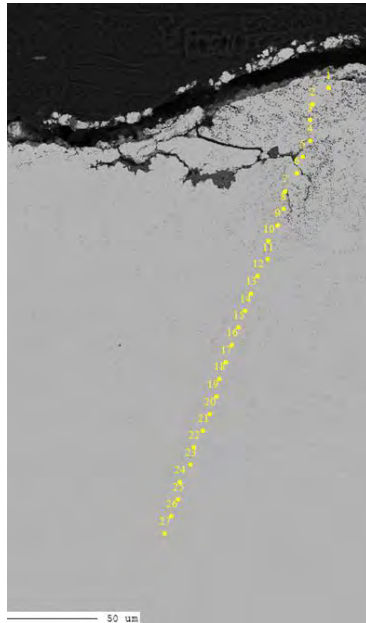
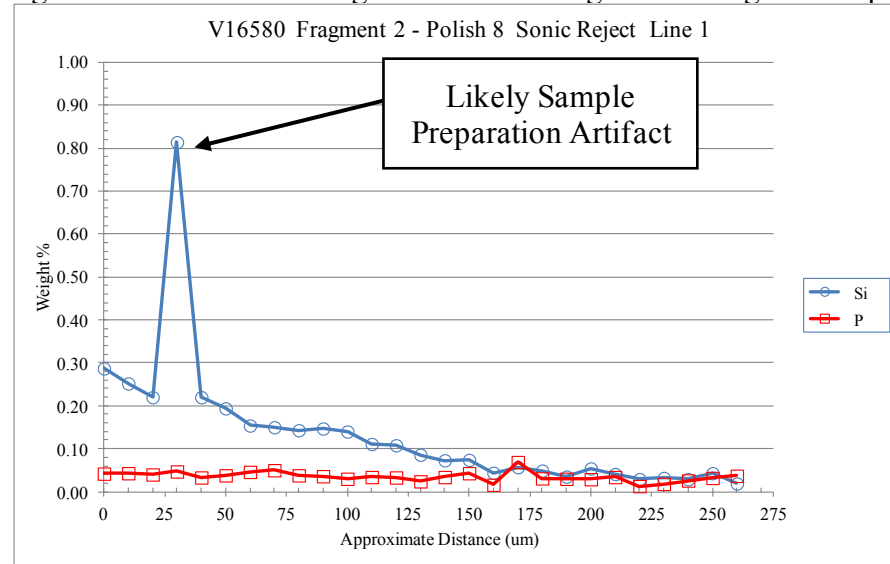
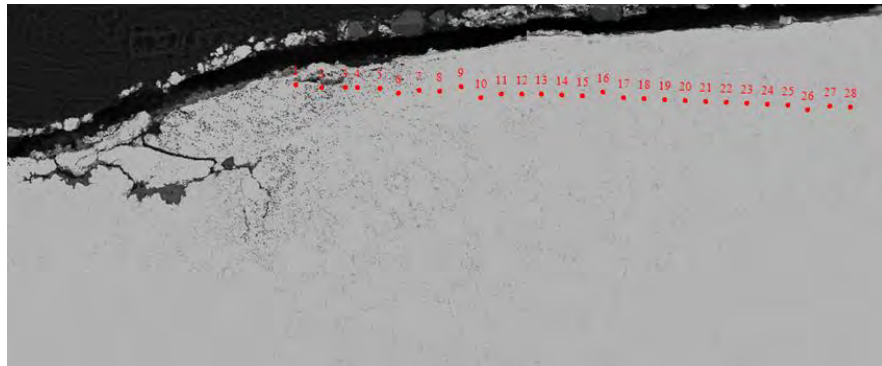
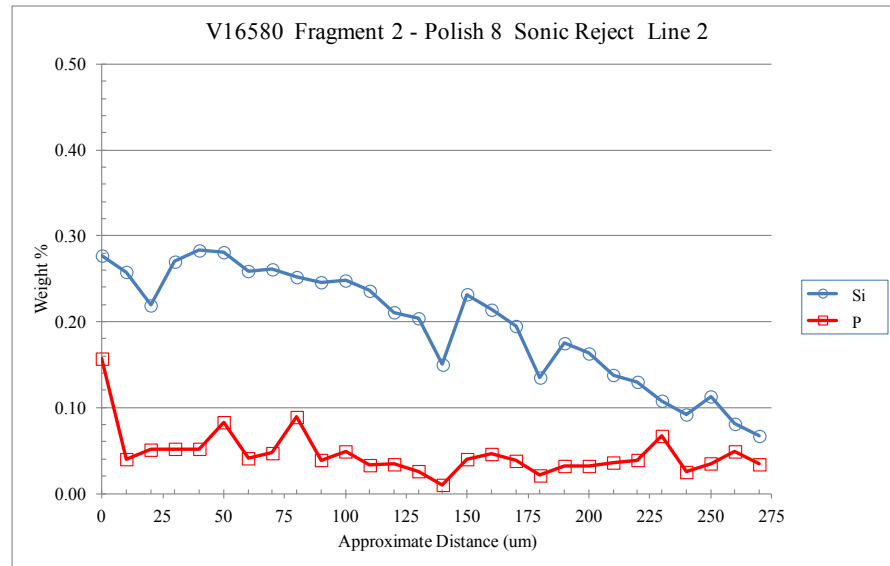
The metallographic section through Fragment 2 was analyzed via electron microprobe. Two line scans extending up to 275  $\mu\text{m}$  away from the inclusion were completed. Review of the data found decreasing concentration gradients of silicon and phosphorous, indicative of a reaction between the inclusion and the base metal. The relative concentrations decreased at increased distance from the inclusion (Figure 63). The gradient was similar to that seen on the prior analysis of Fragment 1.

Figure 63: Electron microprobe line scans taken on Fragment 2 Polish 8 moving away from the inclusion. Weight percent values of Si and P for each trace shown on right. It should be noted that while this data can be used to understand general trends, the absolute value of the weight percent measurement is uncertain due to a lack of calibration of the electron microprobe at the levels observed.
